WORKINGTON TO MARYPORT**Baseline Information****Start co-ordinate:** 298315, 529573 **Finish co-ordinate:** 302966, 536857**Total length:** 8.8km **Defended length:** 2.8km**Sea Wall:** 1.4km **Rock Armour:** 1.4km**Artificial cliff:** 6.0km**Environmental designations:**

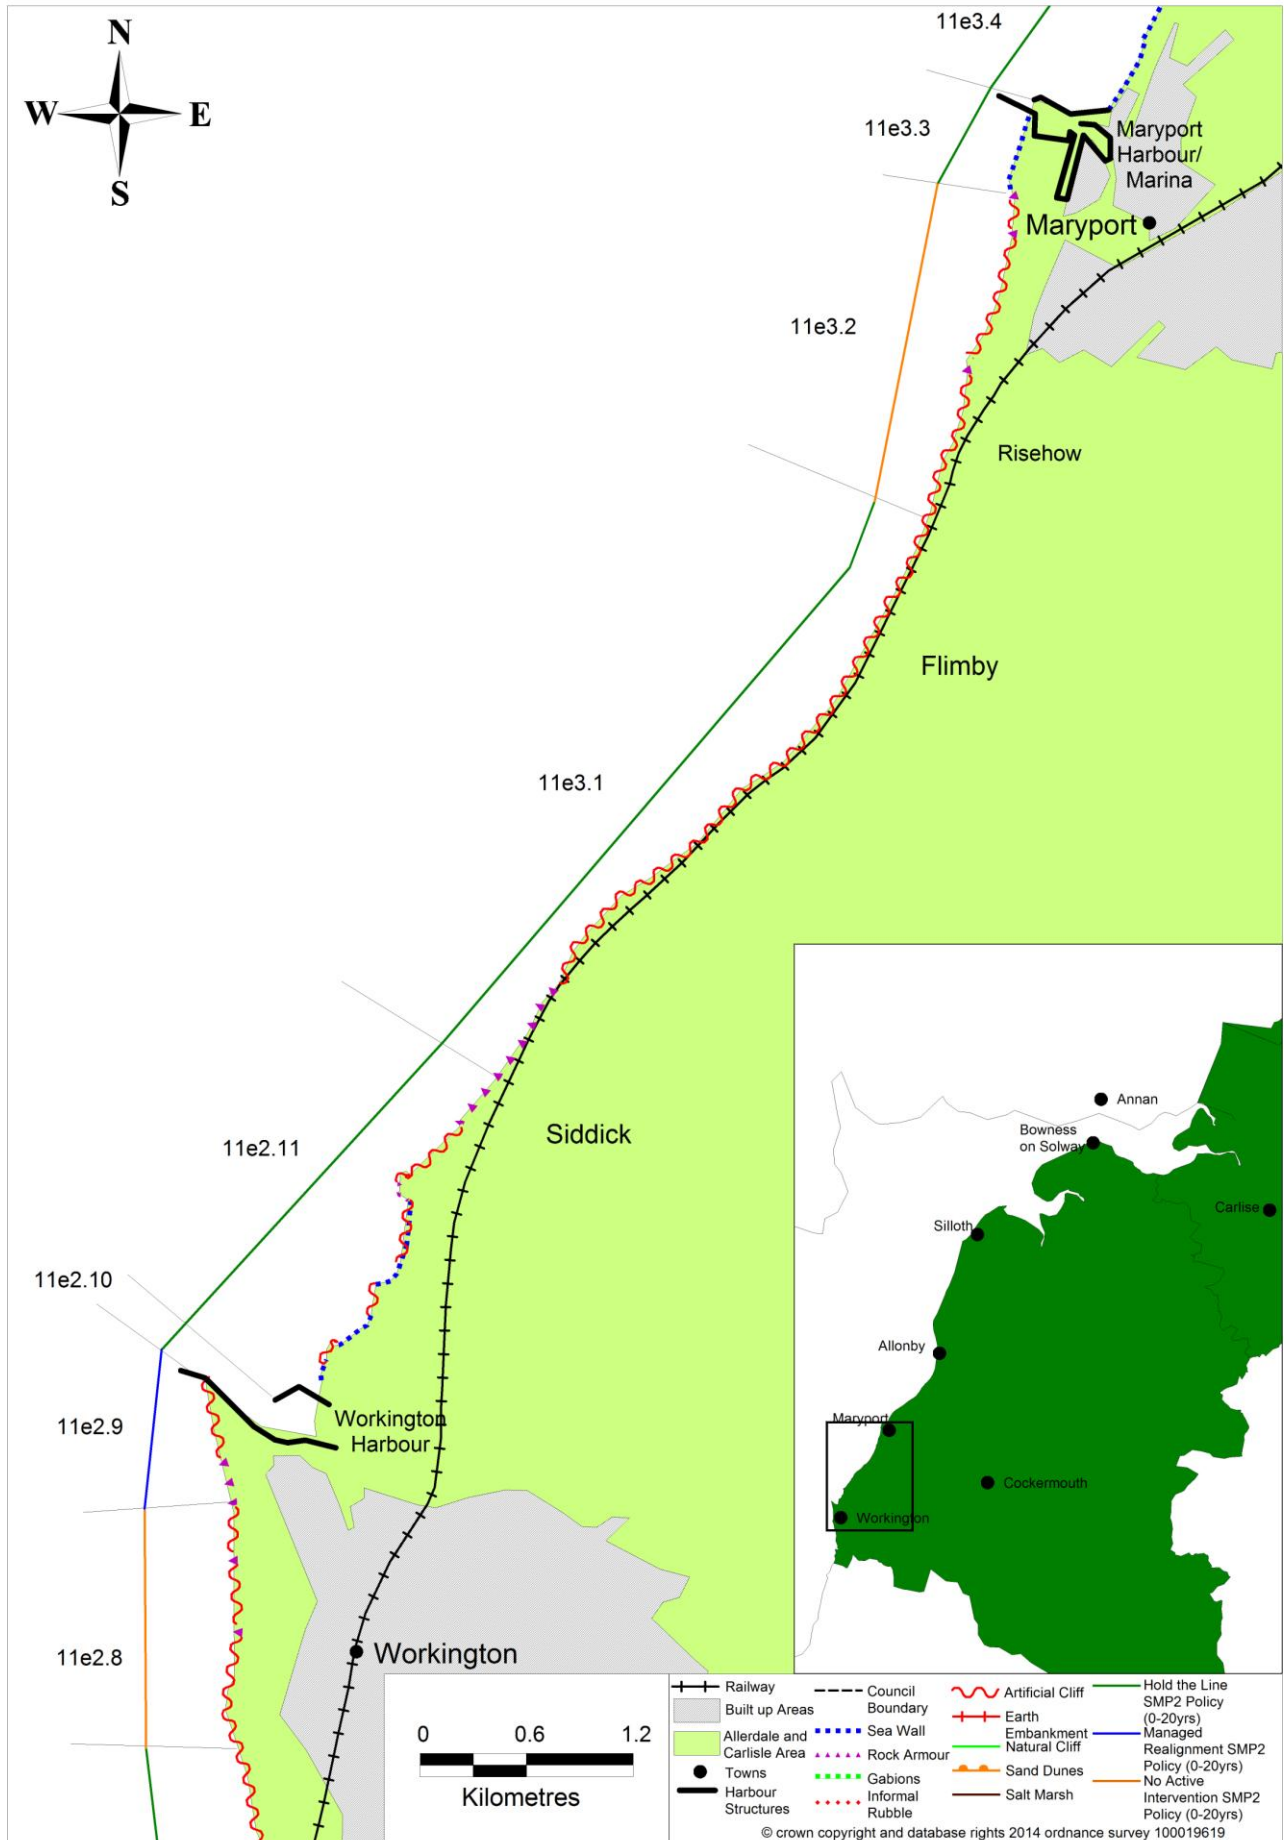
The seawall to the north of Workington harbour is fair condition. Some of the precast slabs on the defences north of Workington harbour have broken away. At Seaton the cliffs have eroded behind the gabion defences, leaving the gabions separated and unsupported causing them to collapse. At Siddick Ponds the defences are in fair condition, with damage to the southern end.

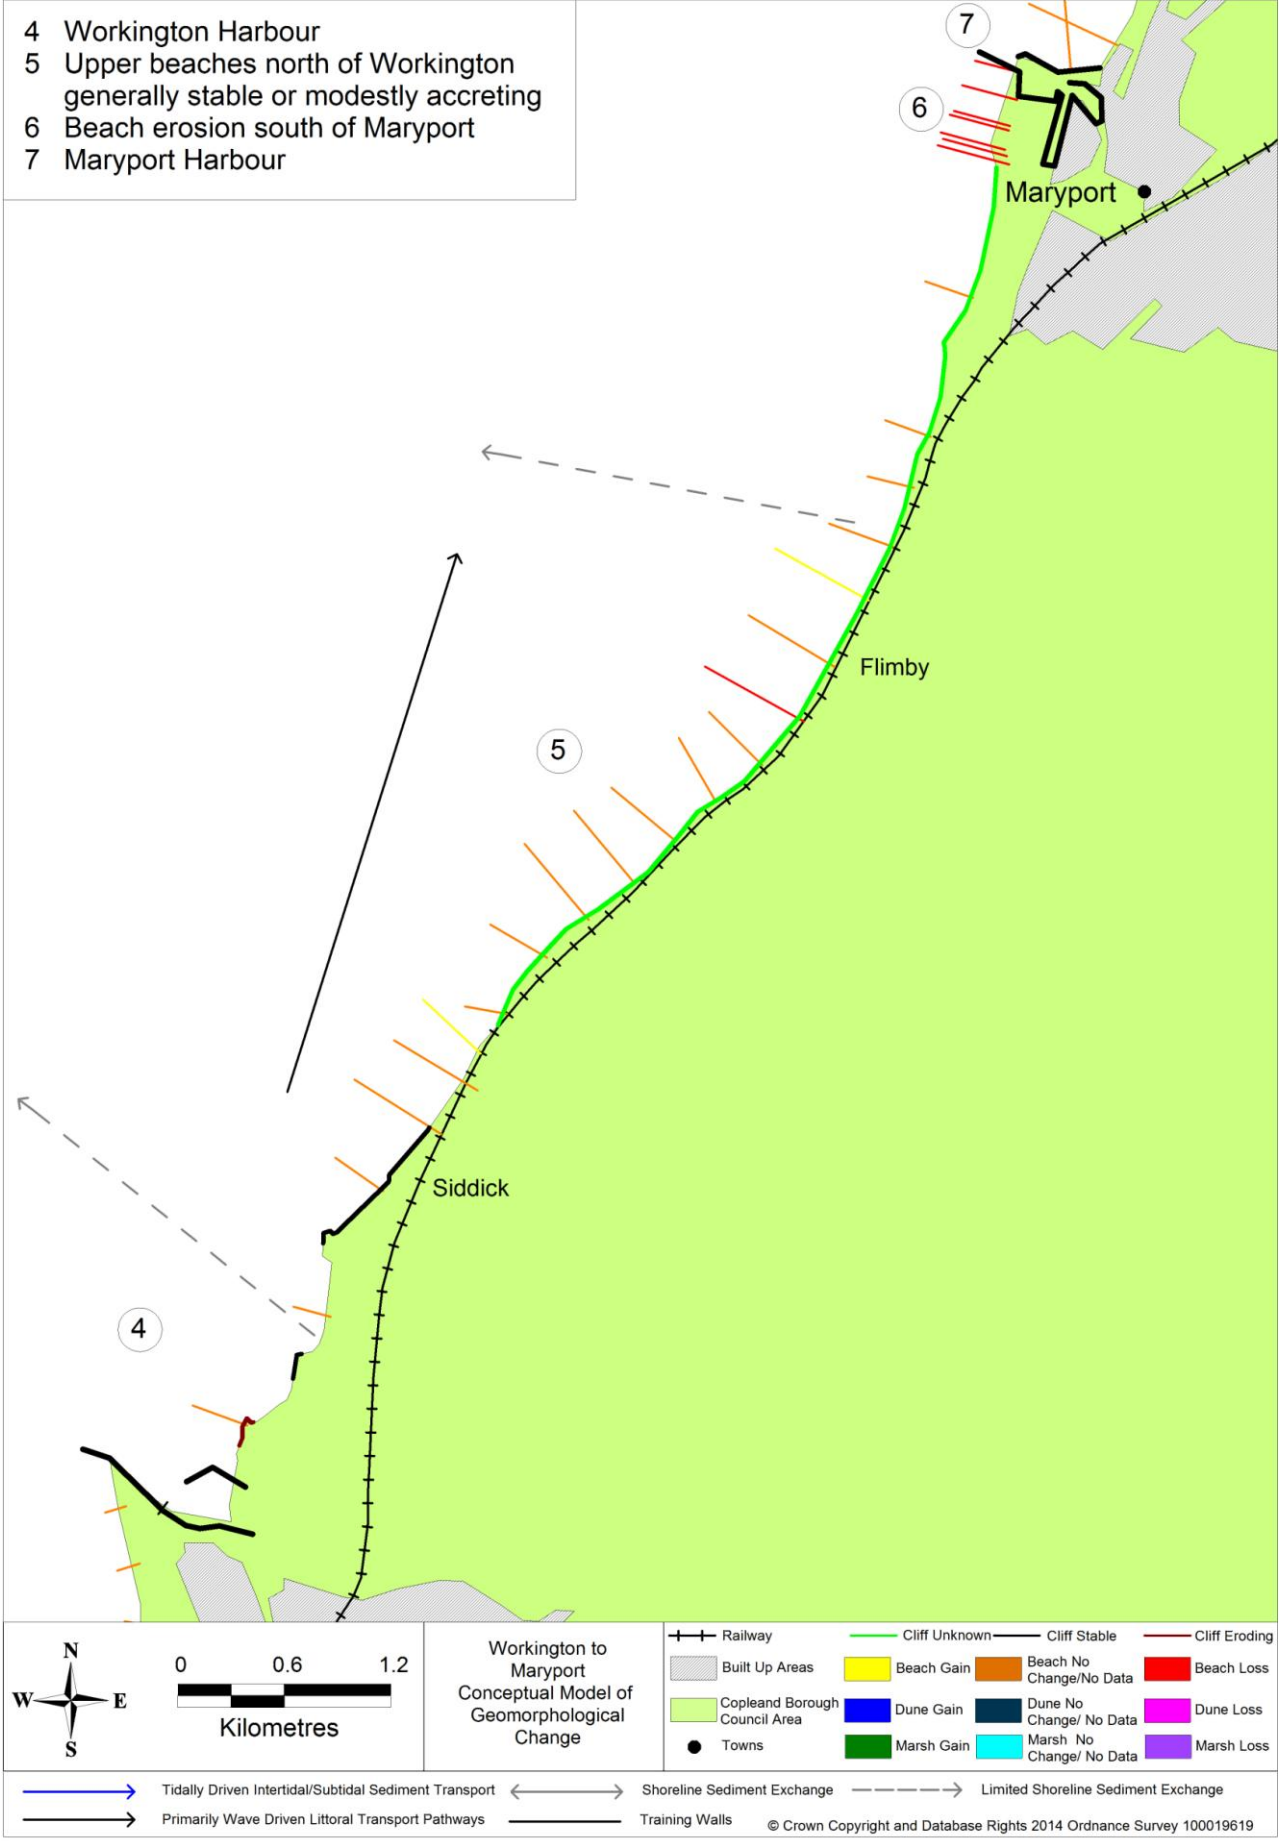
- Beach generally stable between Workington and Flimby. Profile change: 33% – accretion, 17% – erosion, 50% – no change; and
- Erosion south of Maryport. Profile change: 10% – accretion, 80% – erosion, 10% – no change.

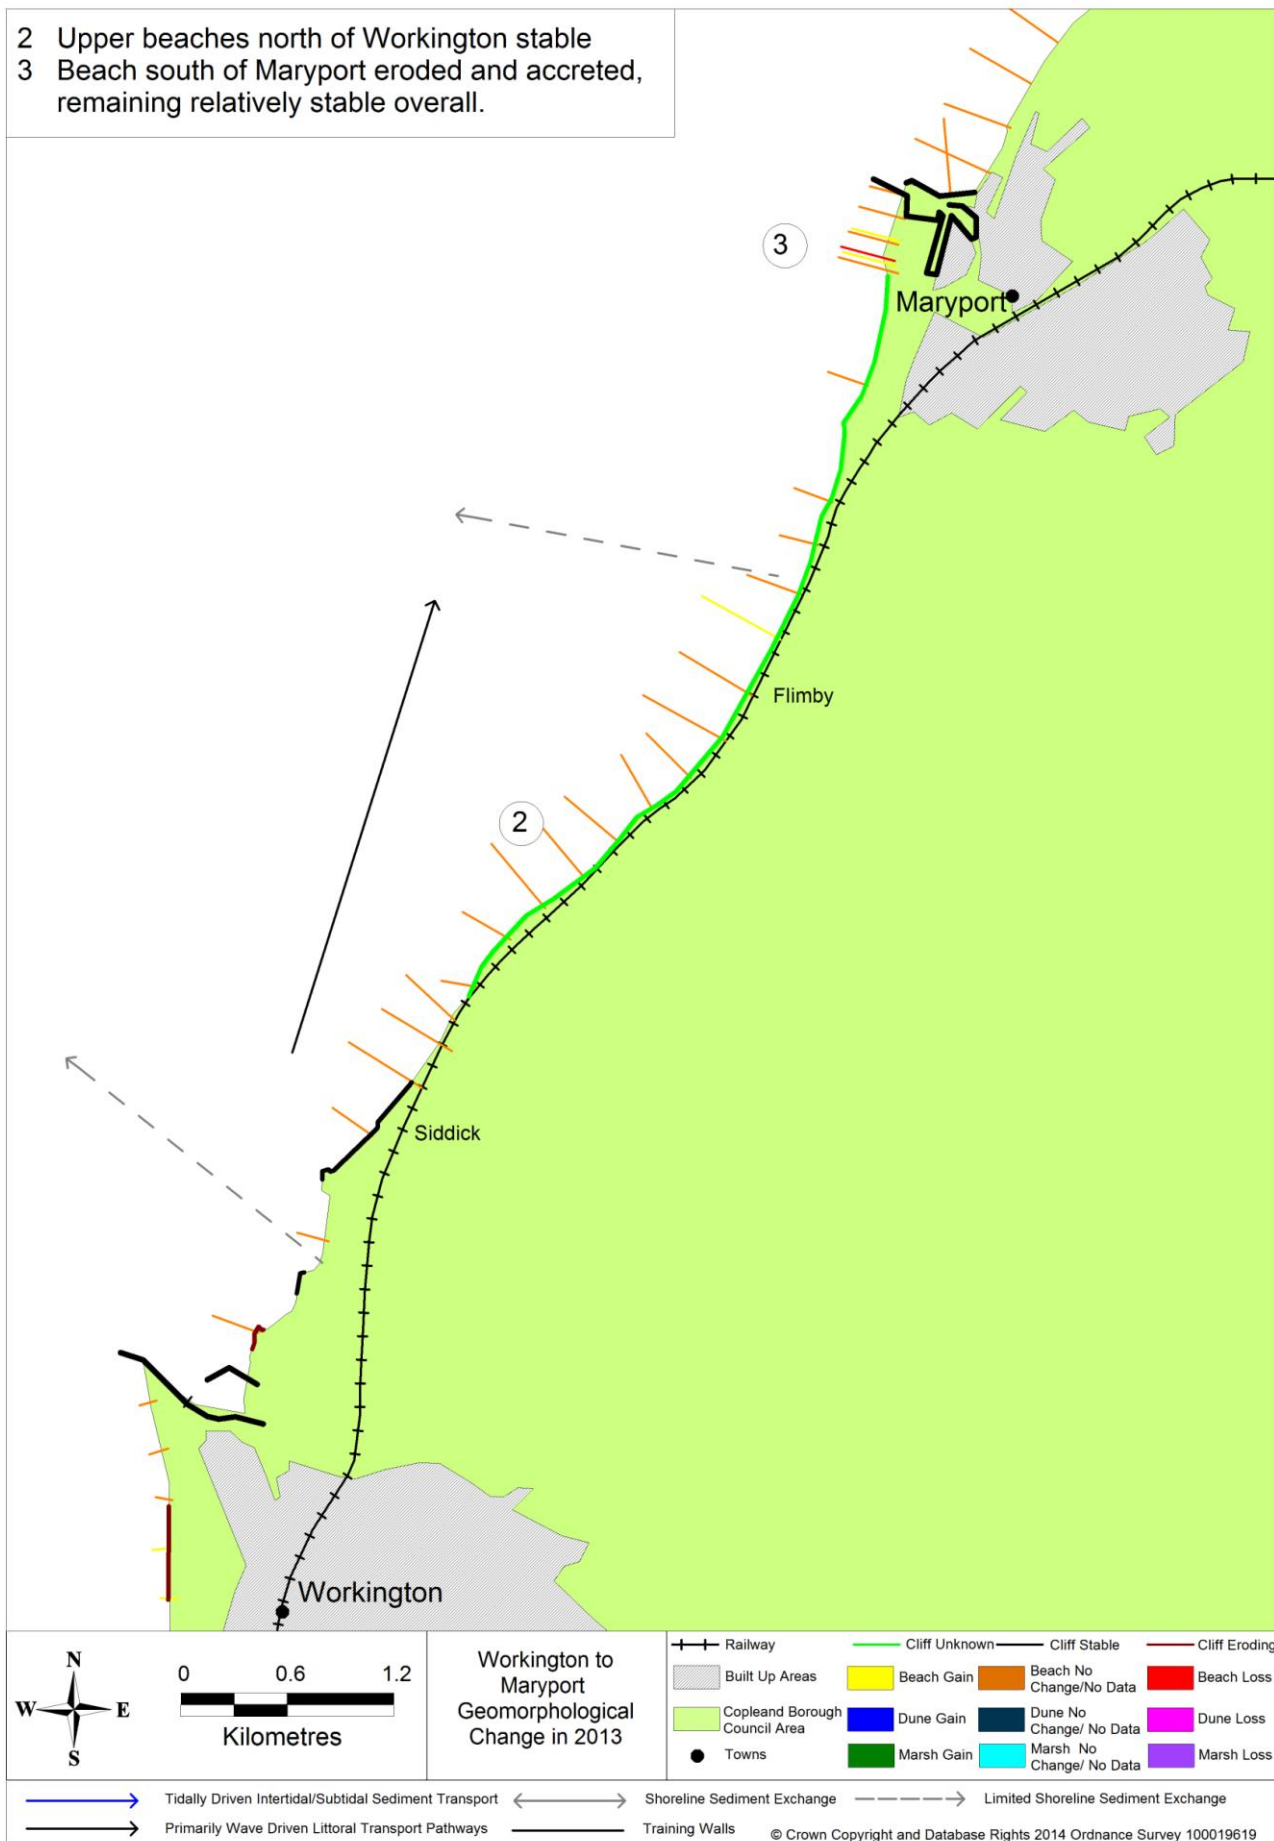
- Only 16 out of 28 profiles recorded;
- Little overall change in beach cross sectional areas between Workington & Flimby. Profile change: 17% – accretion, 0% – erosion, 83% – no change; and
- Little overall change in beach cross sectional areas south of Maryport. Profile change: 30% – accretion, 10% – erosion, 60% – no change

- Continue current monitoring regime;
- Improve additional remote sensing e.g. LiDAR;
- On-going monitoring of condition of artificial defence structures; and
- Carry out remedial works to maintain integrity of defences, as required.
