**ALLONBY BAY (MARYPORT TO DUBMILL POINT)****Baseline Information**

**Allonby Bay (Maryport to Dubmill Point)**  
Geomorphological Change in 2013

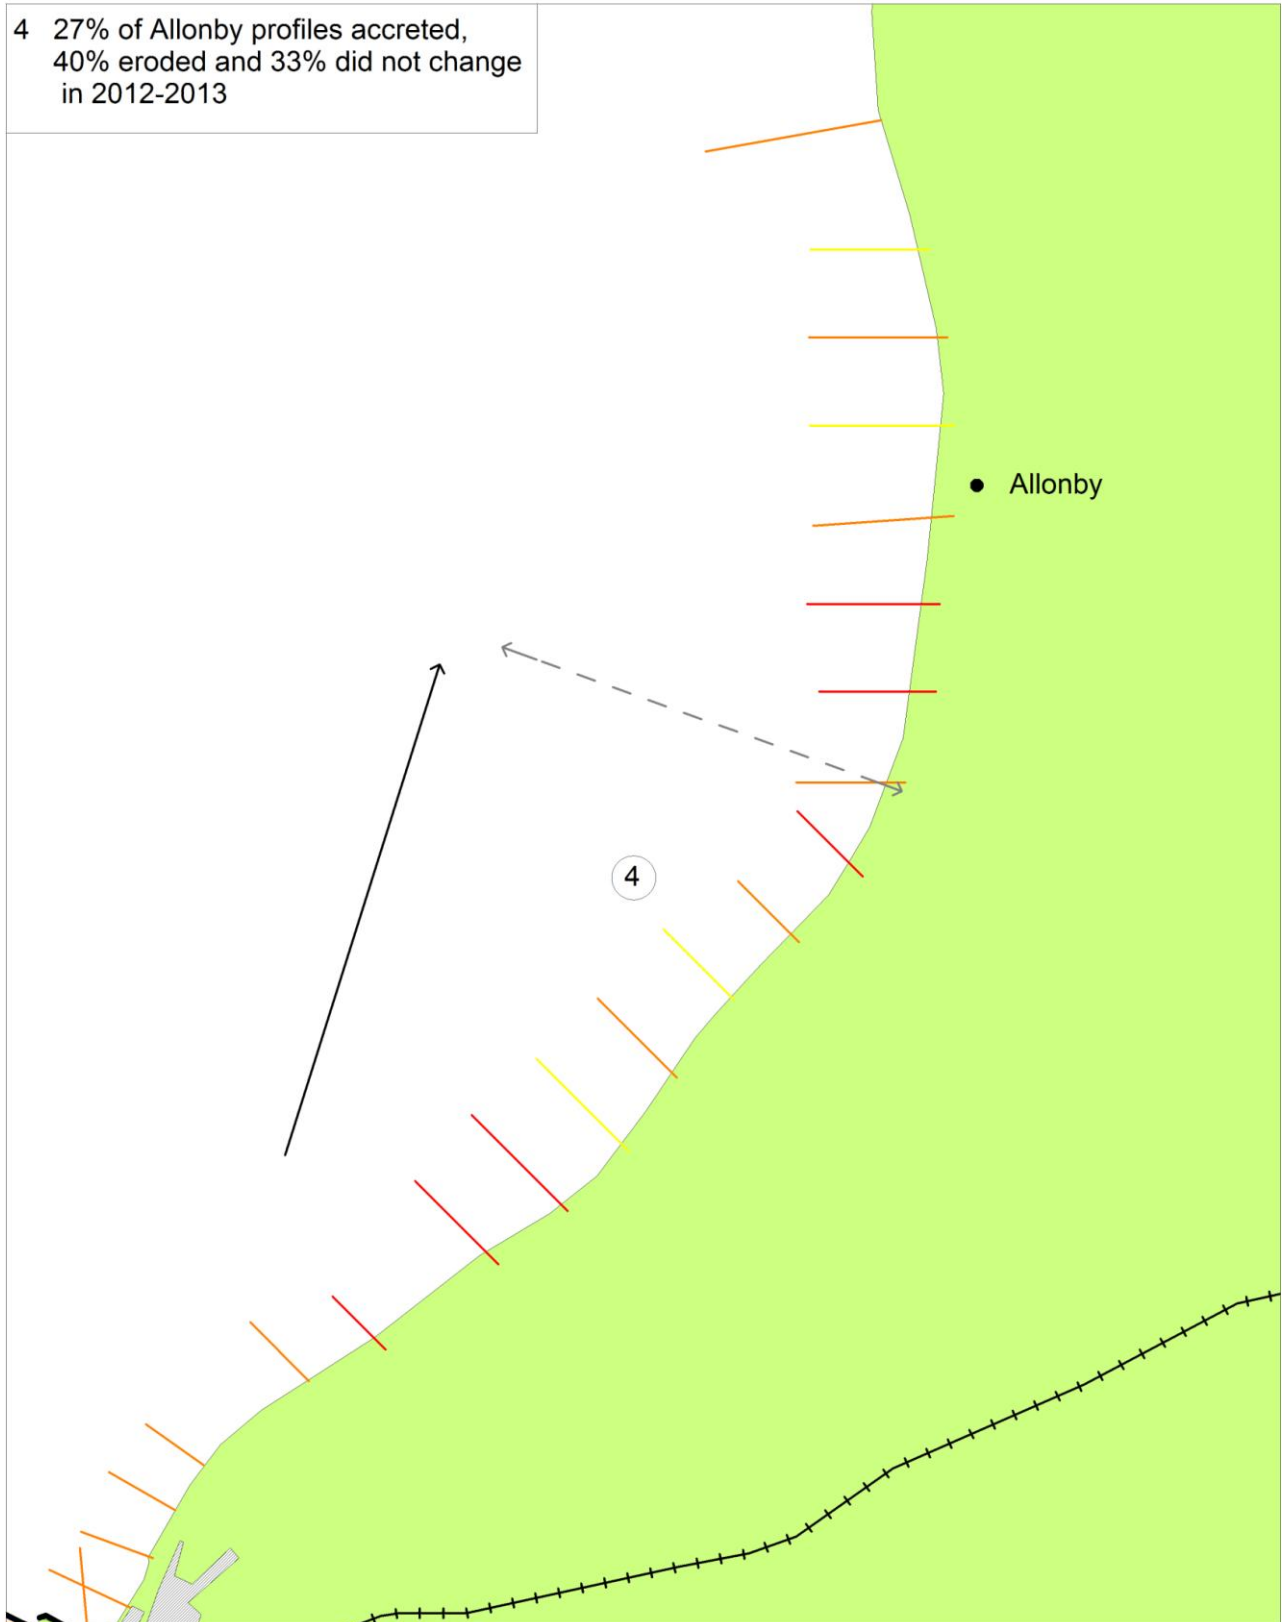
- Change generally the same as overall trend; and
- For the profiles with more than one survey (15 No.) change: 27% – accretion, 40% – erosion, 33% – no change.

4 27% of Allonby profiles accreted, 40% eroded and 33% did not change in 2012-2013
