ALLONBY BAY (MARYPORT TO DUBMILL POINT)**Baseline Information**

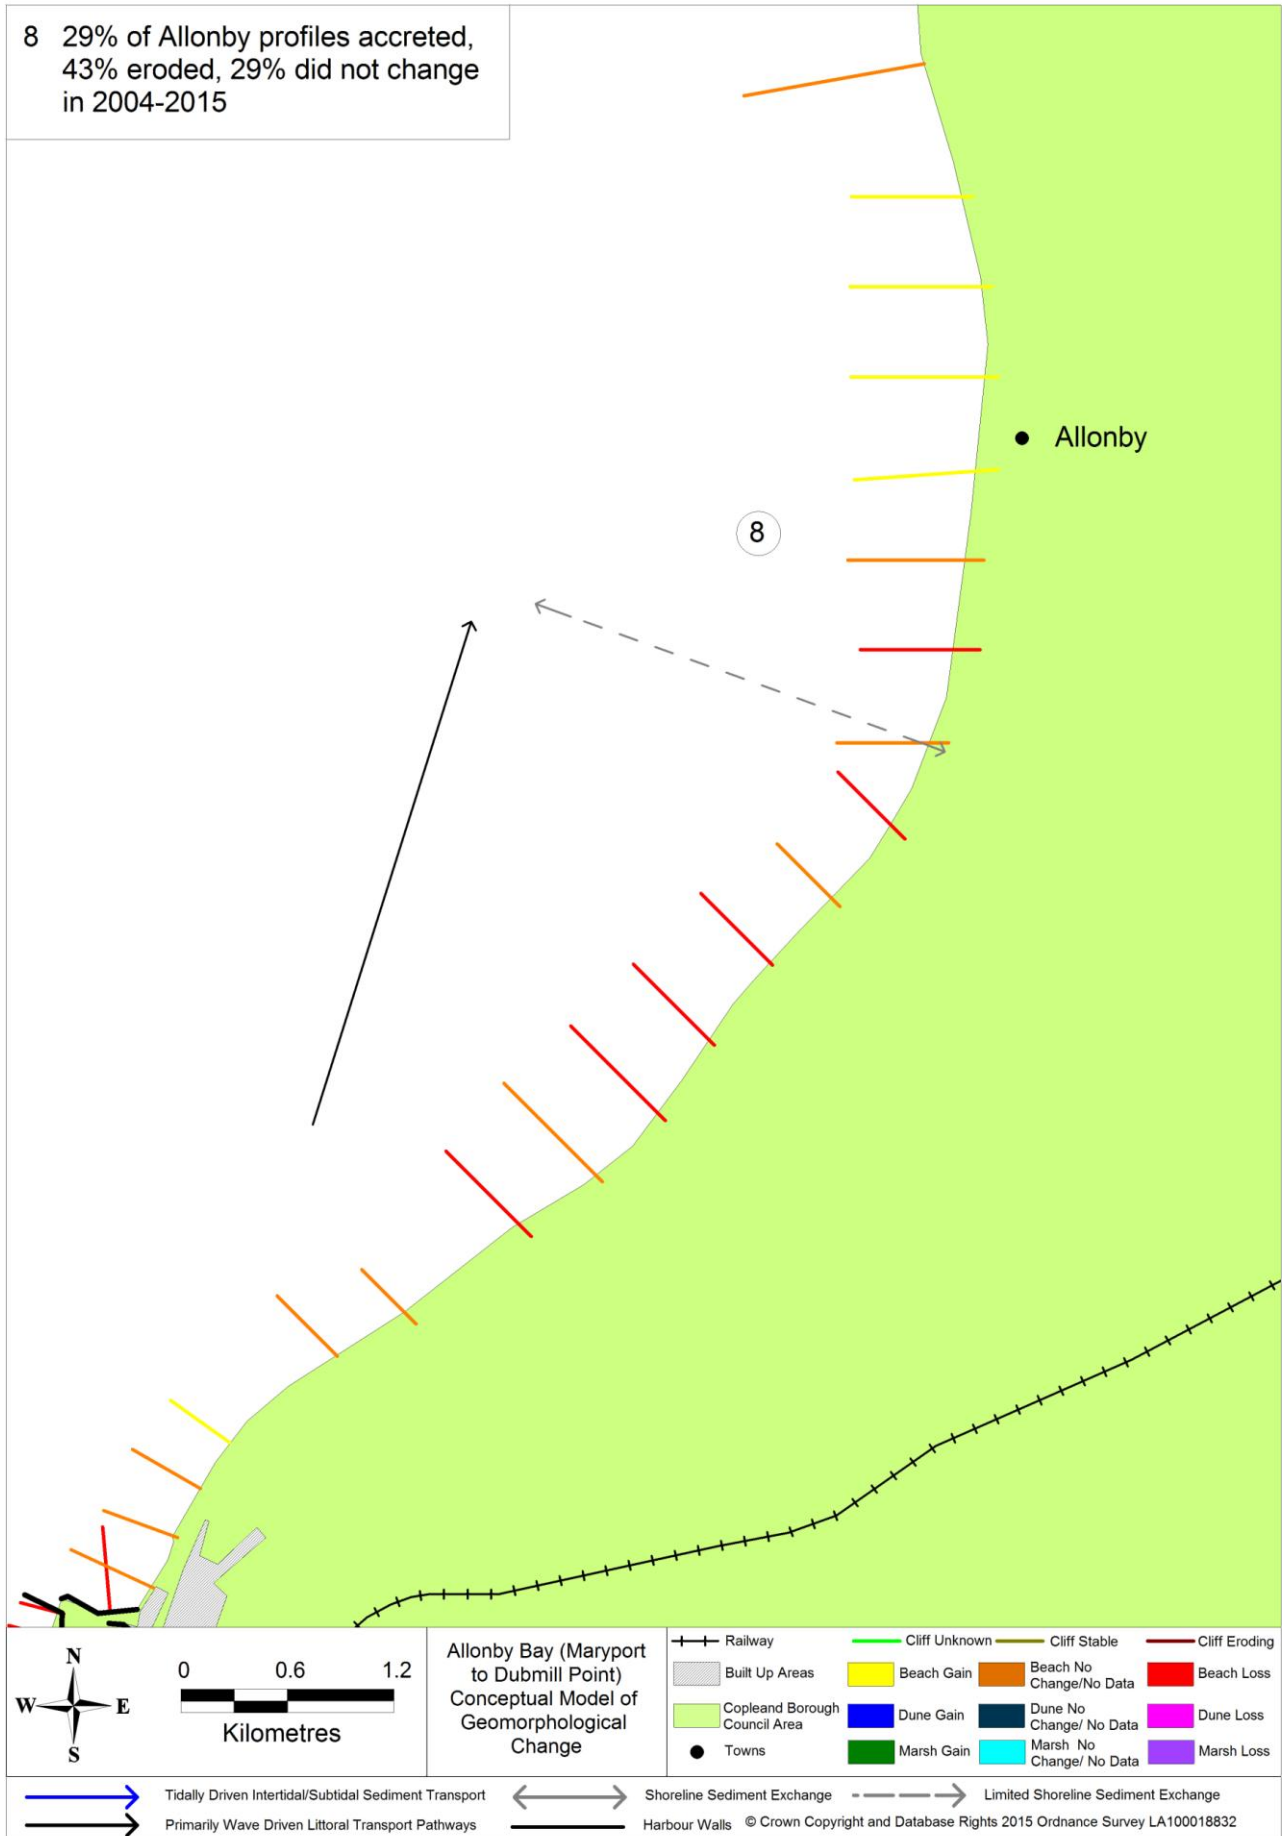
- Generally variable behaviour occurring;
- Erosion south of Allonby;
- Accretion north of Allonby; and
- Overall profile change: 29% – accretion, 43% – erosion, 29% – no change

This behaviour is illustrated graphically on the plan overleaf.

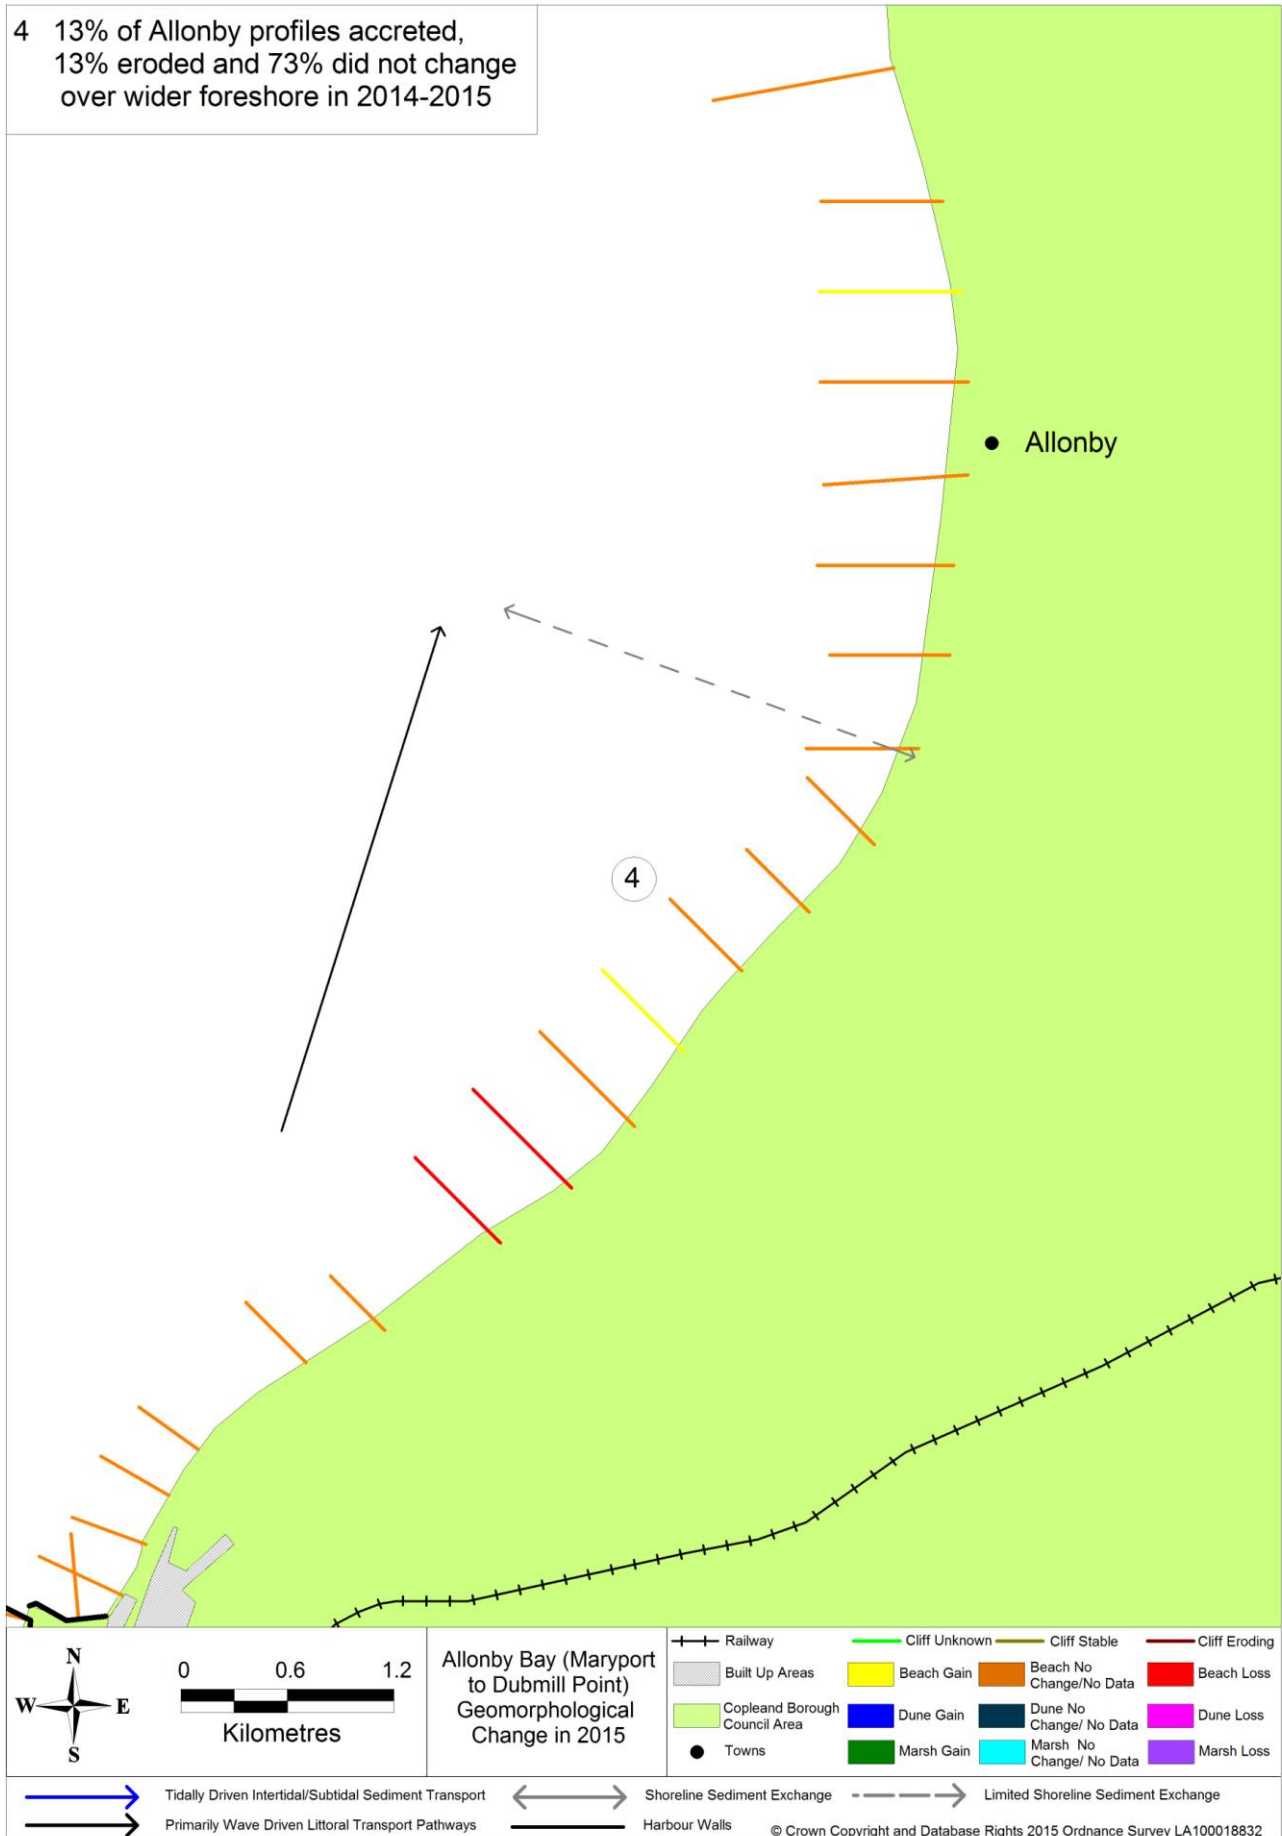
- Only 15 out of 22 profiles available for comparison;
- Change generally the same as overall trend; and
- Profile change: 13% – accretion, 13% – erosion, 73% – no change.

The plot overleaf summarises the results from the monitoring data analysis for this section in 2015.
