# Coastal Morphology Report

## Thorpeness (Phase 1)

RP024/S/2011

July 2011

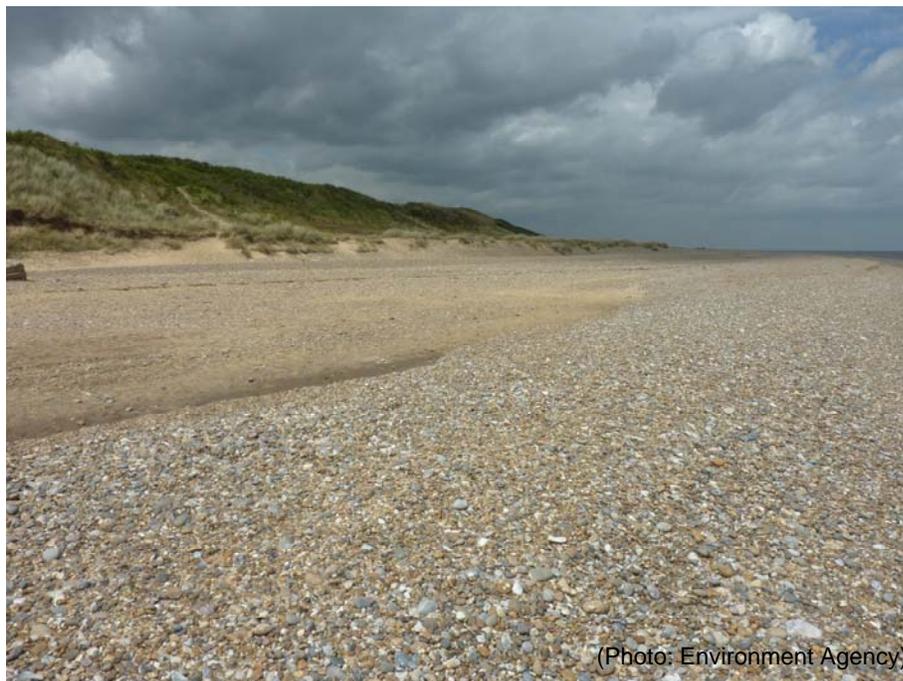
Figure 1 – Thorpeness Ness, looking northwards (June 2011)

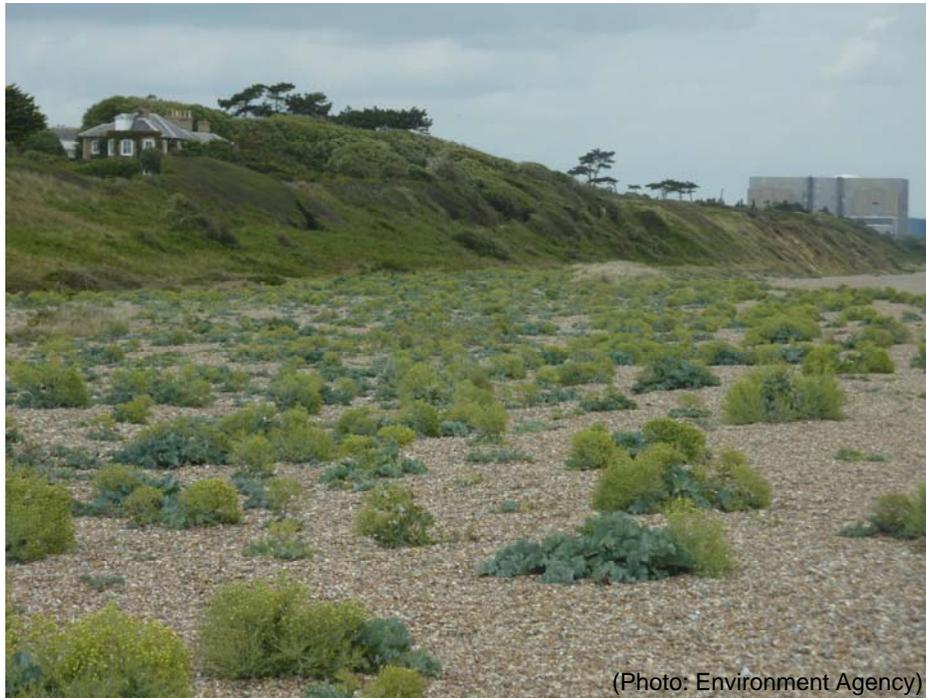
Figure 2 – Vegetated shingle backshore at Thorpeness Ness with Ness House (left) and Sizewell power station (right) in background (June 2011)  
(Photo: Environment Agency)

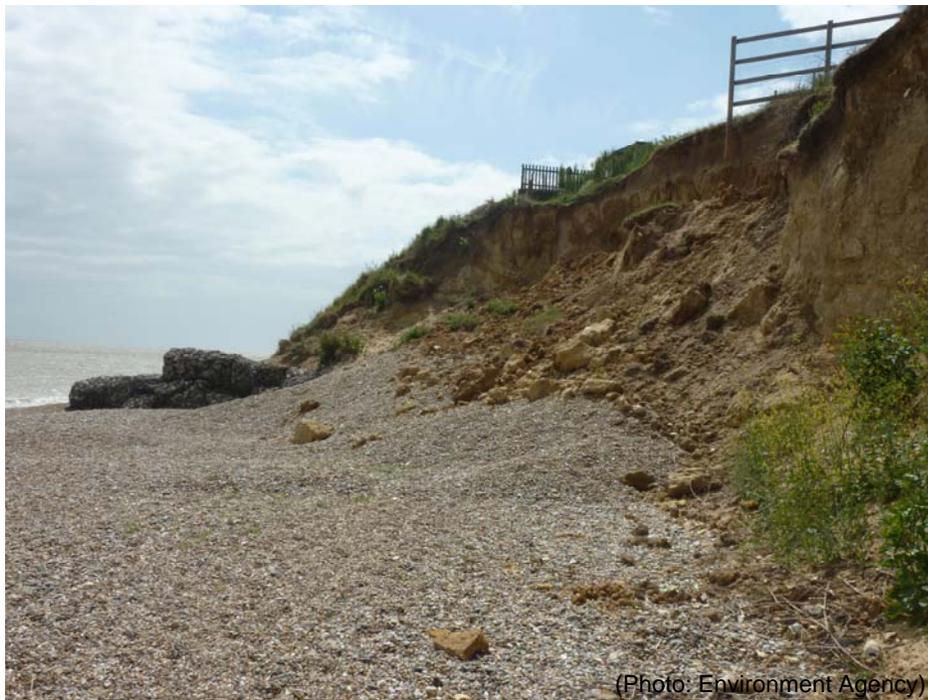
The vertical cliff face here retreats by 4.5 metres between the 2010W and 2010S surveys. According to anecdotal evidence there was increasing erosion pressure during the spring of 2010 which then culminated in the storm event of June 2010, with beach drawdown evidenced along the entire profile. There is a flat foreshore with no ridges or berms and the upper beach at the toe of cliffs is also greatly scoured.

Figure 3 – Area of increased cliff scour just north of gabioned section, looking southwards (June 2011)

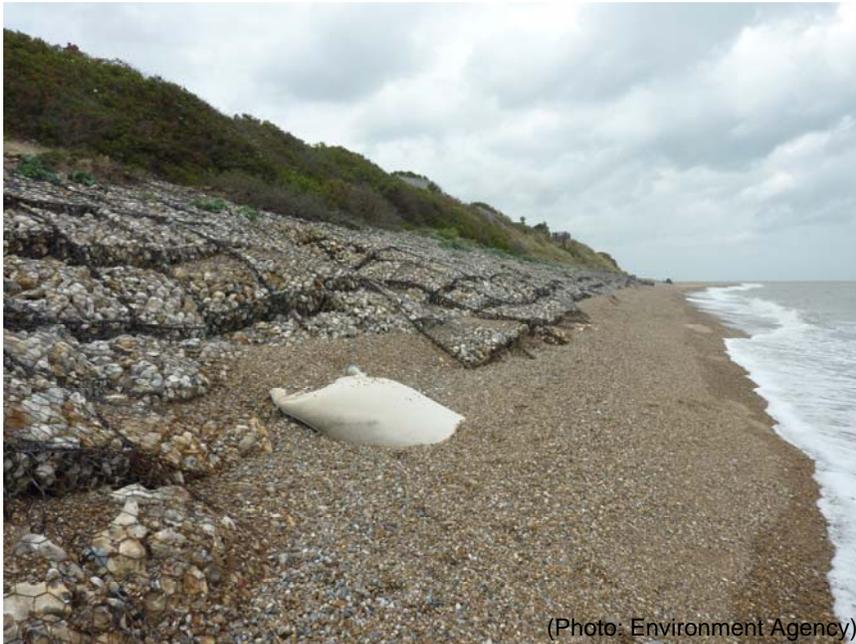
Figure 4 – Gabioned section at Thorpeness adjacent to North End Avenue, looking northwards (June 2011)

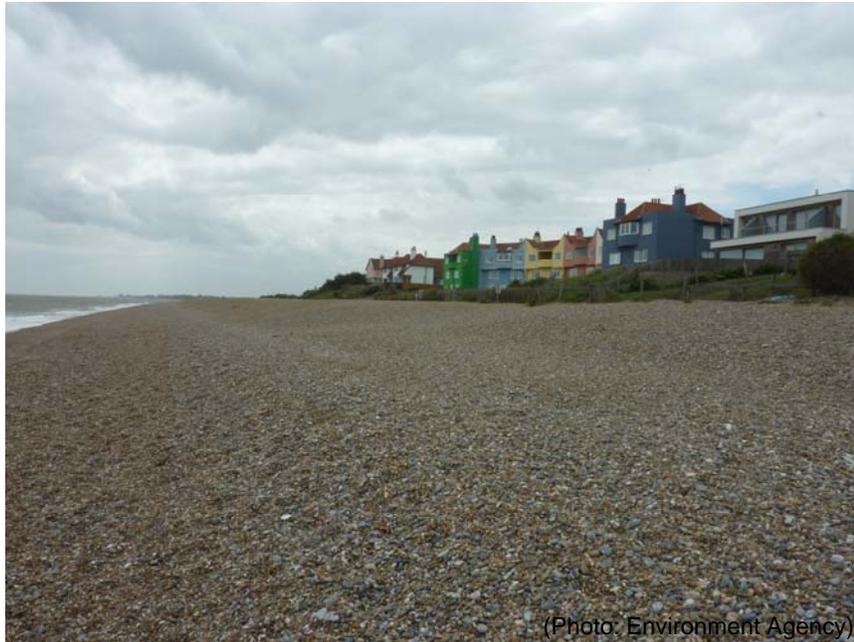
Figure 5 – Thorpeness frontage south of the gabioned section, looking southwards (June 2011)

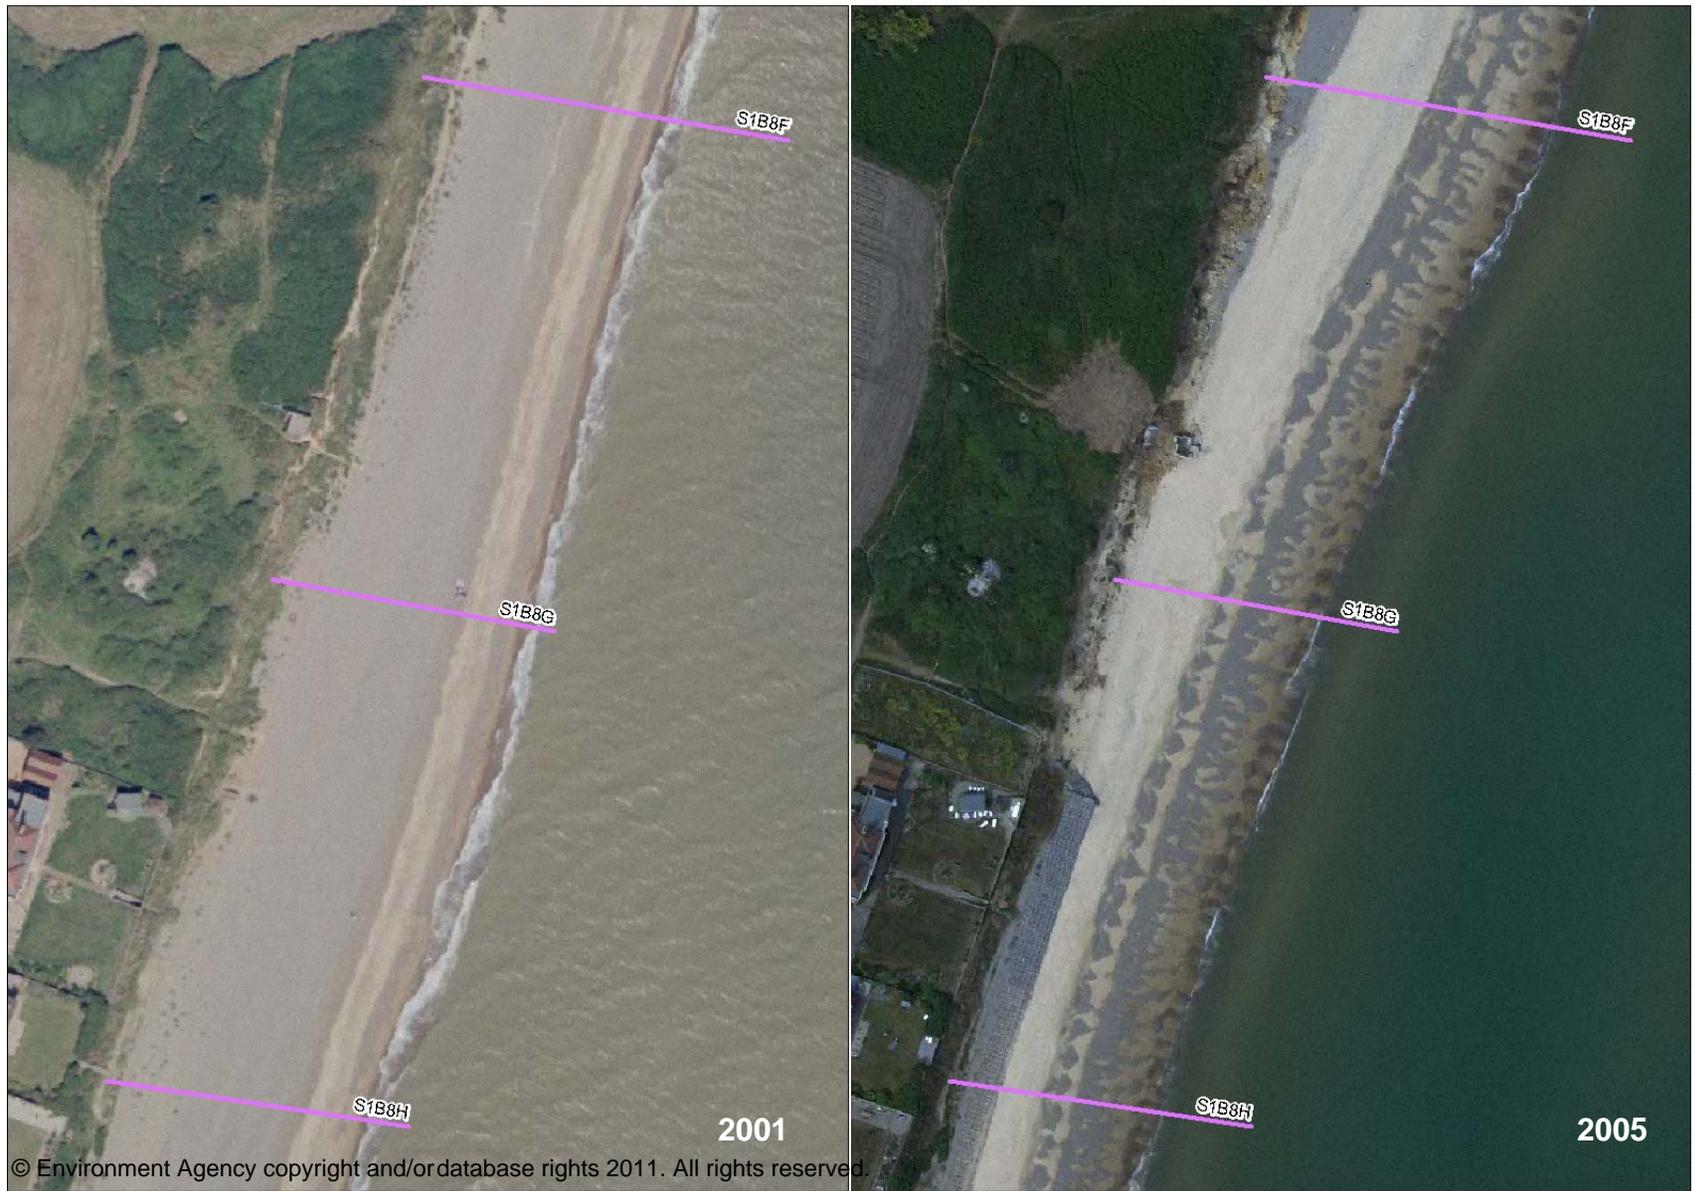
The series of aerial photos below (Figures 6a and 6b) show an erosional event between 2001 and 2005 in the present scour area. There are exposed gabions as well as scour just to the north of this with a structure (just north of S1B8G) no longer sitting on top of the cliff as in 2001 aerial but now located on the upper beach in front of the dune cliffs. This event has not been picked up by any of the beach profiles as the strategic profiles are much further north and south of here and the nearest profile S1B8G, for example, only being surveyed from 2009.

Figure 6a – aerial analysis in the scour area for 2001 and 2005 showing an erosion event in 2005 with exposed gabions and beach scour in the sand cliffs to the north

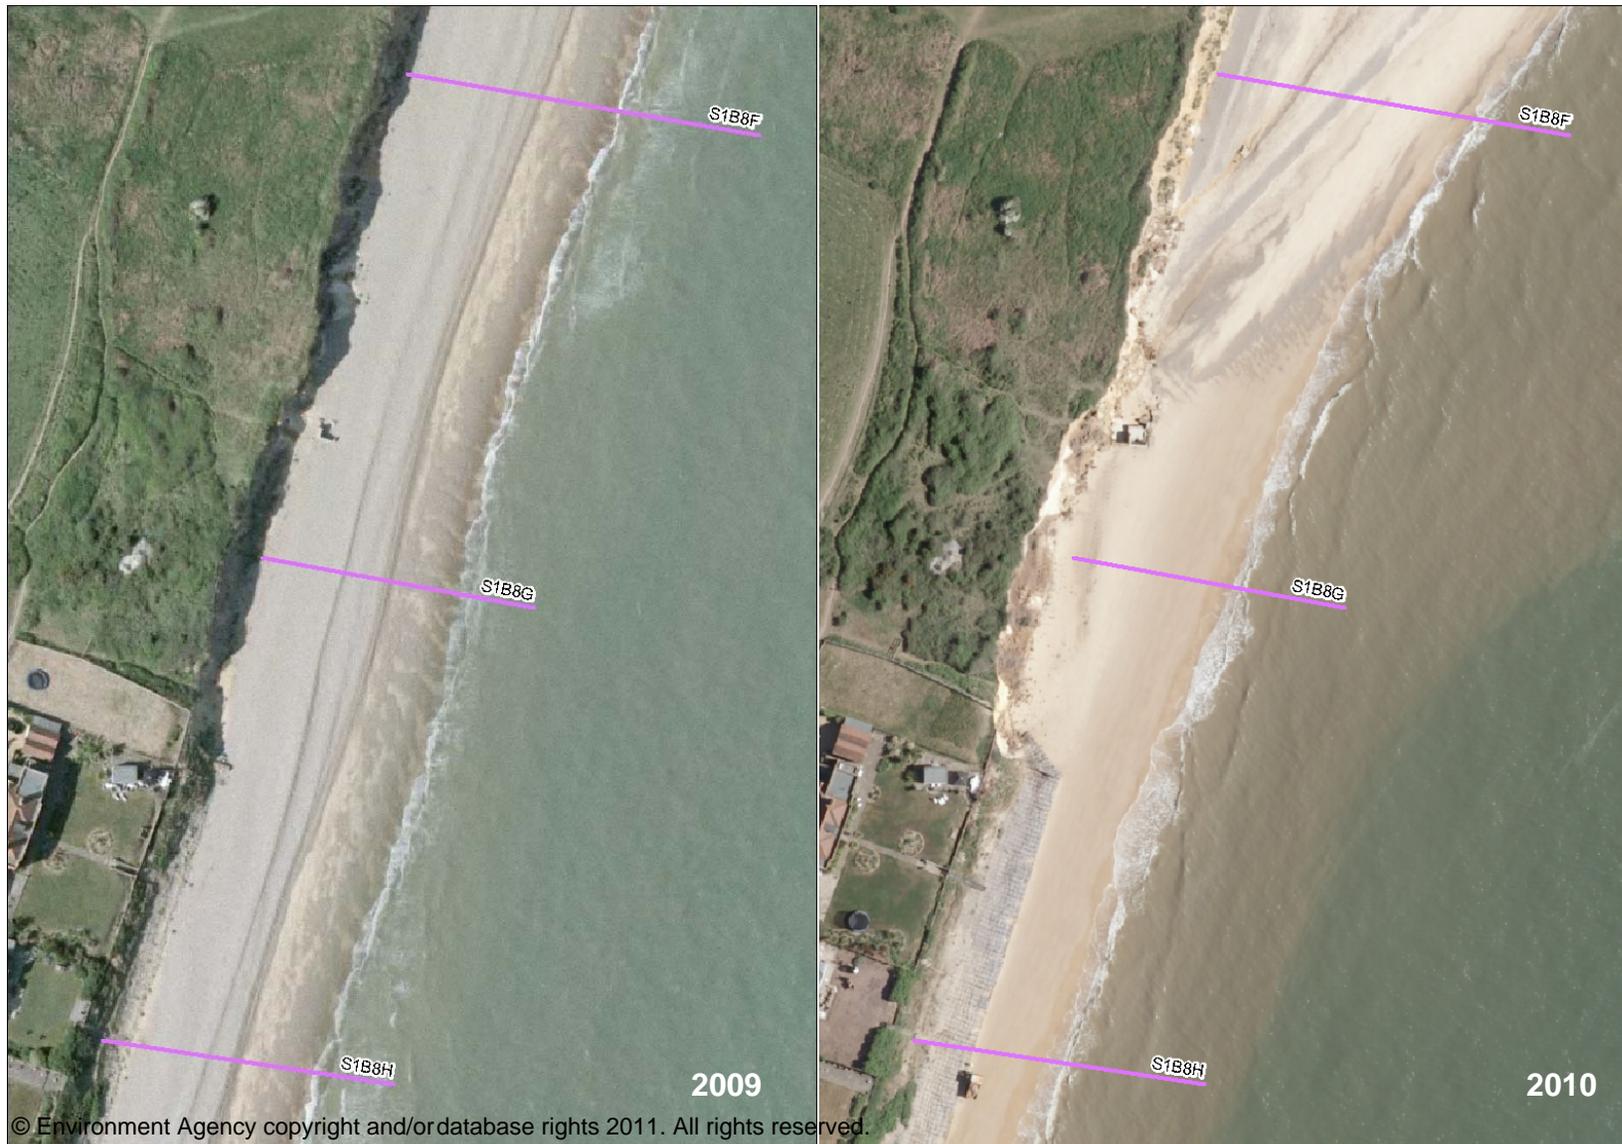
Between 2009 and 2010 aerials photographs, the June 2010 storm event is very much in evidence with renewed exposure of the gabions adjacent to North End Avenue and further scour in the cliff area, just to the north. The distance of cliff retreat evidenced here can be seen in the S1B8G beach profile in Appendix B10 to be around 4.5m (see Figure 8).

Figure 6b – aerial analysis in the scour area between 2009 and 2010 showing the June 2010 storm event with further exposed gabions and increased beach scour in the sand cliffs to the north. The Ness has accreted at its southern end with oblique sediment ridges.

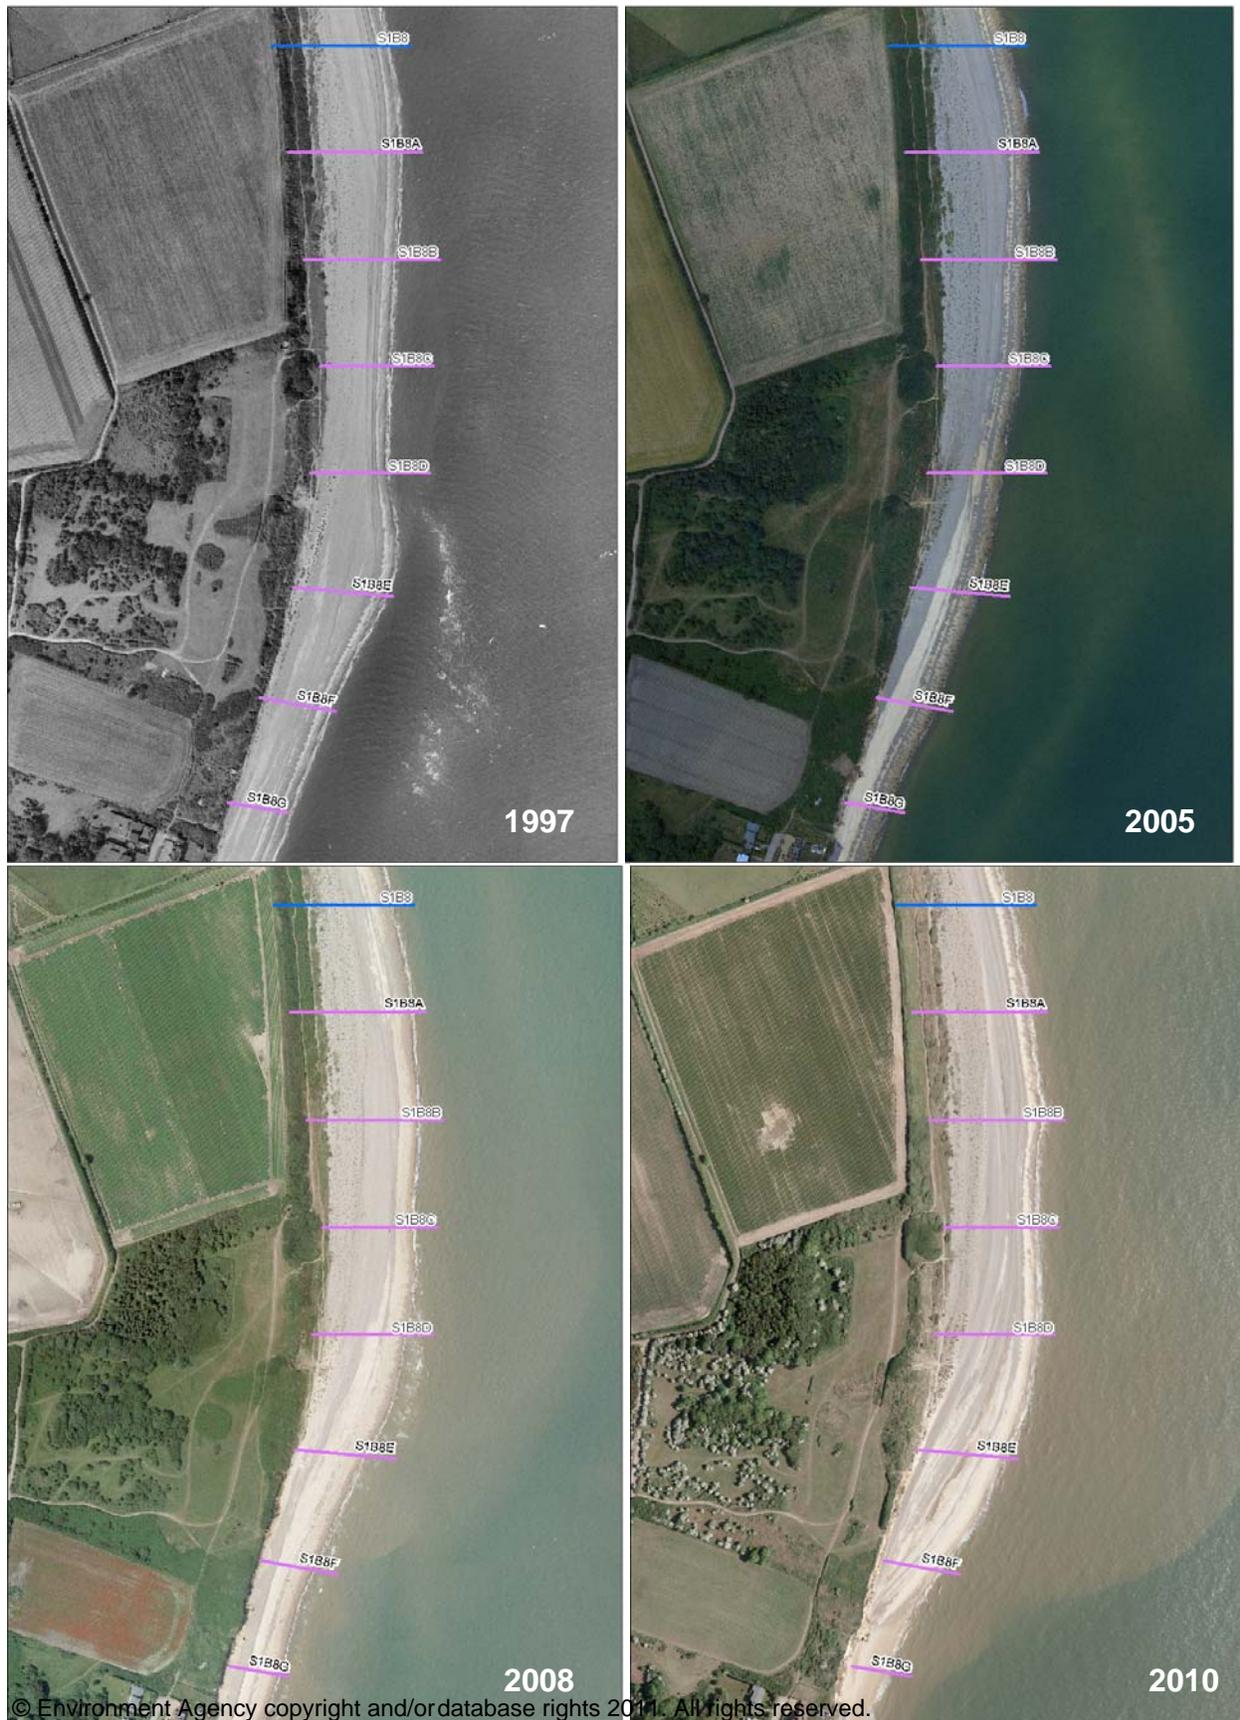
2010 aerials also shows the accumulation of sediment to the south side of the Ness together with foreshore berms at an oblique angle resulting from previous storm events. In previous years the foreshore ridges and berms all appear to run parallel to the beach. The Ness morphology is detailed further in Figure 7 overleaf for the years 1997, 2005, 2008, and 2010, with the erosion events shown in 2005 and 2010 at the southern end of the Ness.

Figure 7 – Comparisons in Ness morphology, 1997, 2005, 2008 and 2010. Erosion events are shown in 2005 and 2010 at the southern end of the Ness. Foreshore berms are most apparent in the 2010 aerial.

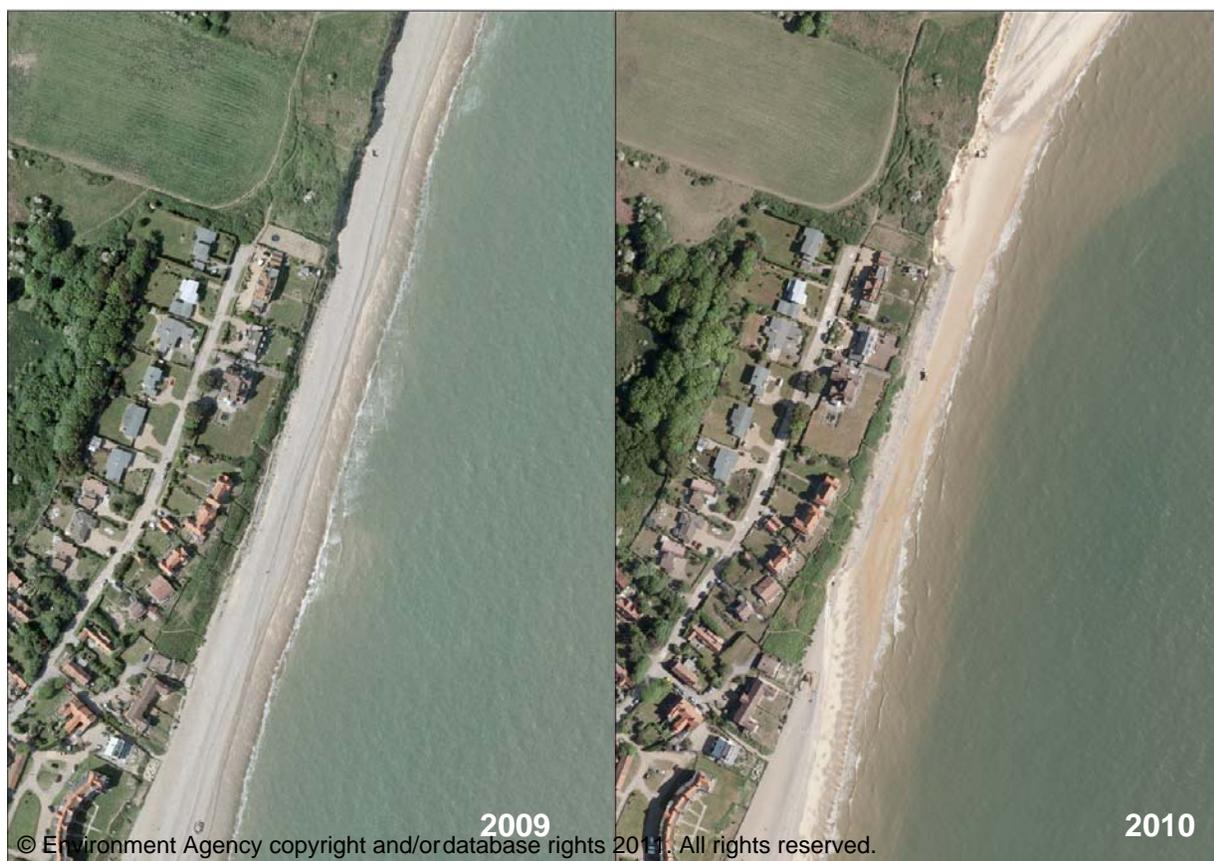
Figure 8 – Beach frontage at North End Avenue showing major scour between 2009 and 2010 aeriels. There is erosion either side of the gabioned area and increased scour north of the gabions. This loss of sediment is associated with increased sediment accumulation at the southern end of the Ness.

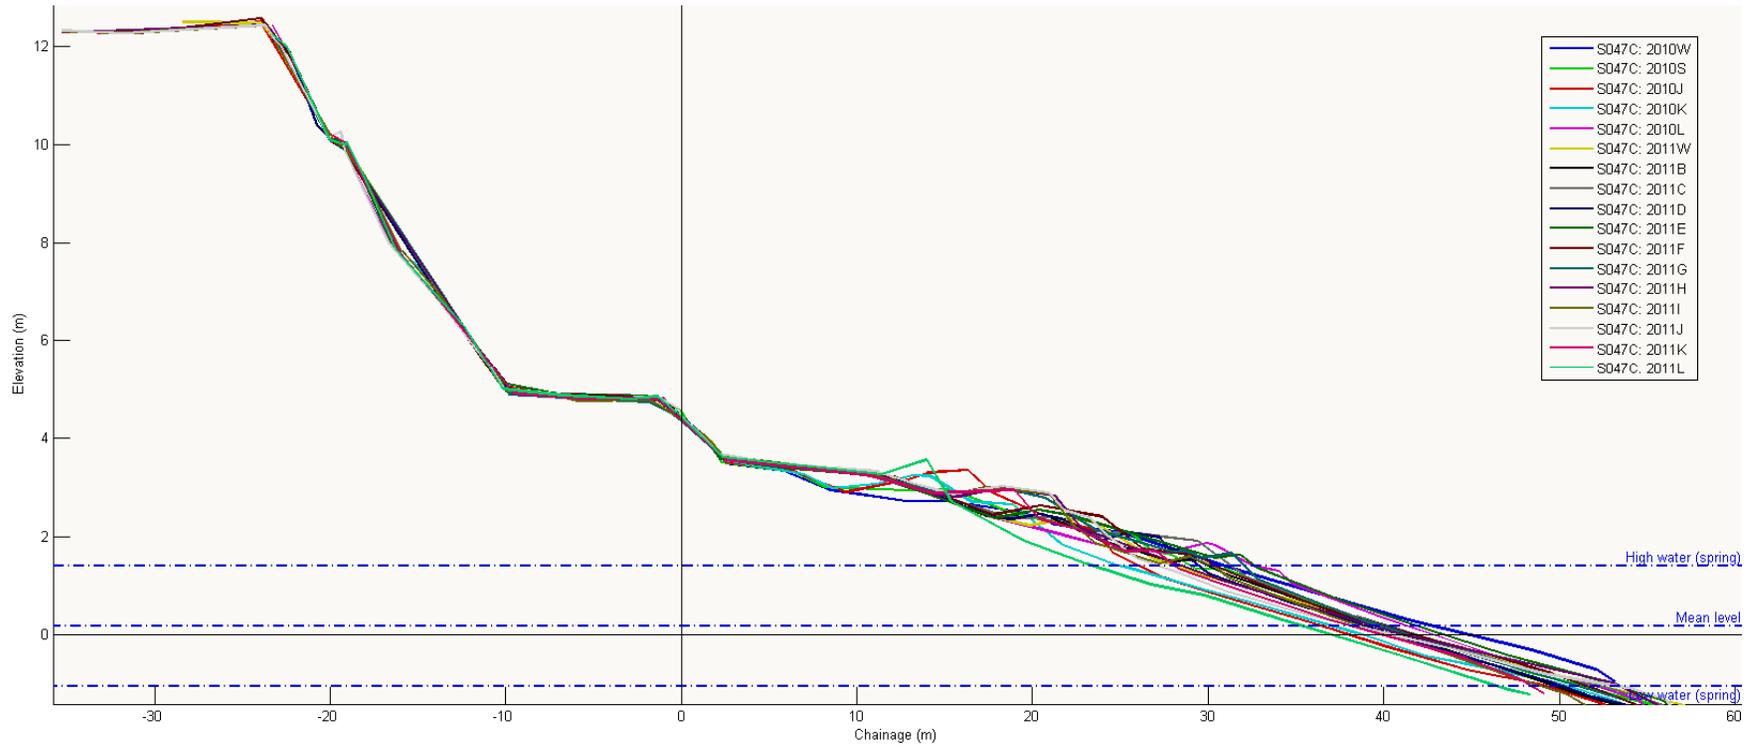
There is no movement in the dune cliff face, which is well established with vegetation. In front of this there is a stable vegetated shingle upper beach leading to the toe of the cliffs. At MHWs beach levels fluctuate naturally by around one metre down to low water. This active beach face showed the highest foreshore berm in October 2010 (2010J). There are no obvious signs of the storm event at this profile location (see Appendix B1).

Appendix B1 – S047C shows a stable beach profile with no obvious signs of the June 2010 storm event. The highest foreshore berm is shown in October 2010 (2010J – red line).

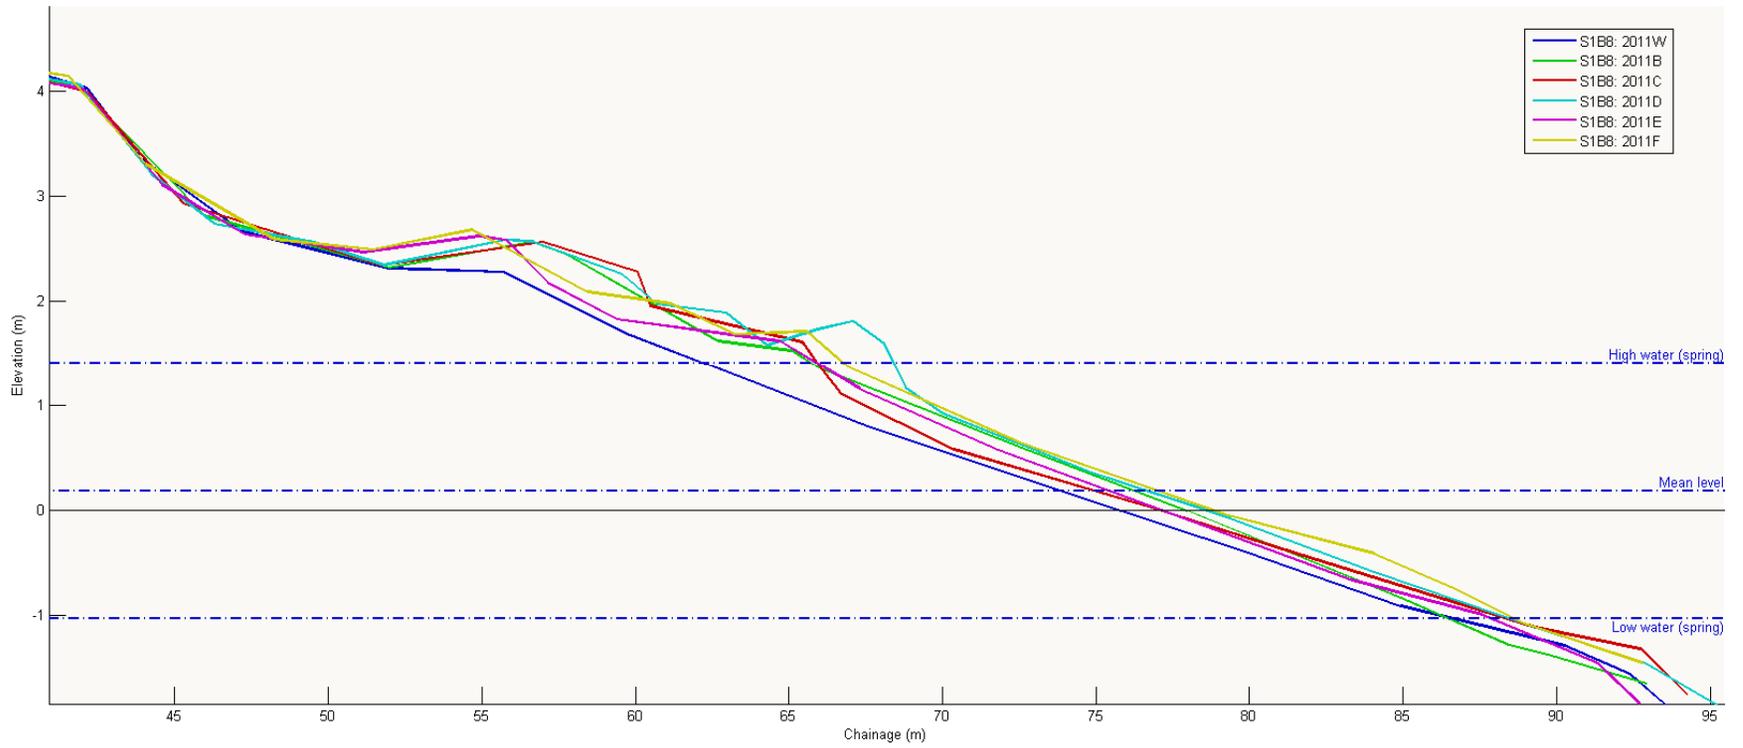
A generally stable beach profile. The recent Suffolk Coastal Trends report (2011) shows this profile to have minimal movement between high and low water – an erosional trend of 0.1 m/yr. The upper beach and cliff face have also shown no movement. There is seasonal movement in the intertidal area and movement of the high water ridge features (berms) along the shoreface. The highest seawards berm is higher than the land landwards of this, creating a trough-shaped beach. There appears to be some lower beach accretion from January to June 2011 (see Appendix B2).

Appendix B2 – S1B8 intertidal area, showing accretion in the period January to June 2011 with the development of high water berms.

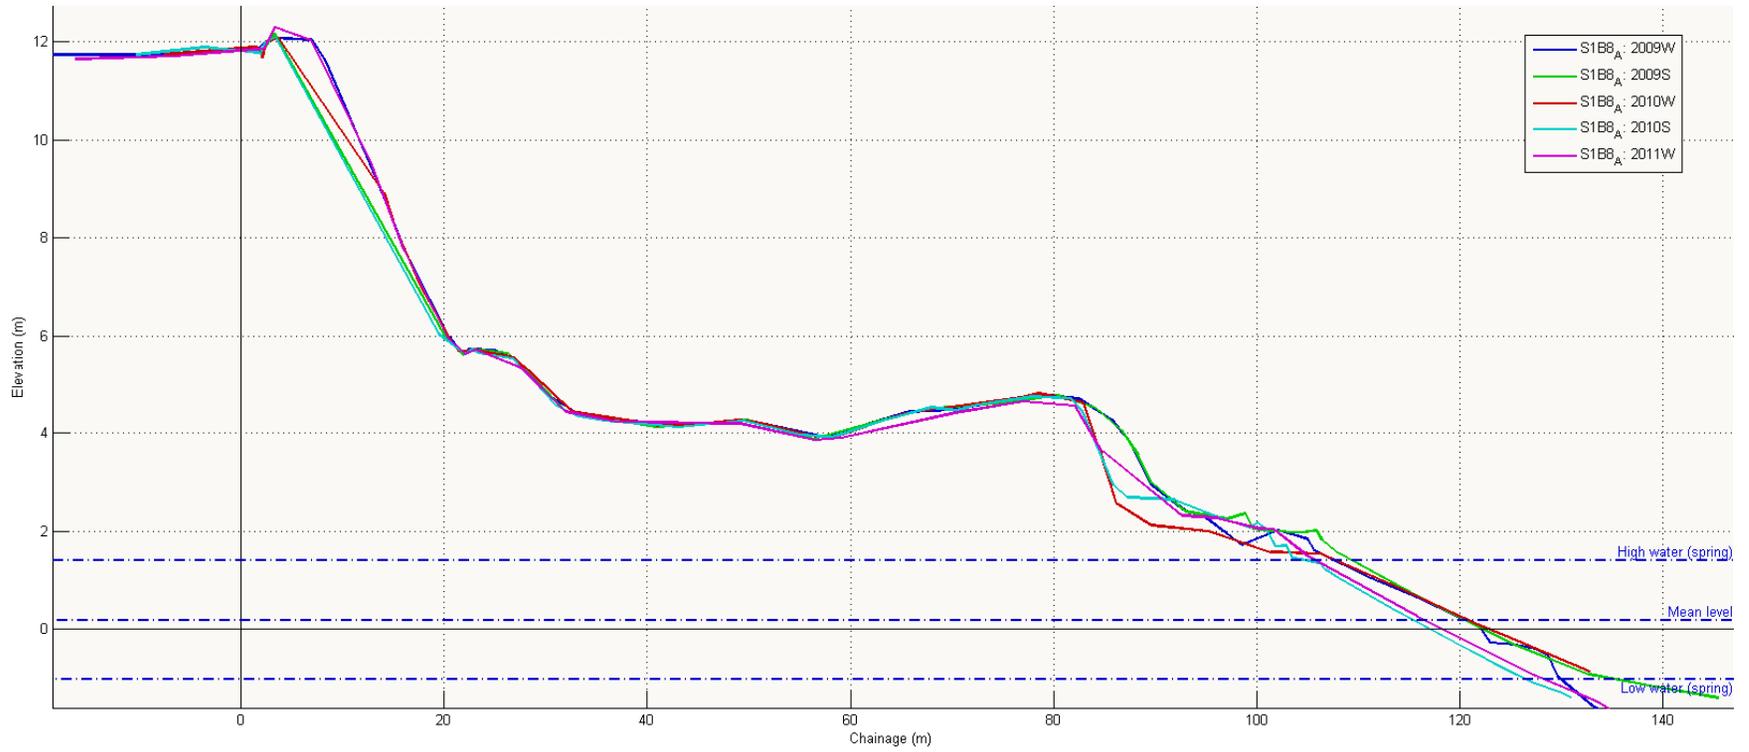
The beach is trough-shaped and backed by sand vegetated cliffs and fronted by the highest foreshore berm. The seaward face of the highest foreshore berm retreated landwards by 3 – 4 metres between 2009W to 2010W but was partially rebuilt by the time of the 2011W survey (see Appendix B3).

Appendix B3 – S1B8\_A, showing a trough-shaped beach

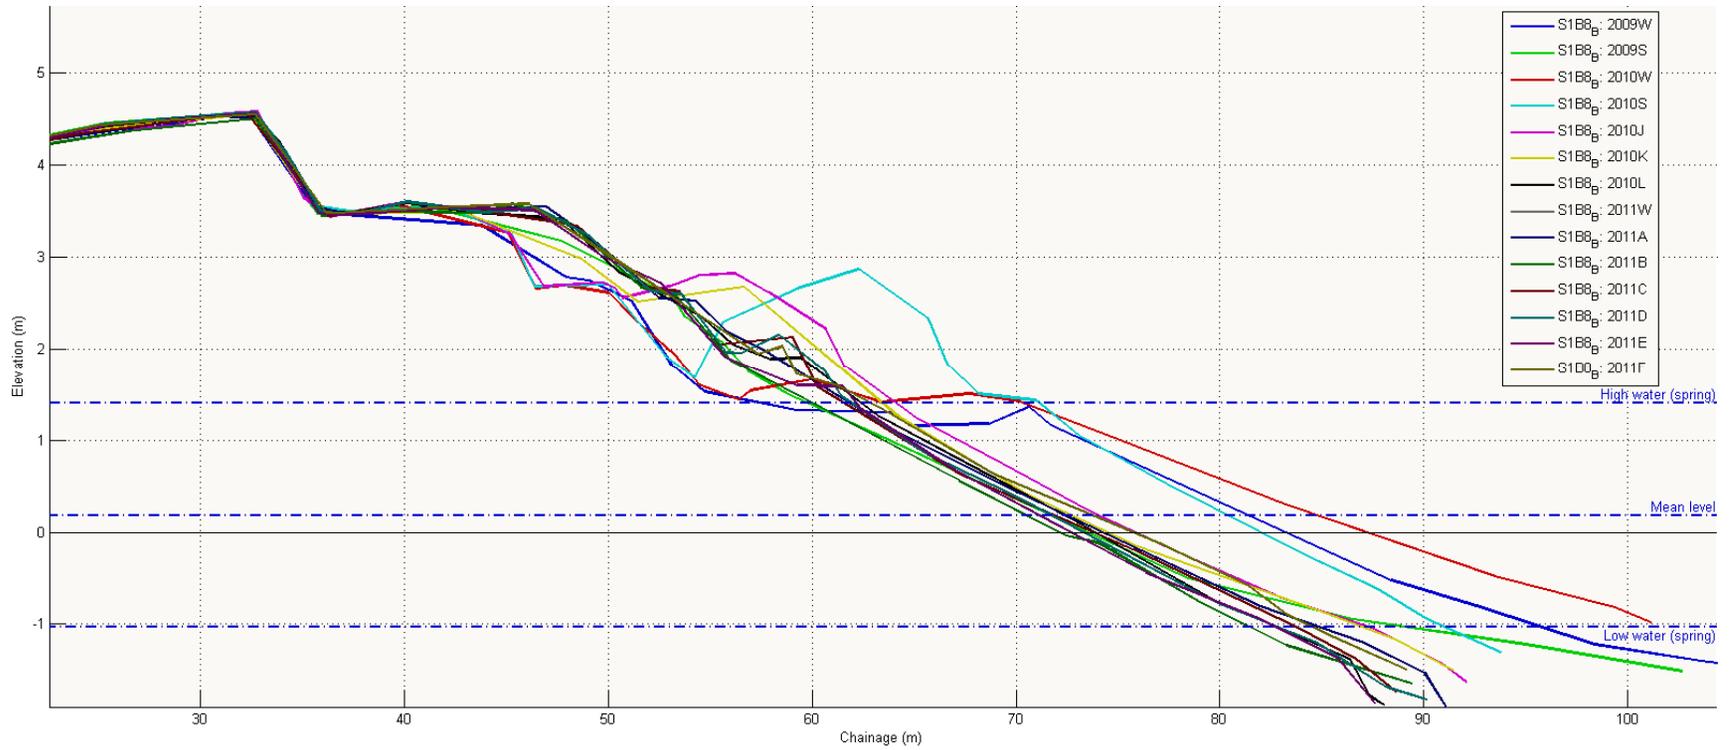
This is a stable trough-shaped beach backed by dune cliffs. The foreshore berm stands at 60m chainage in July 2010 and has moved landwards by 5m in October 2010 survey following which this part of the beach begins to flatten. There is development of a distinct bar feature just above high water between January to July 2010, which may have been as a result of the storm event in May/June. (see Appendix B4).

Appendix B4 – S1B8\_B intertidal area.. The distinct bar feature (in light blue) just above high water between January to July 2010, may have been as a result of the storm event in May/June 2010.

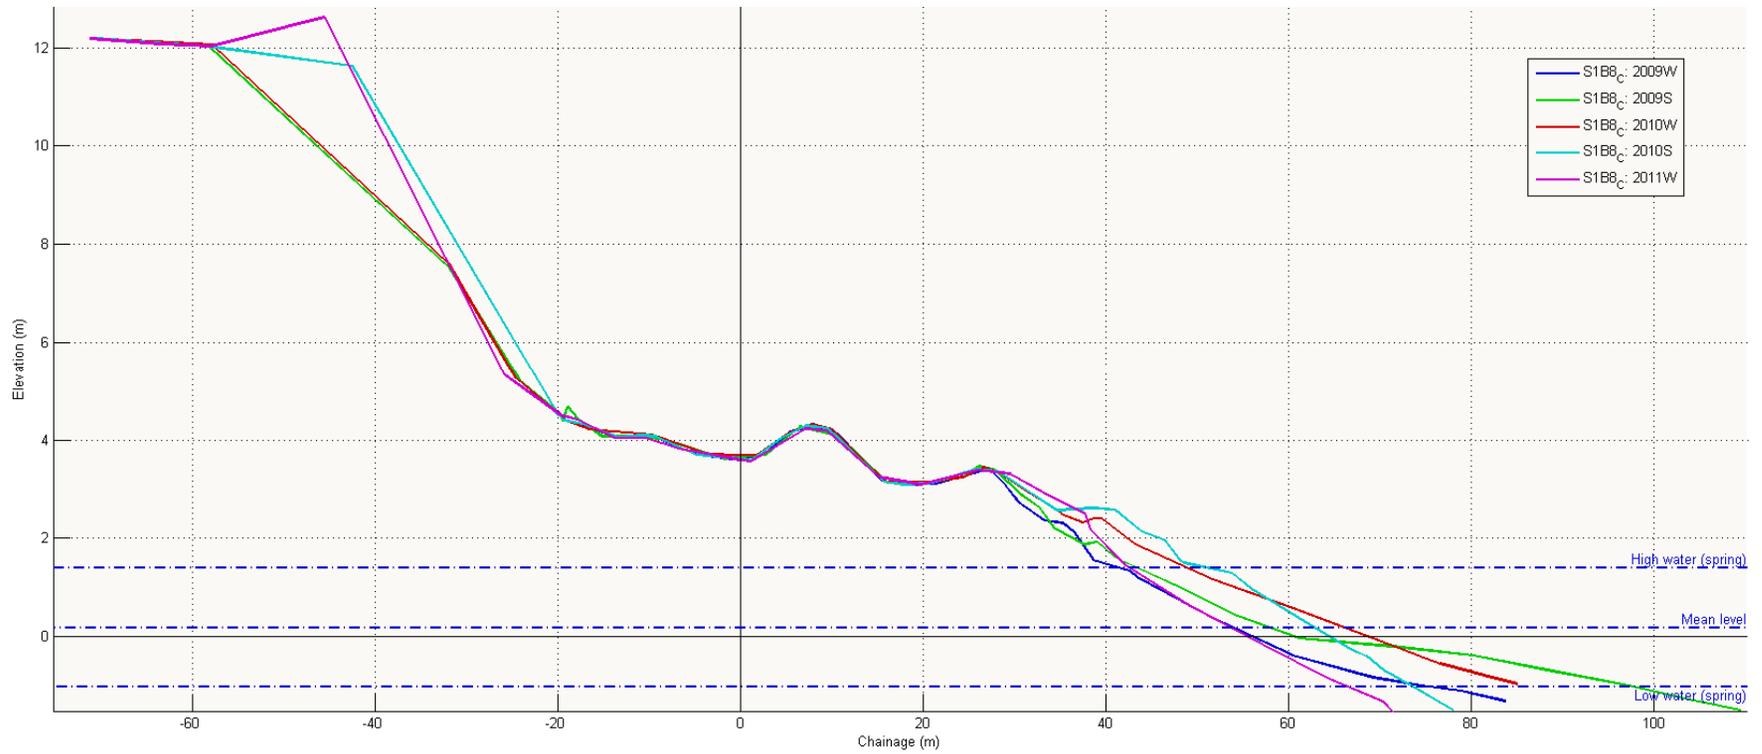
A less trough-shaped beach compared to further north, with the Ness ridge lying more centrally in the upper beach where there is no movement. There was seaward accretion in the beach face intertidal area between January 2009 to July 2010. Then following this survey to 2011W the intertidal area retreated landwards by 10 metres. (see Appendix B5).

Appendix B5 – S1B8\_C showing the midshore berm in the centre of the upper beach. There was seaward accretion in the beach face intertidal area from January 2009 to July 2010. Then following this the intertidal area retreated landwards by 10 metres to 2011W.

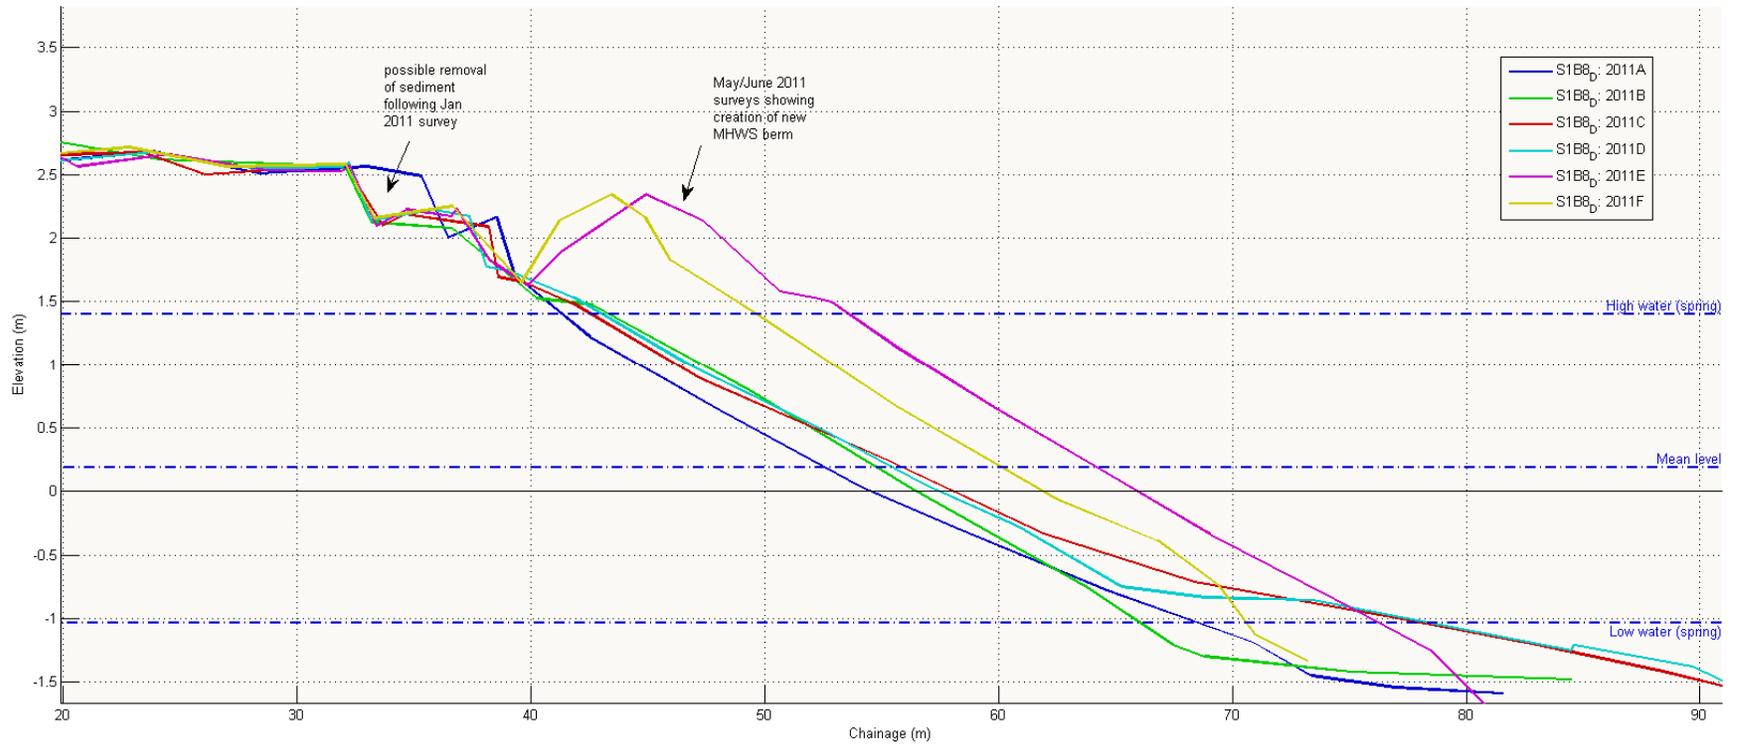
The Ness ridge lies centrally within the upper beach, which appears very stable. The lower beach intertidal area builds seawards from 2009W to 2010S to create a seaward berm which retreats 5 metres by October 2010 and flattening to December 2010.

There is evidence of sediment removal between January and February 2011 at the face of the MHWS berm but this shows no effect on any other part of the beach. By May 2011 a new high water berm is evident moving onshore and is associated with increases in volume in the intertidal area and which retreats slightly by June 2011 (see Appendix B6).

Appendix B6 – S1B8\_D intertidal area showing possible sediment removal following the January 2011 survey. A new HWS berm has moved onshore by the May 2011 survey

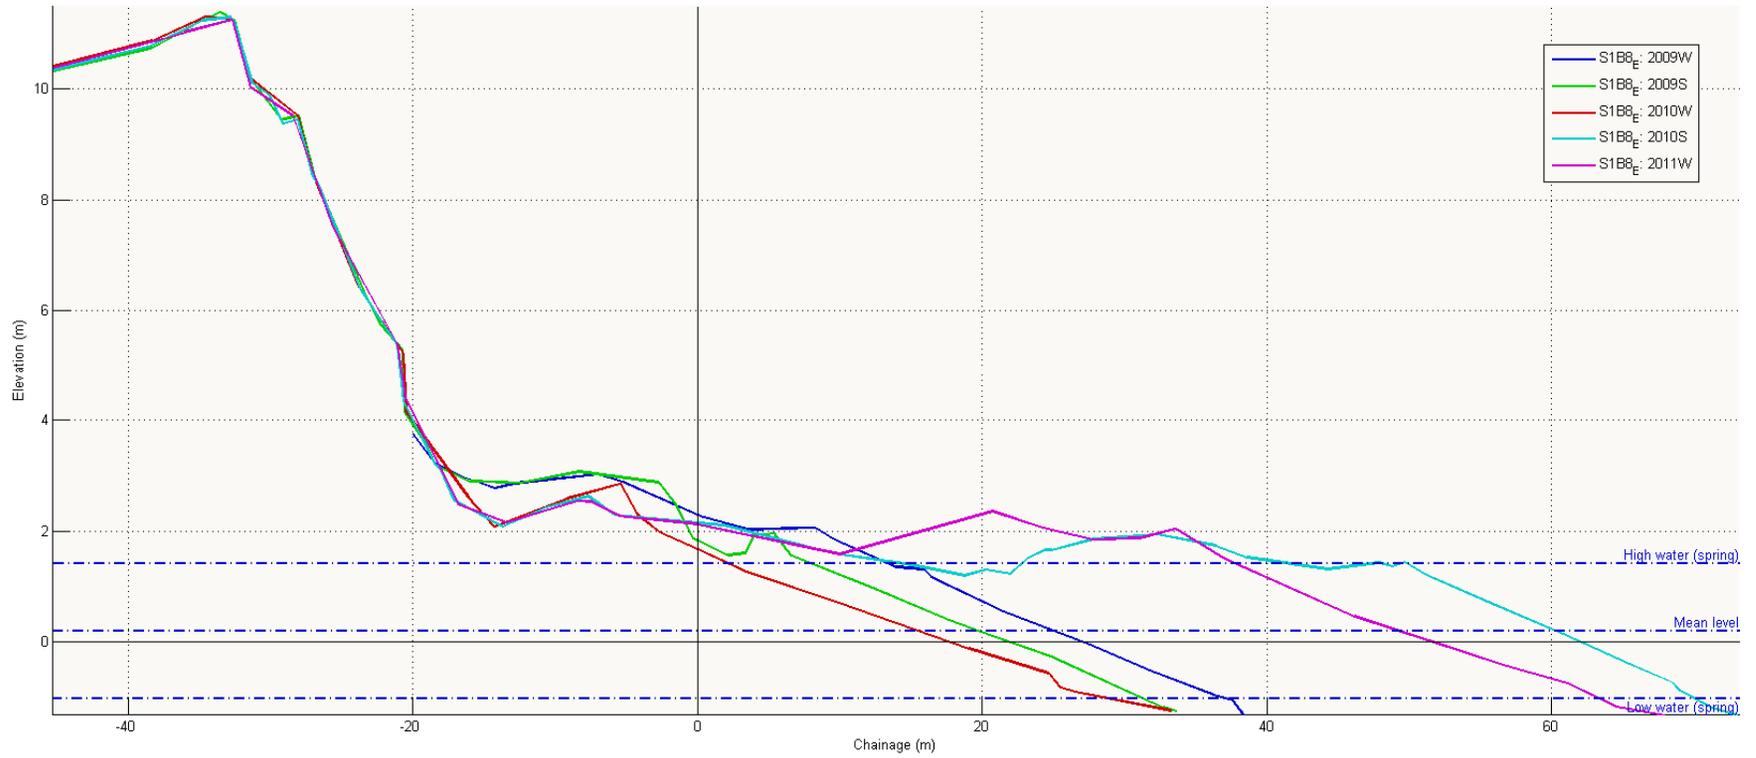
The sand dune cliffs here are much steeper with the Ness ridge lying at the base of the cliffs. In 2009W, 2009S and 2010W surveys the beach is relatively narrow and steep at 24 – 25 metres. However, by summer 2010 the profile has extended seawards by around 35 metres with a distinct ridge just above MHWS along with beach lowering of around half a metre at the foot of the cliffs. By 2011W the intertidal area has receded by 10 metres along with associated movement of high water ridge. Levels at the toe of the cliff remain lower. There are no February 2011 profiles to see if excavation at donor area has had any effect (see Appendix B7).

Appendix B7 – S1B8\_E profile showing beach levels between 2010W to 2010S extending seawards by 35 metres in the intertidal area with associated beach lowering at the toe of the cliffs.

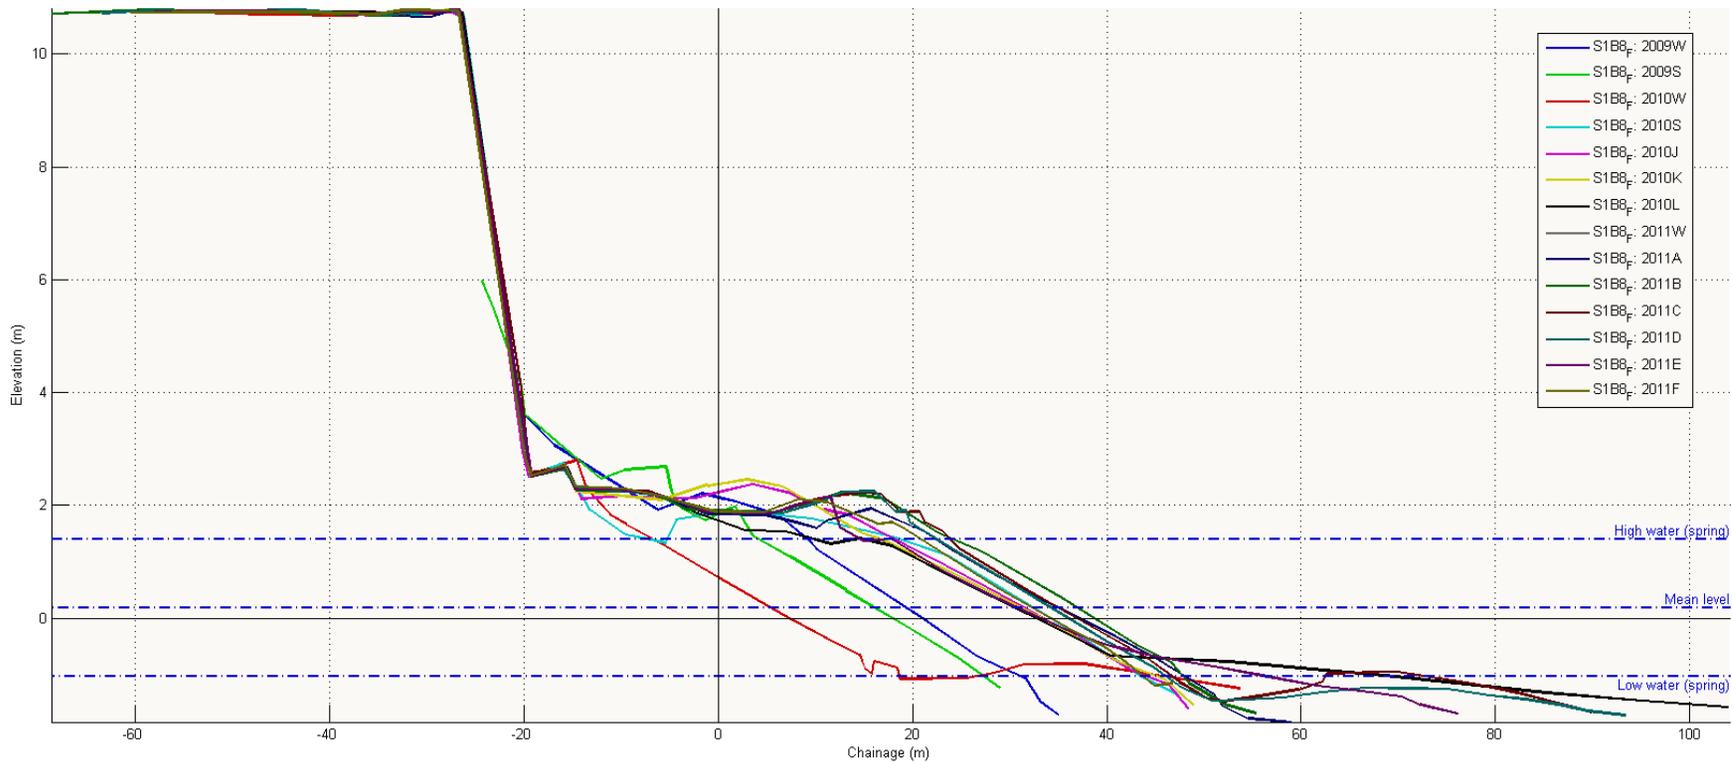
Steep cliffs are fronted by a much narrower beach. The 2010W profile shows a distinct storm profile with beach drawdown and levels 3 metres lower in the intertidal area, a few metres in front of the toe of the cliff. Beach levels have recovered by summer 2010 with a berm at MHWS and lower beach levels behind this (ie in front of the cliffs). There is further beach building by October 2010 where the dip behind the berm has been infilled (see Appendix B8).

Appendix B8 – S1B8\_F. The 2010W profile (in red) shows a distinct storm profile with beach drawdown and levels 3 metres lower at MSL. Beach levels have recovered by summer 2010 (in turquoise) with a berm at MHWS and lower beach levels behind this (in front of the cliffs).
