# Coastal Morphology Report

## Thorpeness (Phase 1)

RP024/S/2011

July 2011

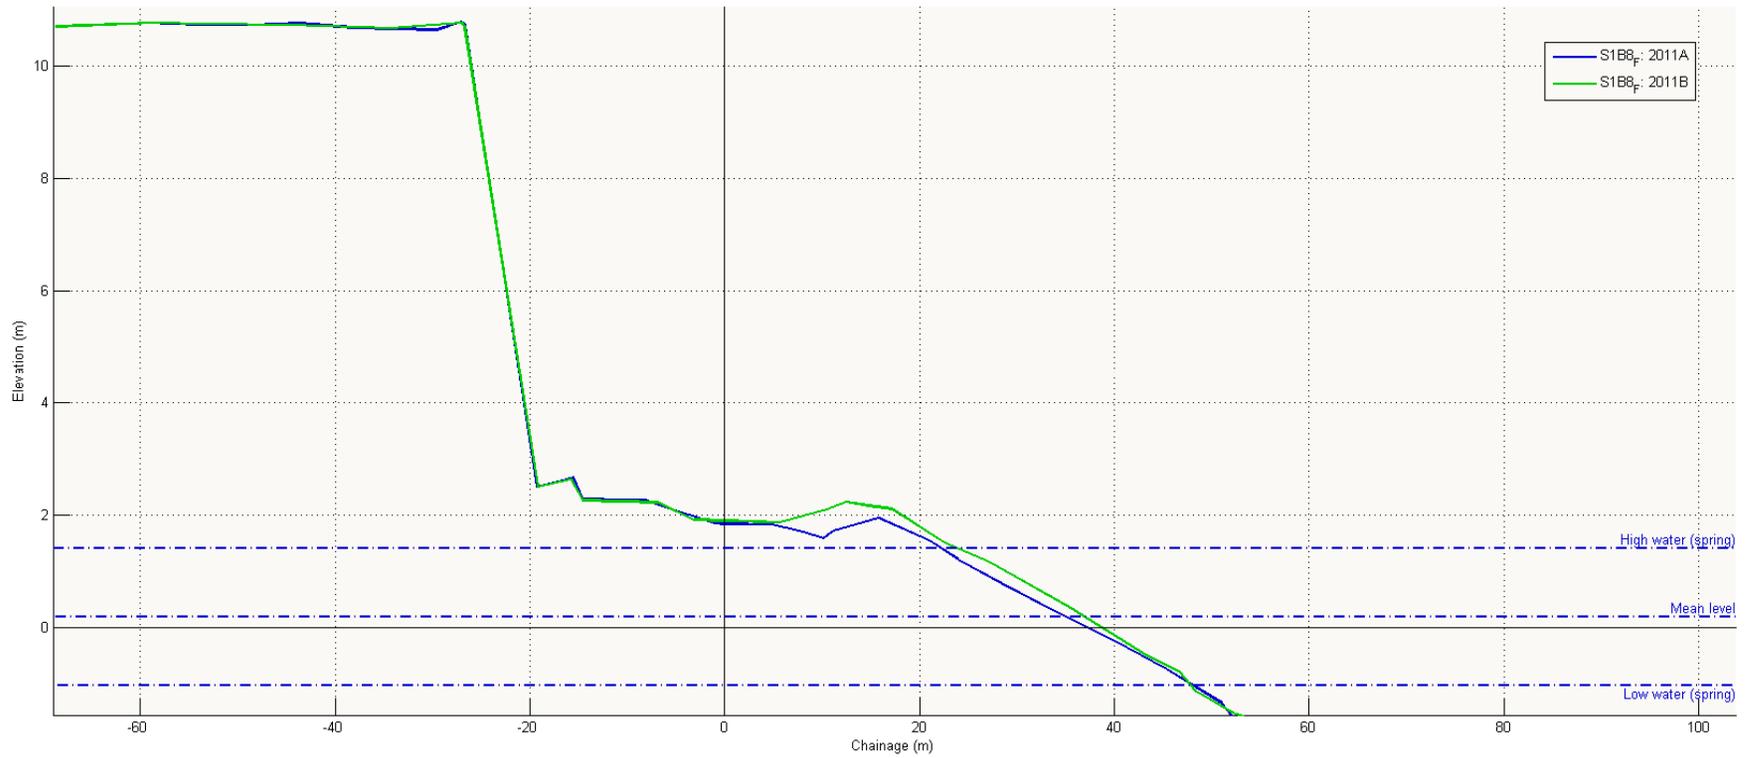
From January 2011 the foreshore continues to build to create a trough beach shape with a MHWS berm with no evidence of any sediment loss. By May 2011 sediment is lost from the face of this berm and by the June survey this has partially repaired itself. Levels are higher in February at the MHWS berm than in January, pre-excavation surveys (see Appendix B9).

Appendix B9 – S1B8\_F. Surveys for January and February 2011 show no evidence of beach lowering following sediment recycling works in February 2011.

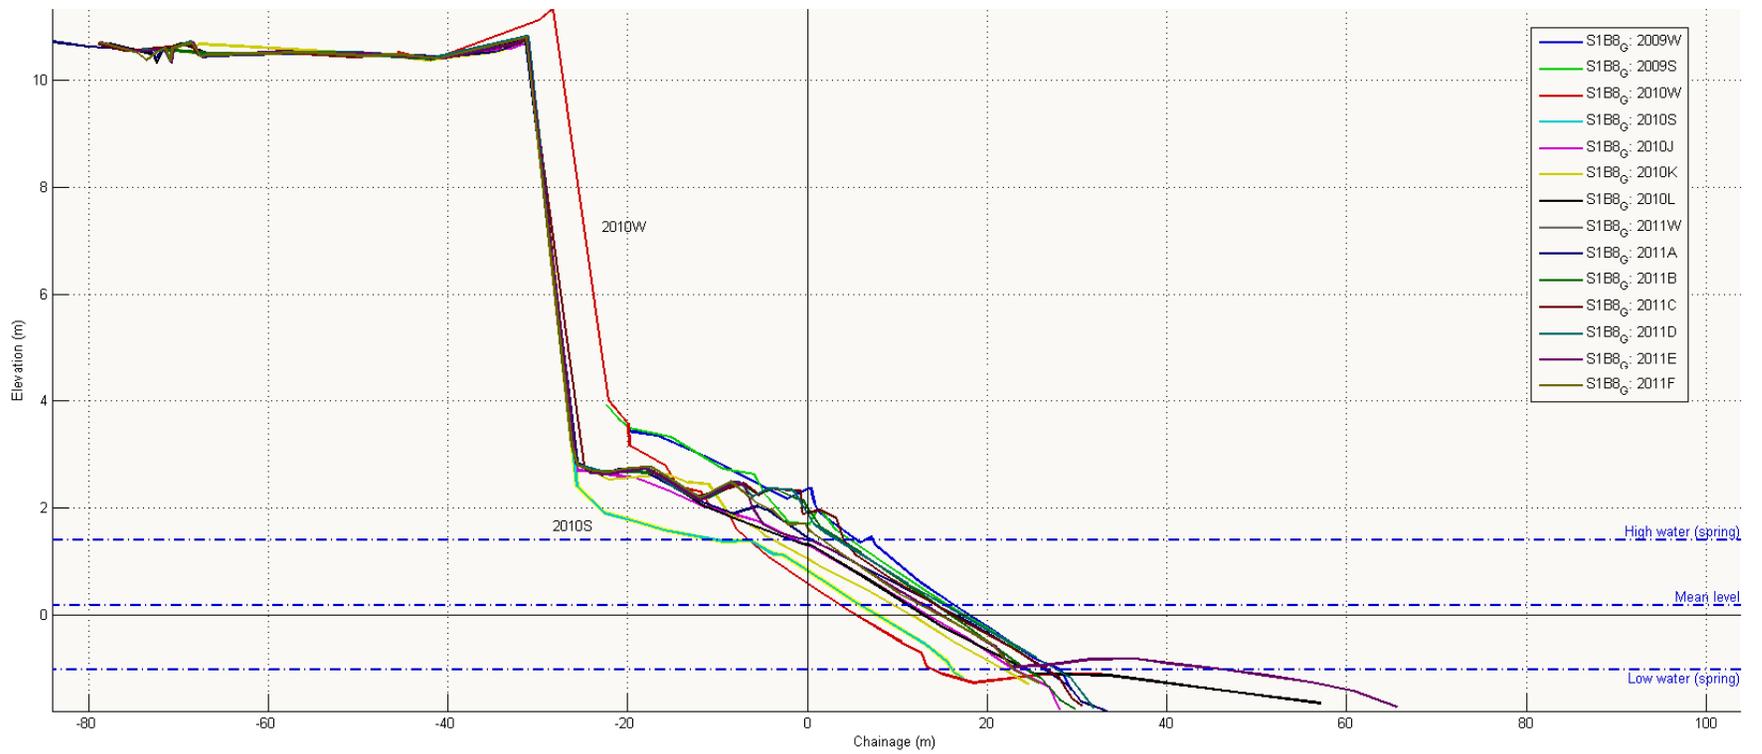
The vertical cliff face here retreats by 4.5 metres between the 2010W and 2010S surveys. According to anecdotal evidence there was increasing erosion pressure during the spring of 2010 which then culminated in the storm event of June 2010, with beach drawdown evidenced along the entire profile. There is a flat foreshore with no ridges or berms and the upper beach at the toe of cliffs is also greatly scoured.

Appendix B10 – S1B8\_G with 2010S highlighted. The vertical cliff face here retreats by 4.5 metres from 2010W to 2010S survey reflecting the storm event of June 2010, with beach drawdown evidenced along beach profile.

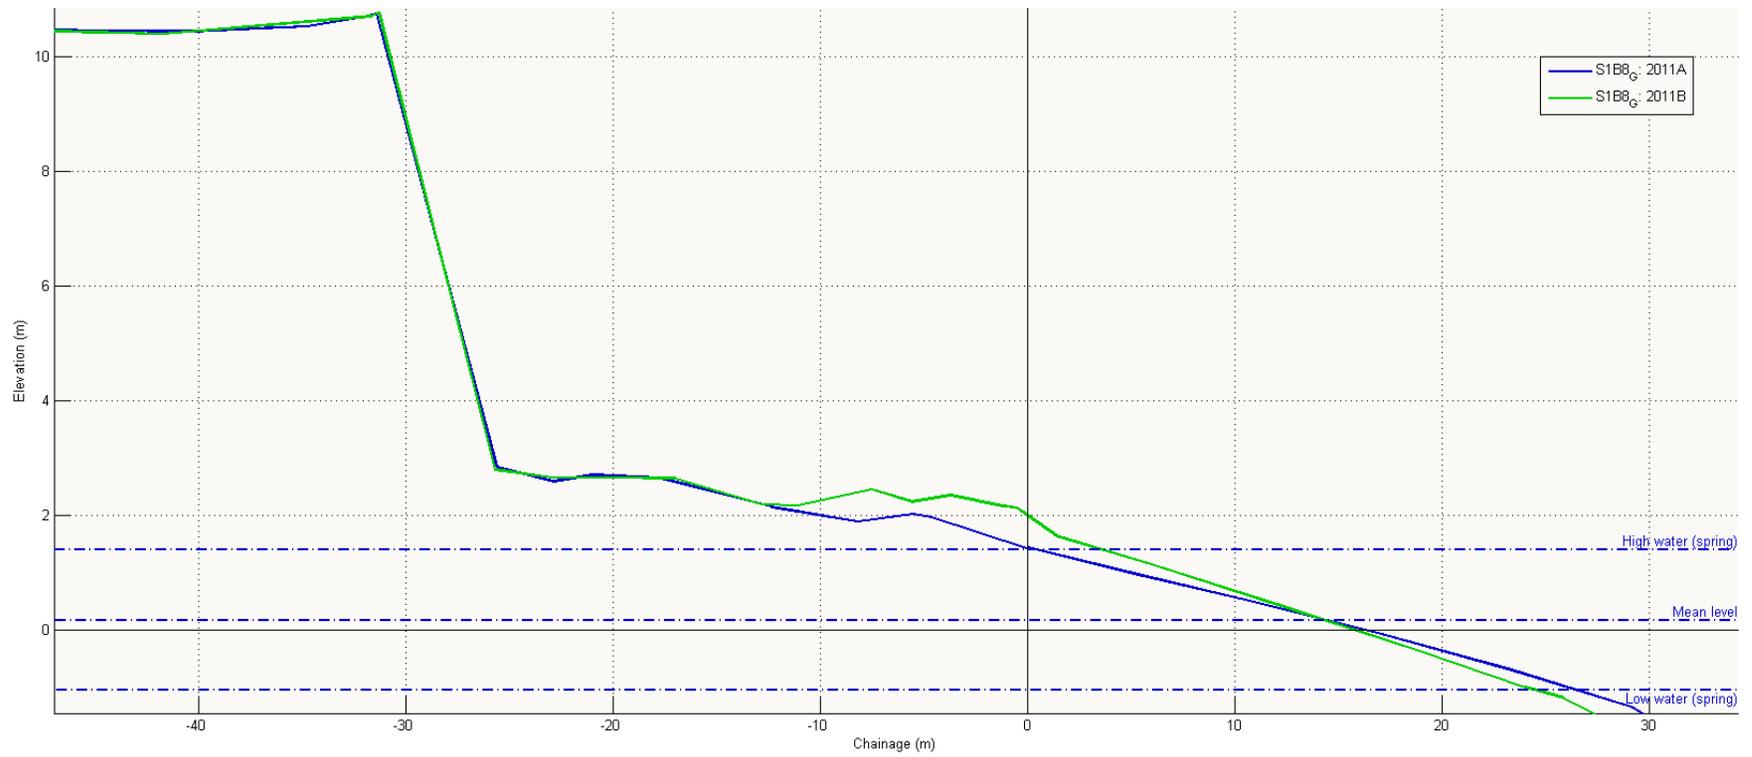
Beach levels recover slightly to October 2010 by half to one metre. A small MHWS berm builds to 2011 April but subsequent surveys showed this to have scoured and moved onshore. There is no obvious reduction in the foreshore between January and February surveys, when beach extraction would have taken place further north – in fact the beach has accreted vertically and seawards at the high water berm (see Appendix B10 and B11).

Appendix B11 – S1B8\_G showing January and February 2011 surveys where a MHWS berm has accreted between January and February.

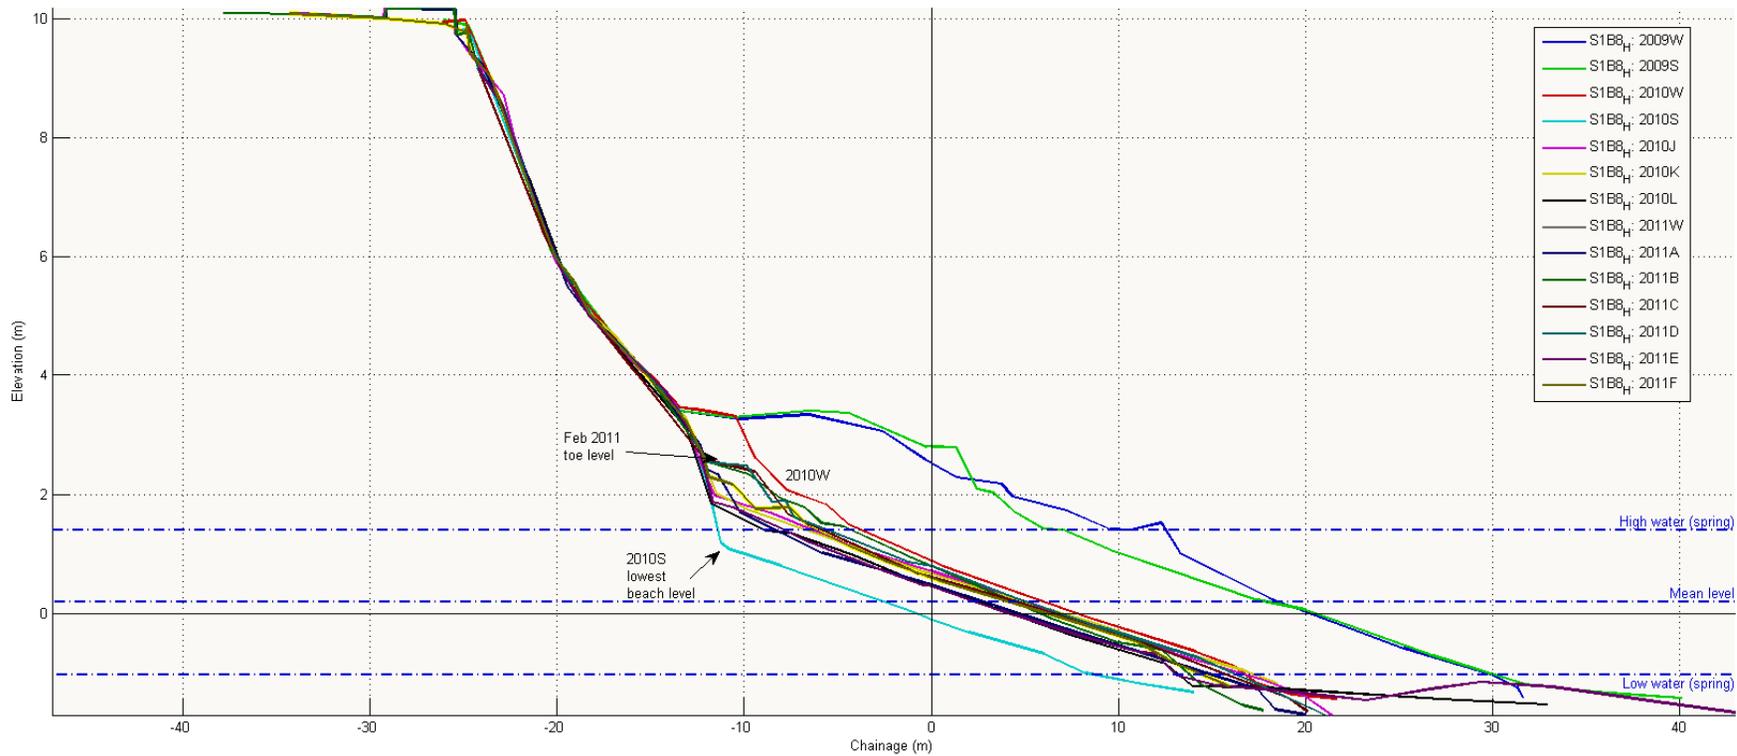
Beach levels drop sharply from 2009S to 2010W by up to 2 metres and then a further 1.5m to 2010S as a result of the June 2010 storm event (therefore beach levels are observed to have dropped sharply even before the storm), and by over 2 metres at the toe of the defence. By October 2010 foreshore levels have recovered slightly.

Levels at the toe of defence in the February 2011 survey have risen by 60 cm possibly as result of the small amount of recharge here at the foot of the gabions and associated with the deposition frontage further south. By May 2011 this toe has returned to January levels (see Appendix B12).

Appendix B12 – S1B8\_H. The lowest beach levels at the toe of the gabions are observed in the summer 2010 profile. However, beach levels had already begun to recede prior to this, between 2009S and 2010W.

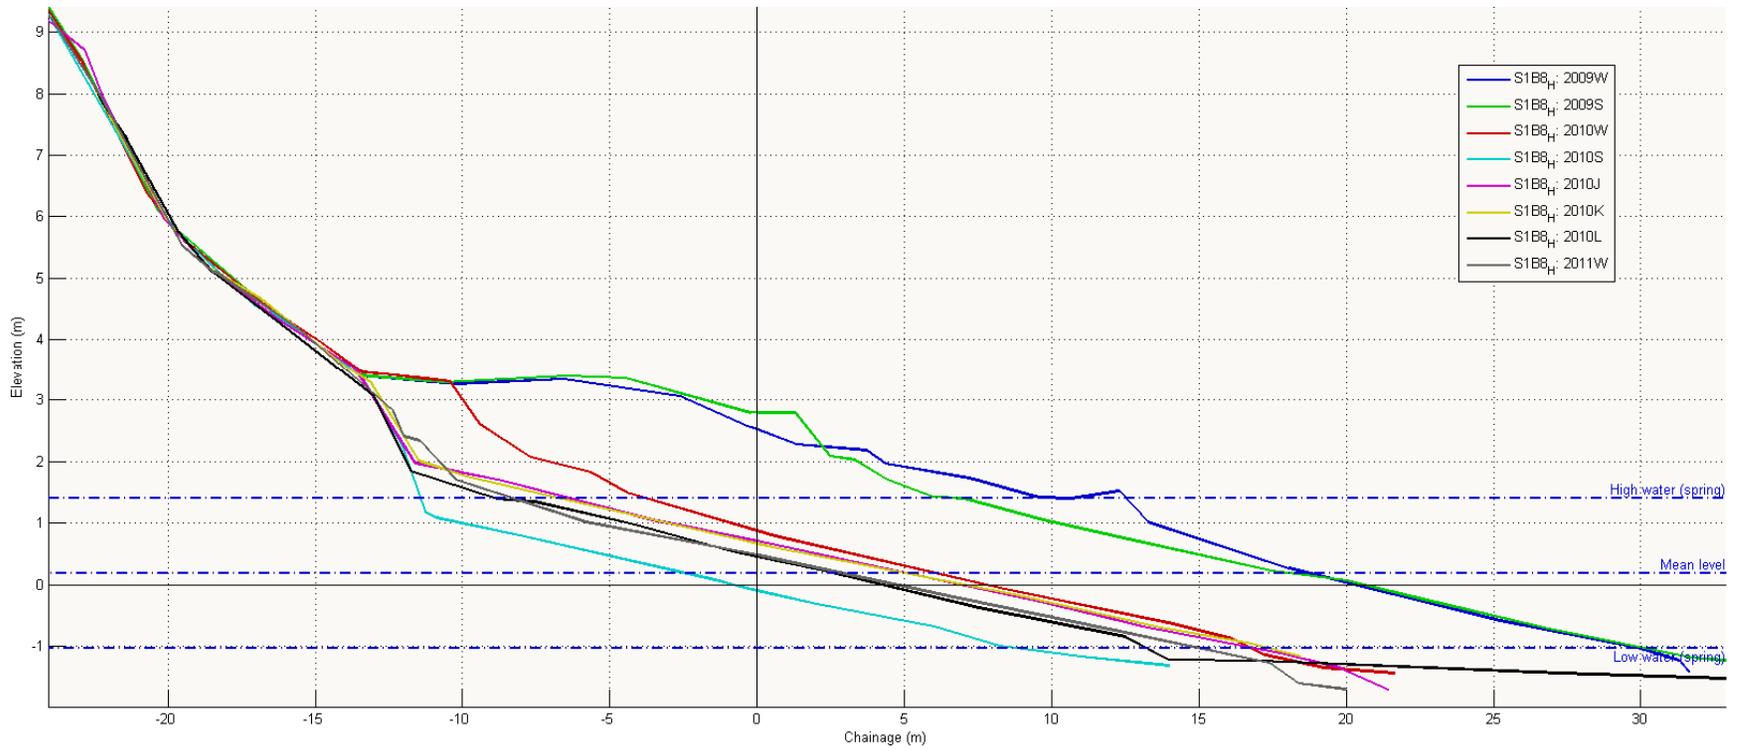
Beach levels in front of the gabion defence drop between 2009S to 2010W in the intertidal area and the upper foreshore. By 2010S levels drop sharply at the defence toe by almost 3 metres to show the beach at its lowest level following the June storm. By 2011W beach levels have recovered slightly with a one metre accretion at the toe following limited repairs to the original gabions (see Appendix B13).

Appendix B13 – S1B8\_I showing beach levels at their lowest in 2010S following the June storm event.

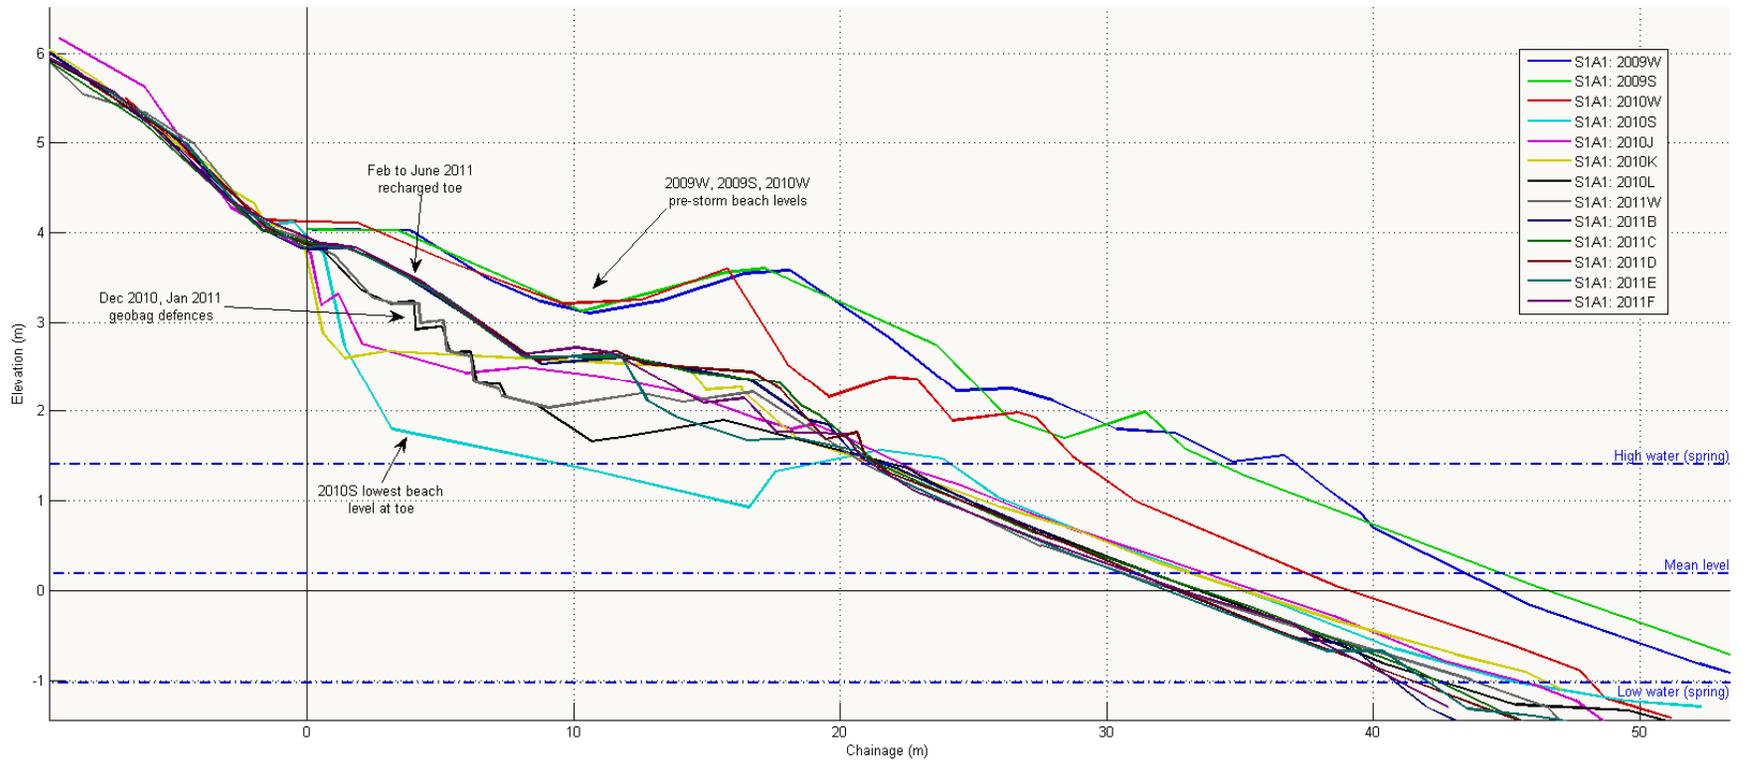
The recent Suffolk Coastal Trends analysis showed this profile as a very dynamic beach with periods of erosion and accretion. There was overall accretion to 2001 followed by a period of erosion to summer 2010 with beach levels returning to landwards of their 1991 position. An overall mean trend of no movement (0.1 m/yr) is recorded. Summer 2010 levels were at their lowest at the toe of shingle backslope defence, following the sustained storm event in May/June 2010. Intertidal water levels subsequently moved onshore by around 20 metres.

The natural rebuilding of the toe at this site can be observed in the October and November 2010 surveys. In December 2010 and January 2011 the bare geobags are observed at the toe of the backslope in a stepped shape. Subsequent surveys from February to June 2011 show deposited sediment from the recycling operation covering this defence and maintaining profile, albeit at lower levels than from 1991S to 2009W (see Appendix B14).

Appendix B14 – S1A1 from 2009W only, showing the lowest beach toe levels during the 2010 summer profile.

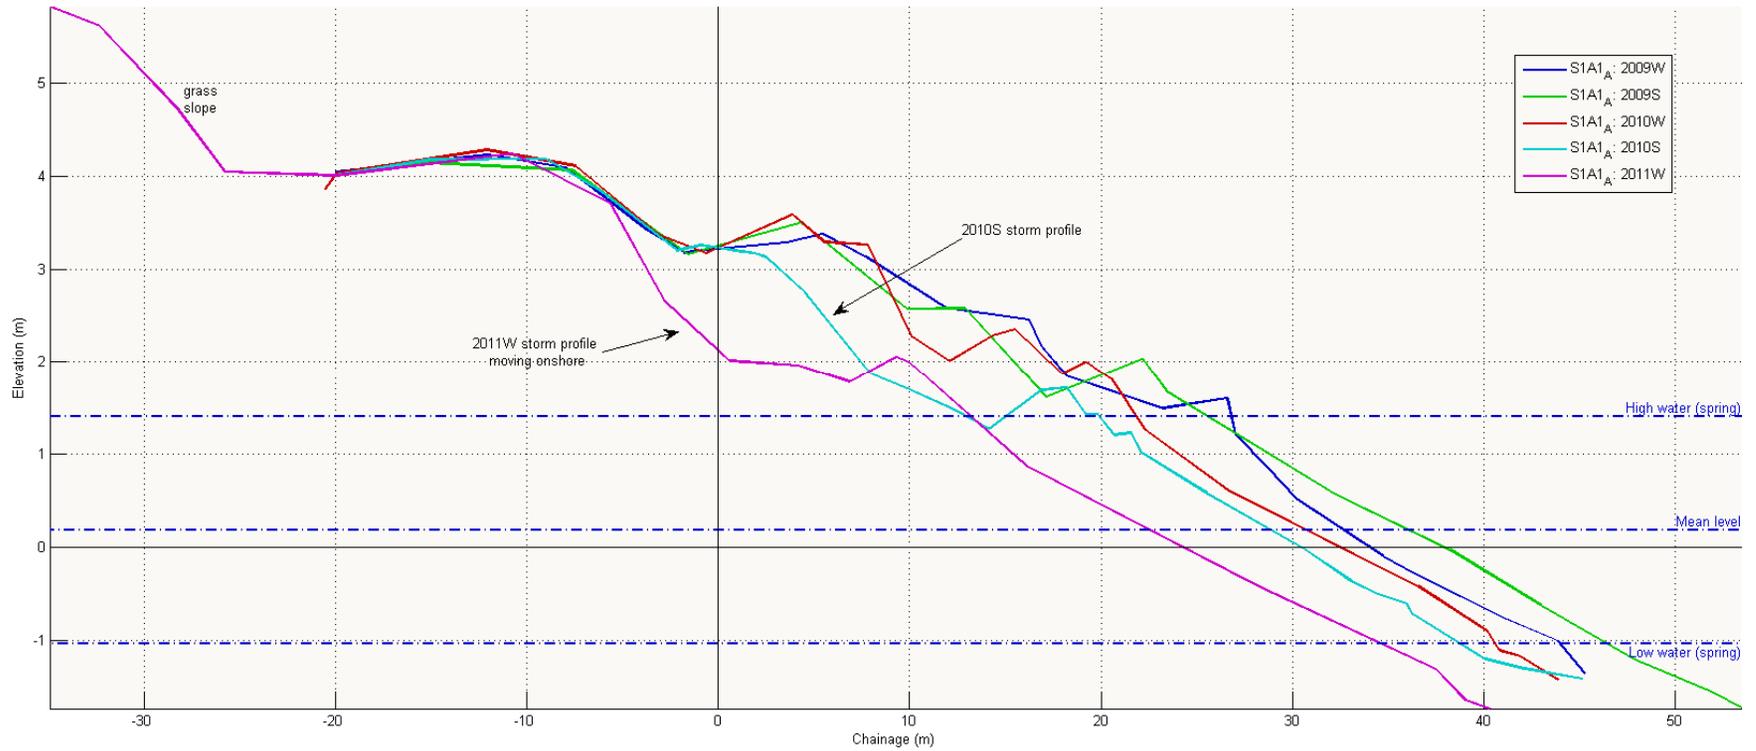
The few surveys available show a fairly dynamic beach with a storm profile shown in 2010S following the June storm event, where beach levels have dipped at toe of shingle backslope by one metre in height. This area of scour is also associated with a drop in height of similar depth

in the intertidal zone. In 2011W (January) survey beach levels did not recover – with the area of scour moving further onshore towards the foot of shingle bank (see Appendix B15).

Appendix B15 – S1A1\_A showing beach steepening and erosion south of the deposition frontage.

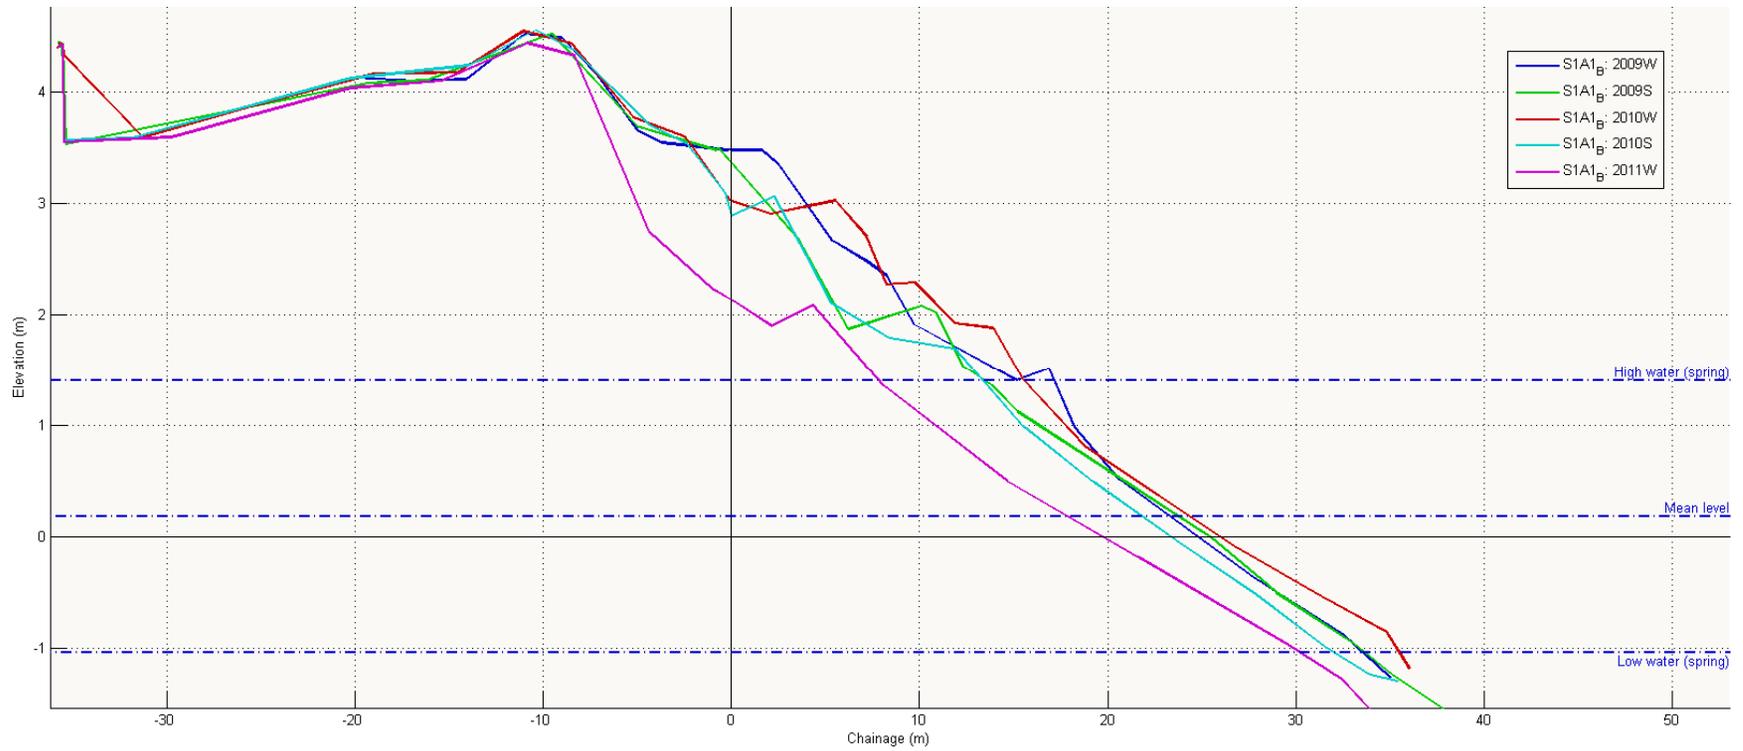
This profile shows no evidence of the June 2010 storm in its surveys. There is no movement in the berm visible midway across the upper beach. The winter 2011 profile however shows scour at the seaward face of this berm and in the intertidal area (see Appendix B16).

Appendix B16 – S1A1\_B profile showing scour in the beach face and intertidal area in January 2011W survey

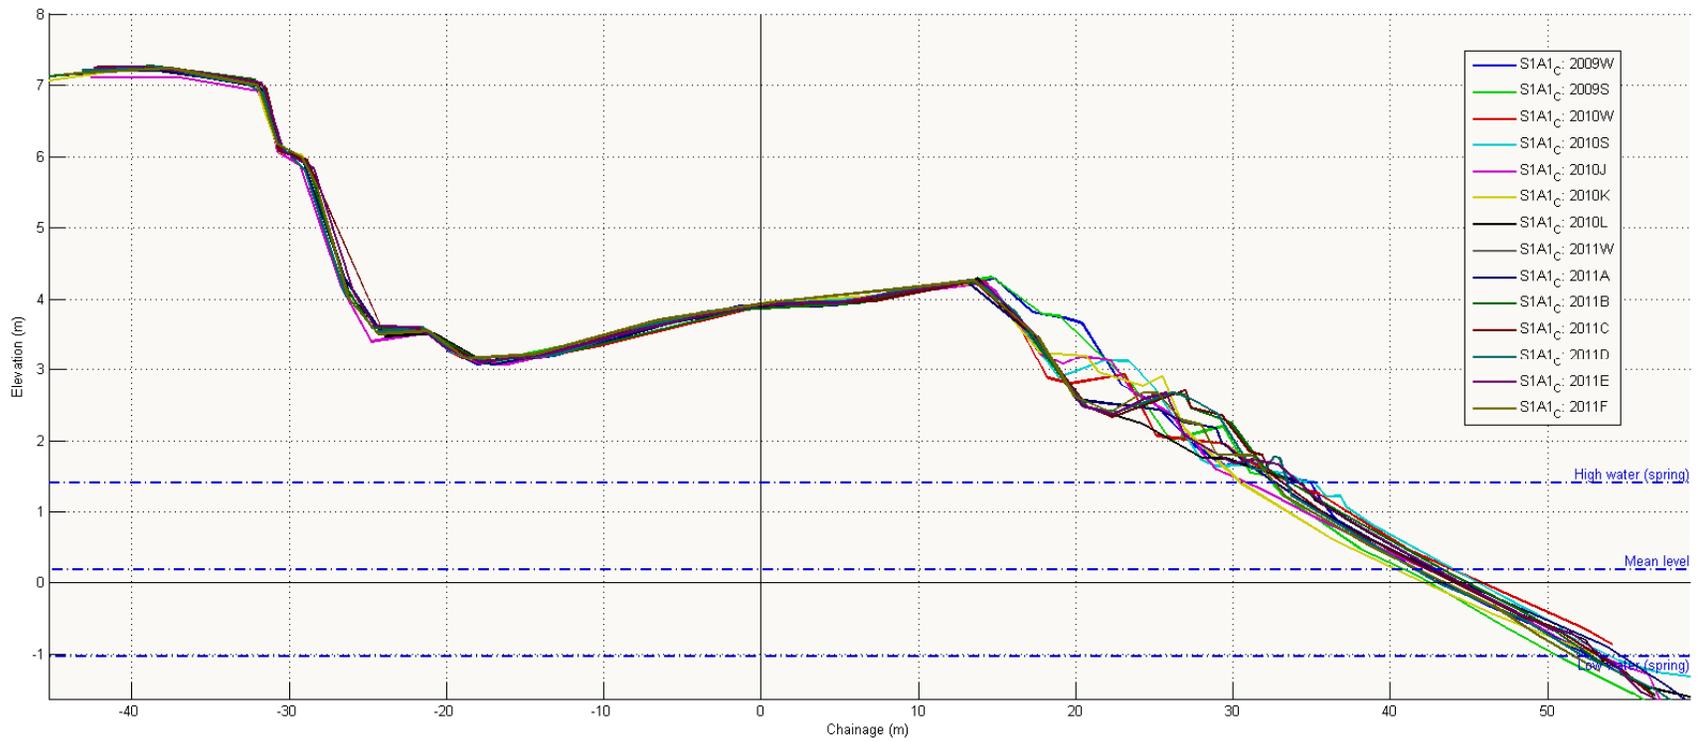
At this point the beach returns to a slightly more trough shaped as noted on the Ness. A stable beach only showing sediment movement seawards of the midshore berm (the active beach face). There is evidence of scouring in 2010W but not 2010S as might be expected. Subsequent beach rebuilding from December 2010 builds a new berm seawards of the midshore berm just above MHWS level. Intertidal levels remained fairly constant during the survey period (see Appendix B17).

Appendix B17 – S1A1\_C profile showing a return to a more trough shaped beach shape as experienced further north on the Ness and with erosion of the beach face from 2010W

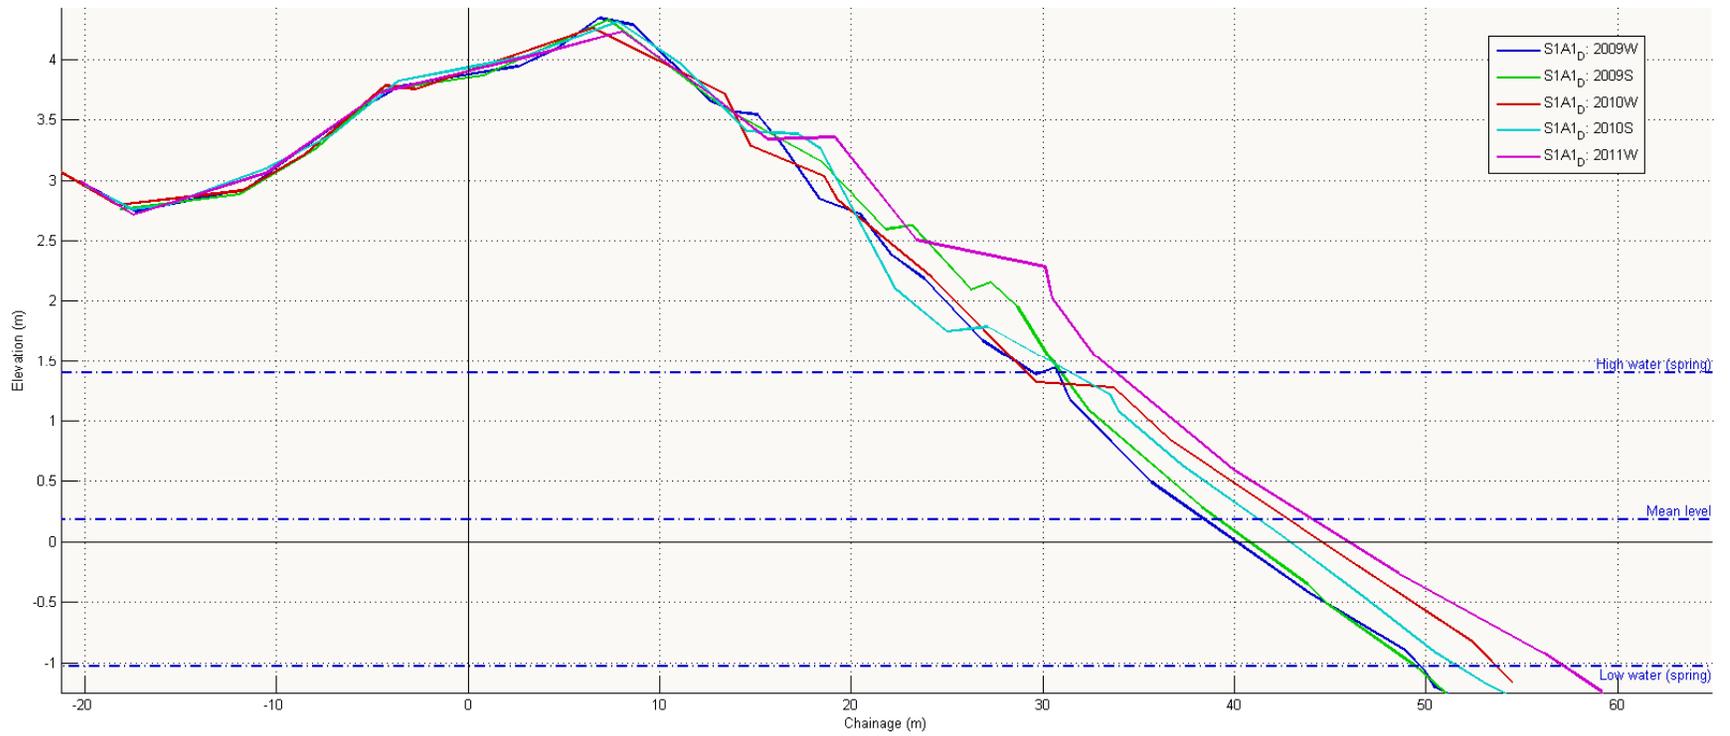
A stable beach profile with a midshore berm at a height of over 4m AOD. The face of the berm above high water and the intertidal zone show beach building to winter 2011 (see Appendix B18).

Appendix B18 – S1A1\_D profile showing beach accretion to 2011W survey

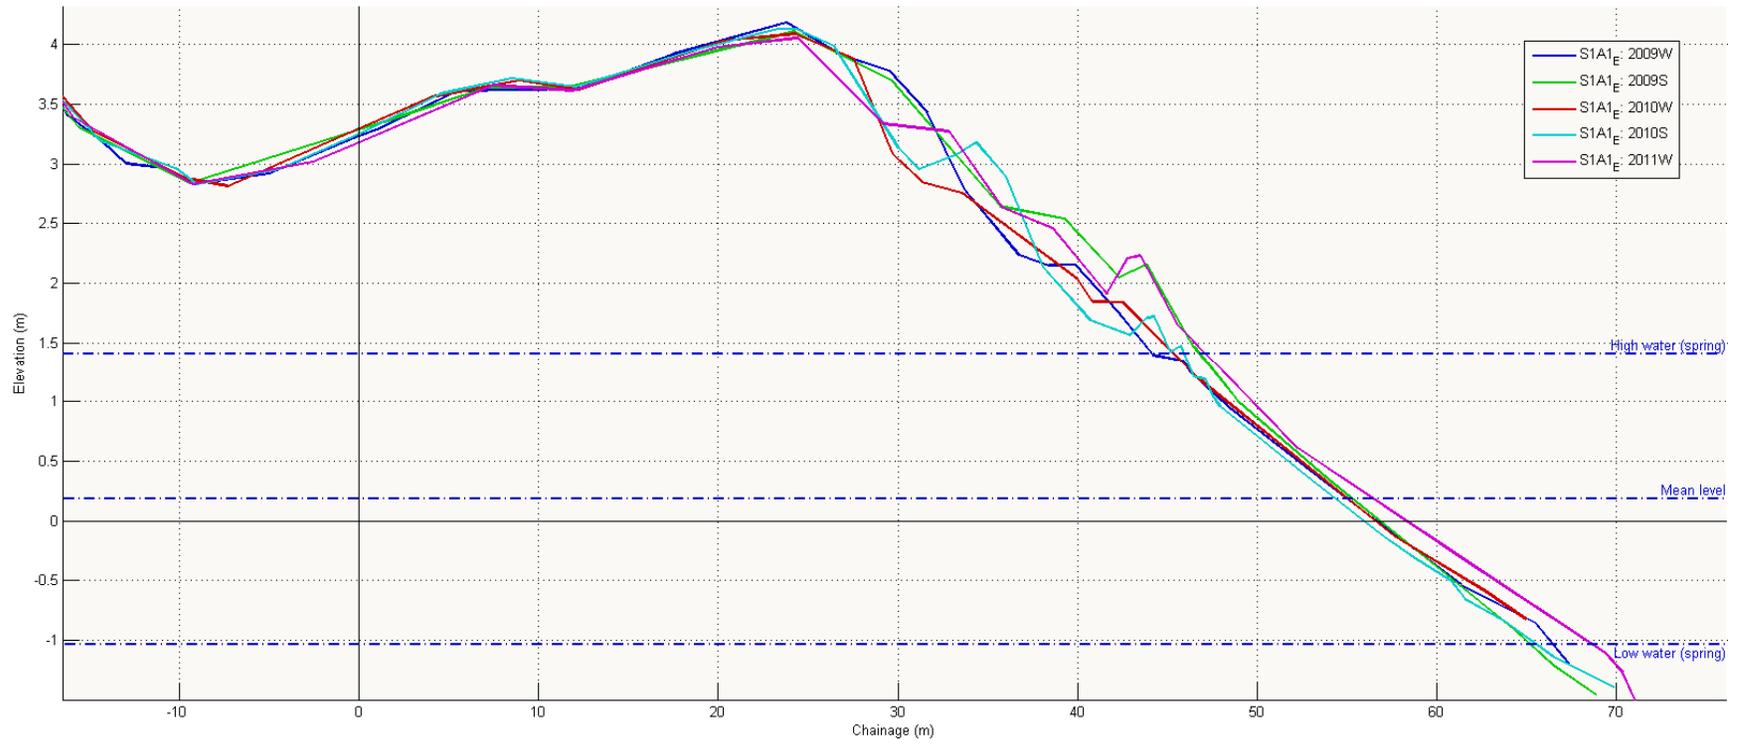
A broad trough-shape beach fronted by the highest berm of 4m AOD. The beach face is dynamic seawards of highest crest with slight accretion in the intertidal area to 2011W (see Appendix B19).

Appendix B19 – S1A1\_E profile showing a trough shaped beach profile with an active beach face

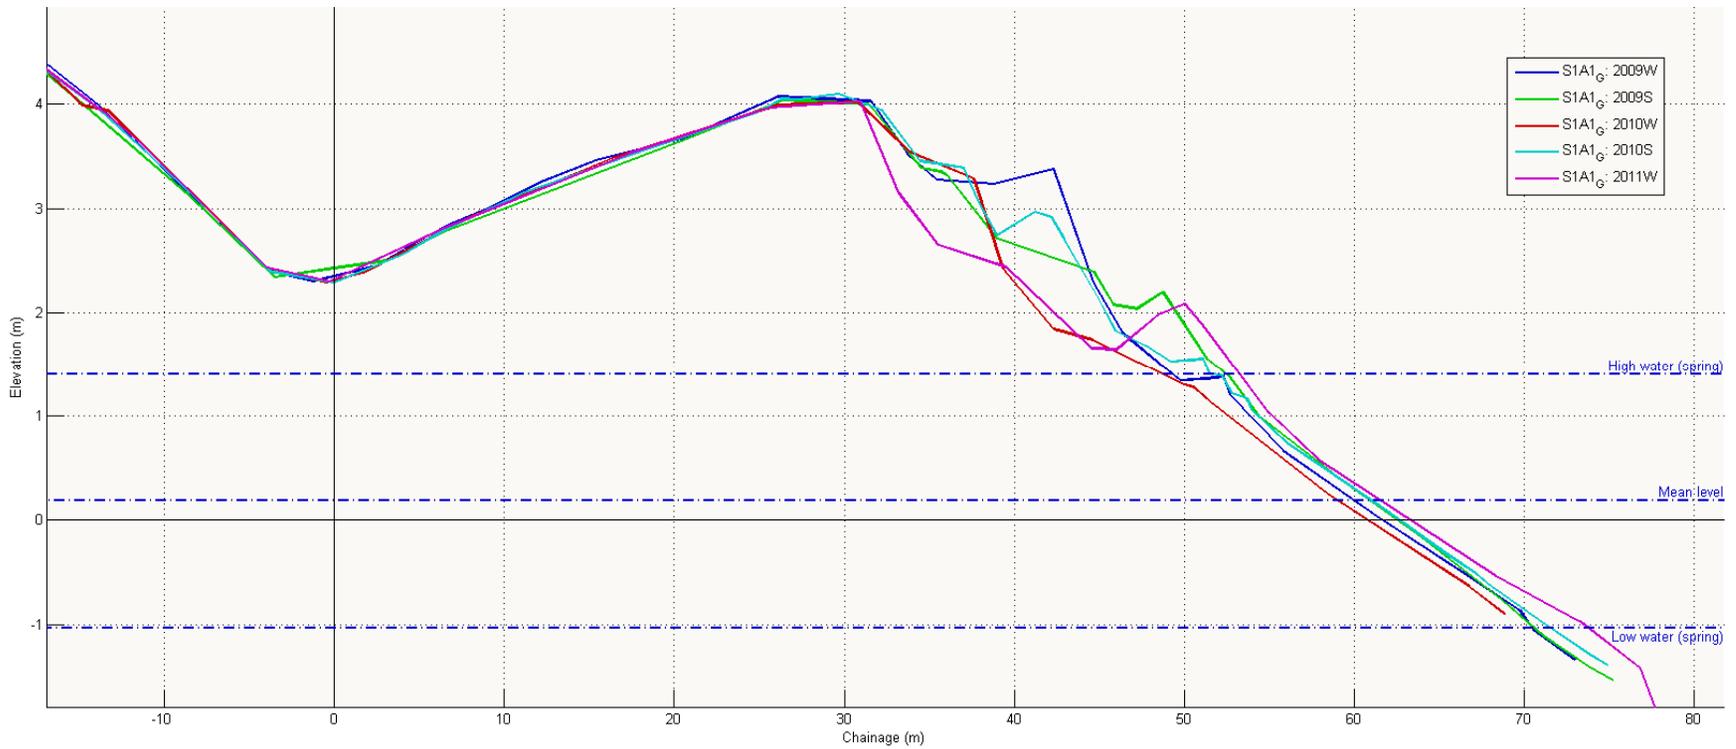
The beach frontage continues southwards with a trough-shaped backshore fronted by a slightly lower beach berm at 4mAOD. There is a dynamic beach face in front of the highest crest with no rotation in the intertidal area. The most recent survey shows a fairly eroded beach face fronted by a high water berm. (see Appendix B20).

Appendix B20 – S1A1\_G profile shows a trough shaped beach fronted by an active beach face with the most recent survey (2011W highlighted) showing a scoured beach face

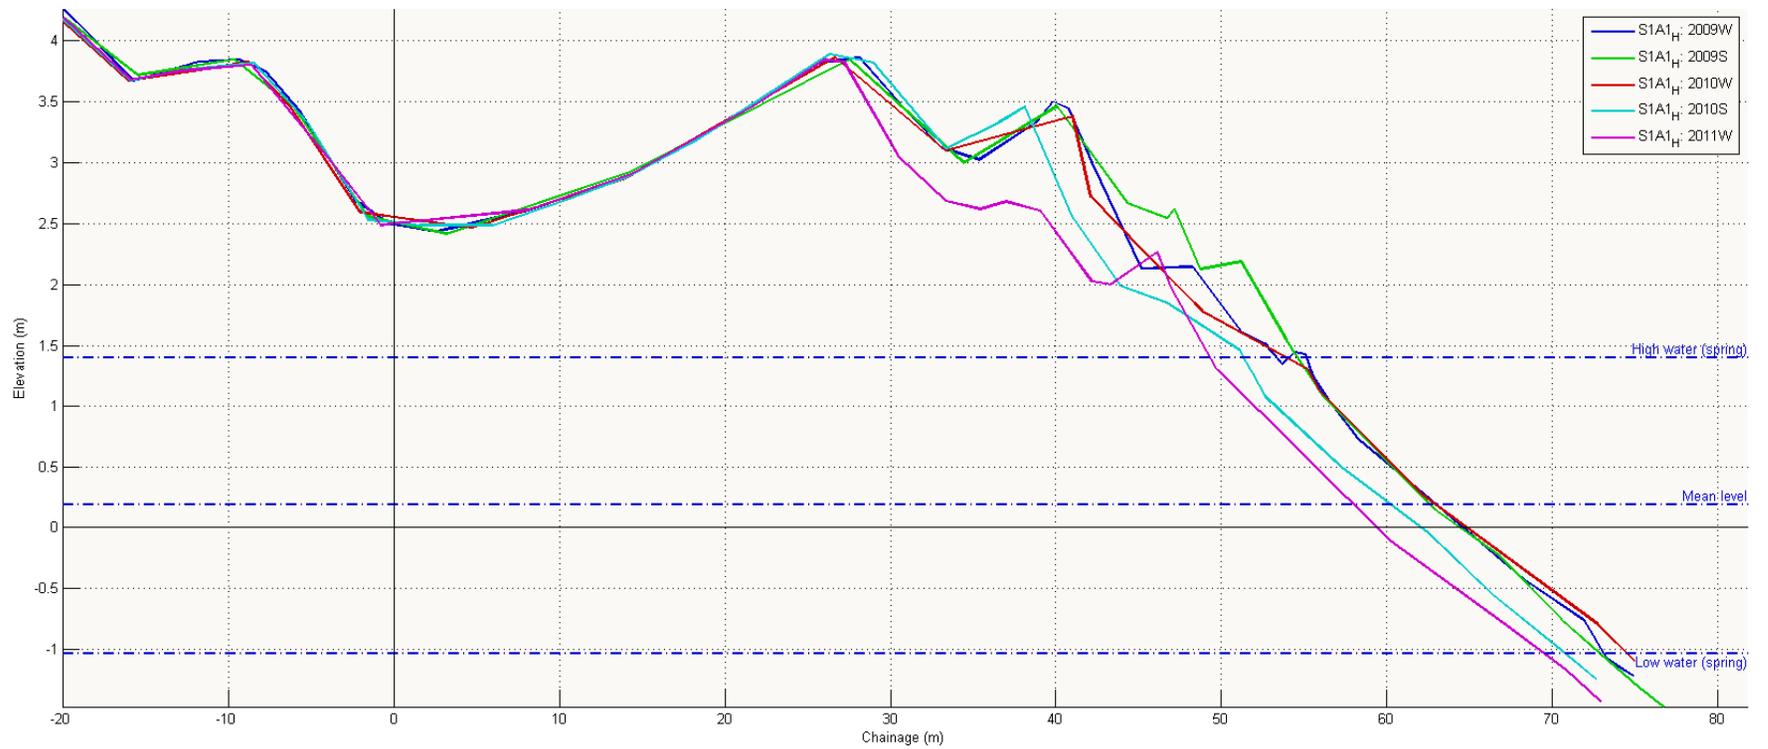
As this frontage continues south beach morphology retains its distinctive trough shape with the highest foreshore berm slightly lower at 3.8 mAOD . The foreshore face of this berm has receded by around 10 metres with intertidal area receded by around 5 metres during the survey period with loss in height of the most seaward berm (see Appendix B21 and B22).

Appendix B21 – S1A1\_H. A typical trough shaped beach along the southern Thorpeness frontage with the beach face receding by around 10 metres to winter 2011.

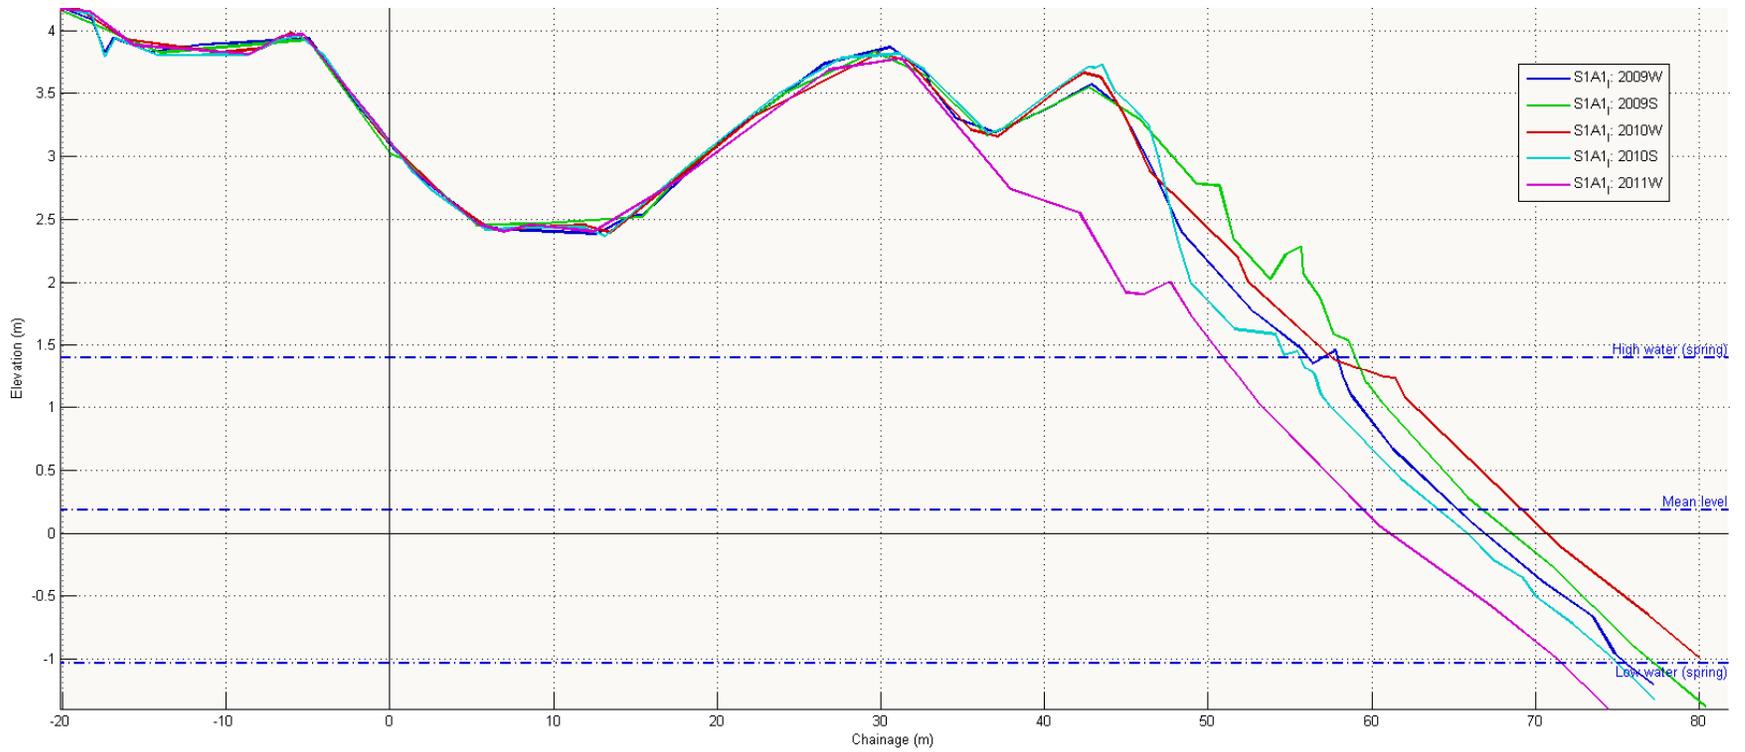
Appendix B22 – S1A1\_I. A typical trough shaped beach along the southern Thorpeness frontage with the beach face receding by around 10 metres to winter 2011

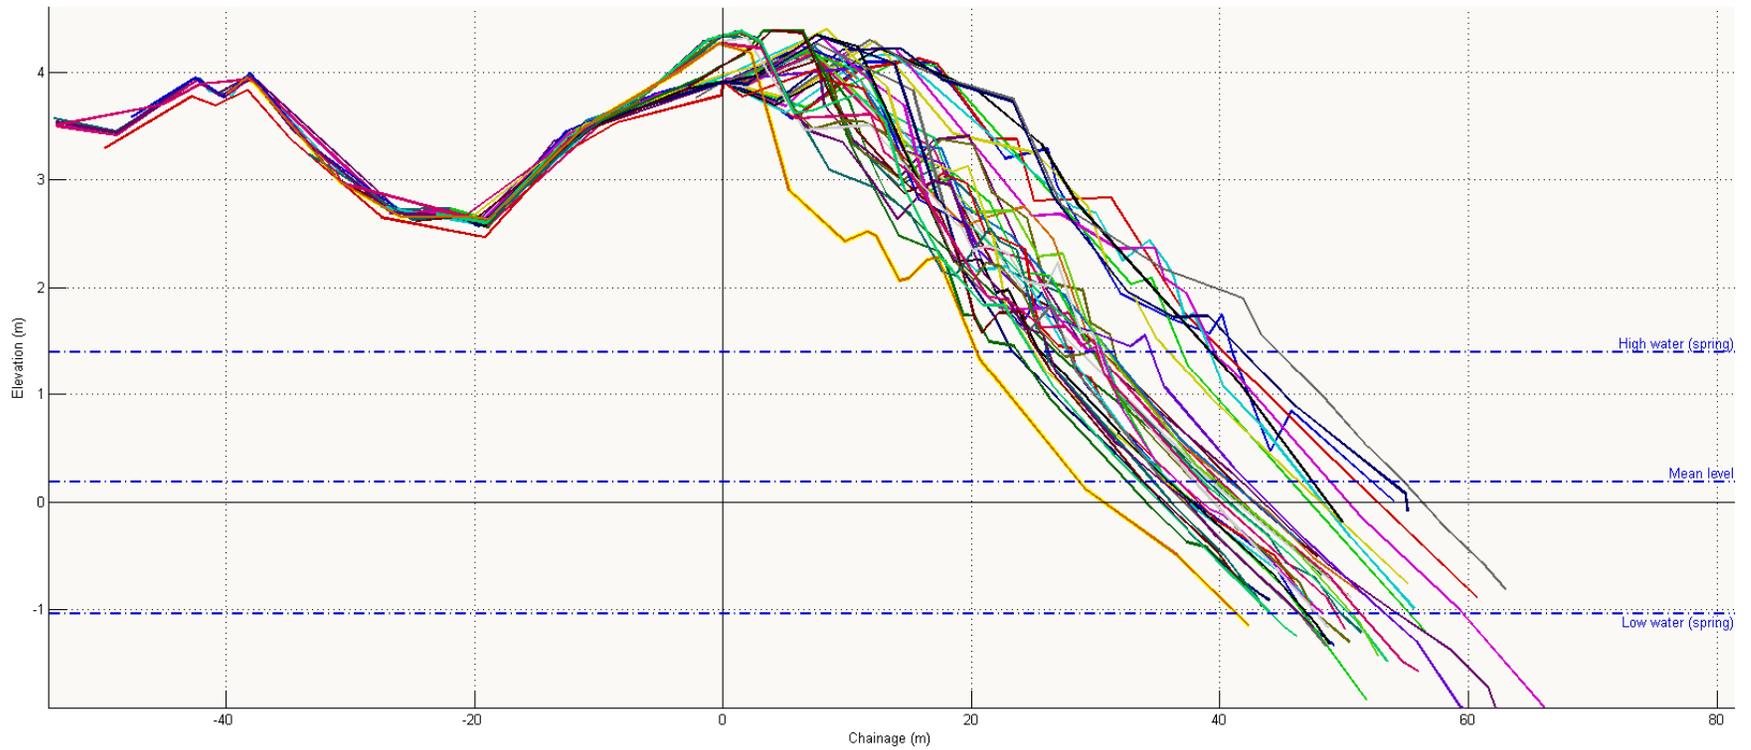
The Suffolk Coastal Trends Analysis report (2011) shows S1A2 to have a moderate erosional trend of 0.8 m/yr. There is progressive retreat of the foreshore with no beach steepening in the intertidal area. However the beach face in front of the highest midshore berm does show some steepening. This highest midshore berm with a height of 4 metres has moved landwards by 15m metres during the survey period There is no movement in the backshore. (see Appendix B23).

Appendix B23 – S1A2 – surveyed since 1992W, this profile clearly shows a mean erosion trend of 0.8 m/yr with the foreshore retreating landwards at a steady rate. The highlighted yellow profile is the most recent survey, 2011W
