Southeast Strategic Regional Coastal Monitoring Programme

BEACH MANAGEMENT PLAN REPORT

Littlestone-on-Sea

Document Title: **Beach Management Plan Site Report 2005/2006**

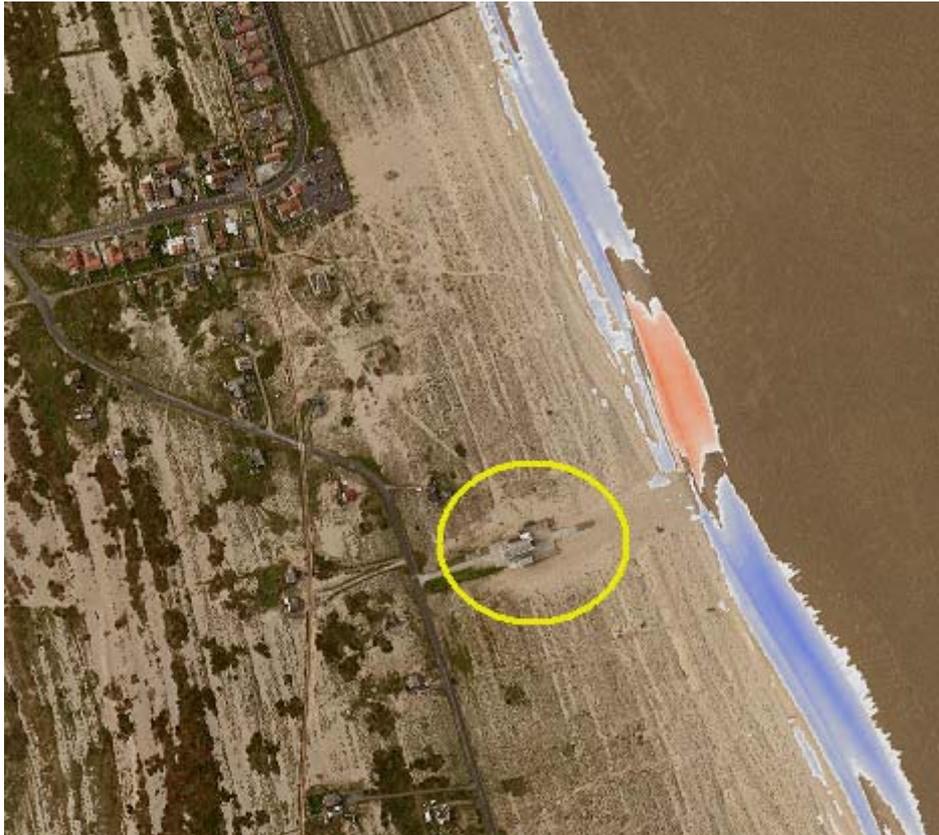
Figure 4.3 – The 2004-2003 beach difference model is shown superimposed on the aerial photos of 2005. Located in yellow is the lifeboat house at the southern end of Lydd-on-Sea. Note how an otherwise constant band of accretion (blue) is interrupted by a small area of erosion in front of the lifeboat ramp (red), suggesting possible anthropogenic changes to beach levels.

Section MU17.1.3 accreted by the greatest volume of any section over the 2003-2006 period (93,939m²). The northern boundary of the recycling programmes that influenced sections MU17.1.1 and 17.1.2 so greatly are unknown at the time of writing. The difference models suggest that mechanical extraction of shingle has not occurred in this section as large areas of beach loss, typical of sections MU17.1.1 and MU17.1.2, are not present here in any of the 3 survey years reported. However, an otherwise uniform shore-parallel band of beach accretion, present in all 3 year-on-year difference models, was interrupted by 2 small areas of erosion/unchanged beach topography, suggesting some anthropogenic influences to the beach (Figure 4.3). The 2003-2004 difference models locate these 2 small erosional zones in front of the lifeboat ramp and in front of an access road used by boats near the Anchorage beach cottages (profile 4c00737). Strangely, both these areas of erosion have moved north by 200m in 3 years, indicating beach movement by users of the lifeboat house and access road may not be the only cause of this erosion. Unfortunately, no anthropogenic beach movement logs exist to support this theory at present. It is also possible that the operation of the lifeboat and other craft is simply increasing the erosion potential of the beach here.

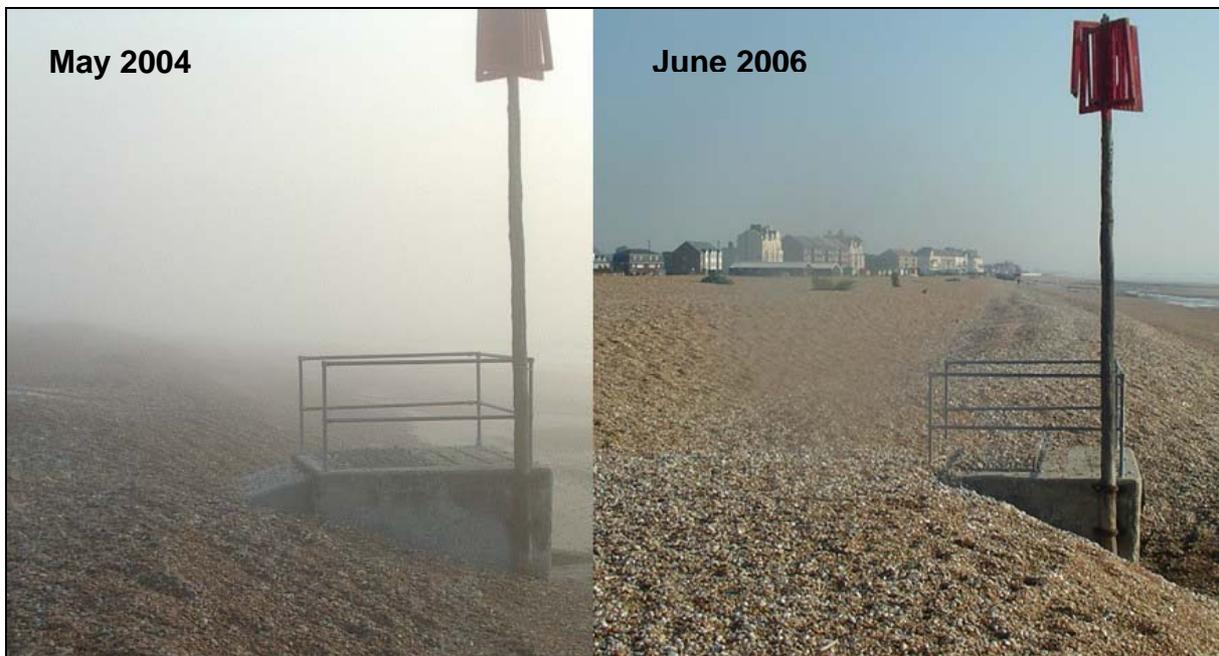
Figure 4.7 – Survey photos looking north from profile 4c00631 highlighting accretion in the south of MU17.3 from 2004 to 2006, probably caused by the outfall shown and the lifeboat station ramp situated to the south of these photos.

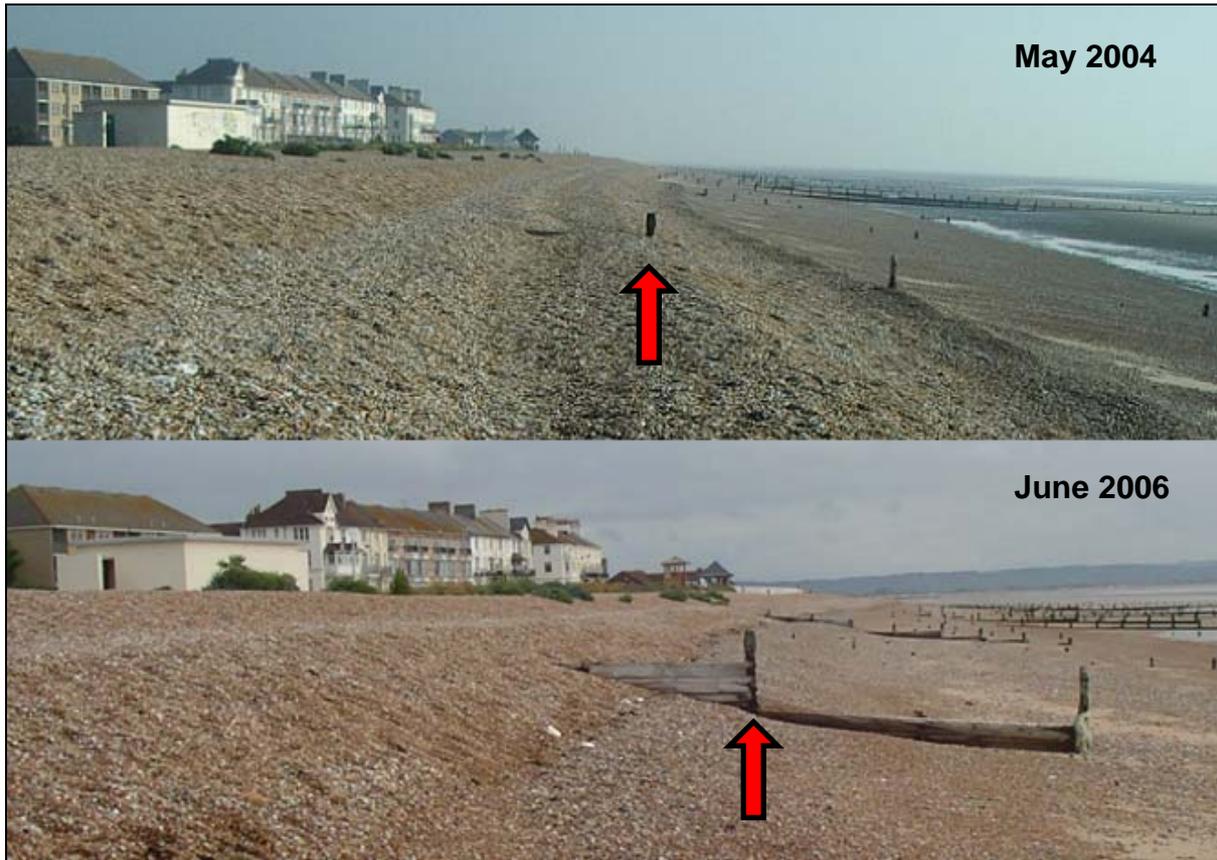
Figure 4.8 – Survey photos at profile 4c00620 looking north. The red arrows indicate the same groyne pile from different survey days with notably different levels of shingle submergence.

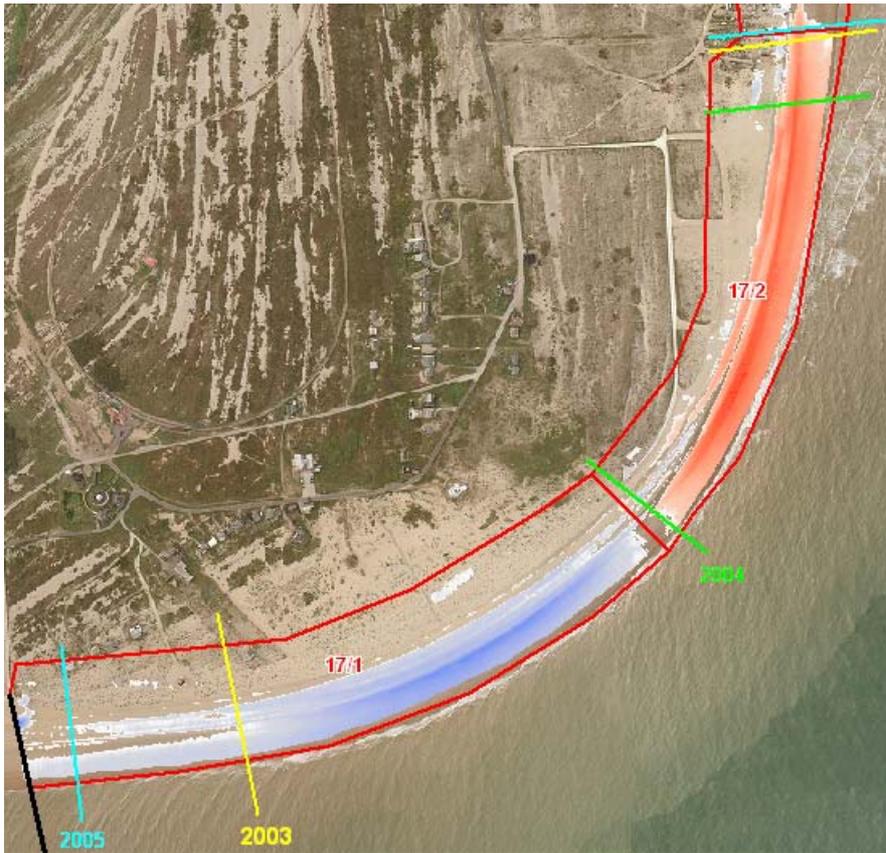
Figure 9.1 – Perceived recycling boundaries on the ness peninsula (MU17) from 2003-2006 (green, yellow and blue lines), superimposed on the aerial photos from 2005 and the difference model showing accretion in section MU17.1.1 and erosion in section MU17.1.2 from 2003-2006.

- In the winter of 2003, recycling stretched through the entirety of MU17.1.2 and most of MU17.1.1.
- In the winter of 2004, recycling stretched through all but the northern tip of MU17.1.2, but did not extend to MU17.1.1. This would explain the great accretion seen in this section compared with marked erosion a year previous and a year after (Table 4.0, and Figure 9.1).
- In the winter of 2005, recycling extended through almost all of MU17.1.1 and MU17.1.2.
