BEACH MANAGEMENT PLAN REPORT

Bulverhythe

BMP 71

Document Title: **Beach Management Plan Site Report 2008**

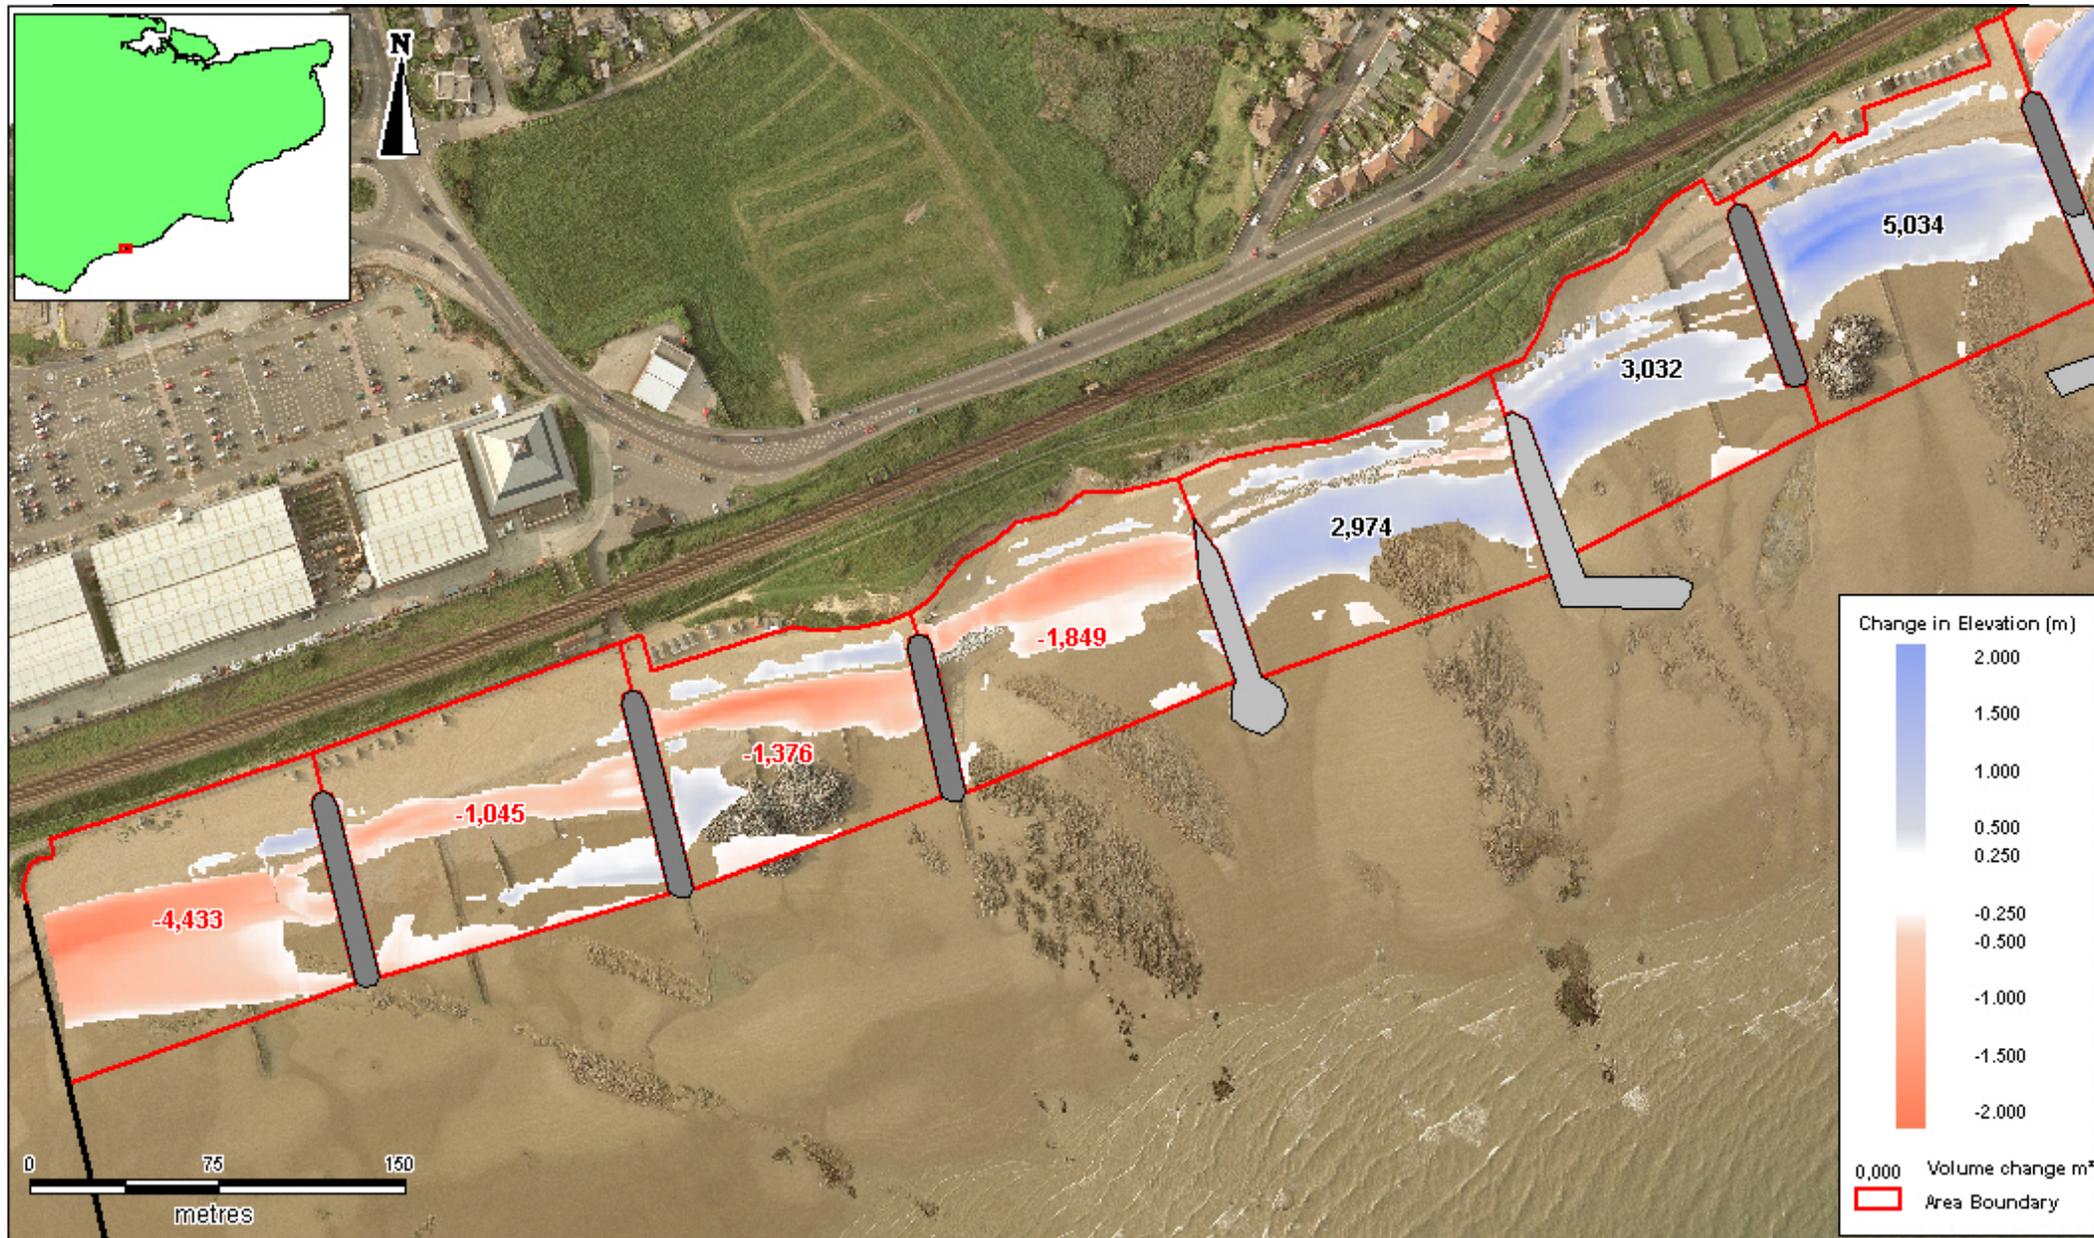
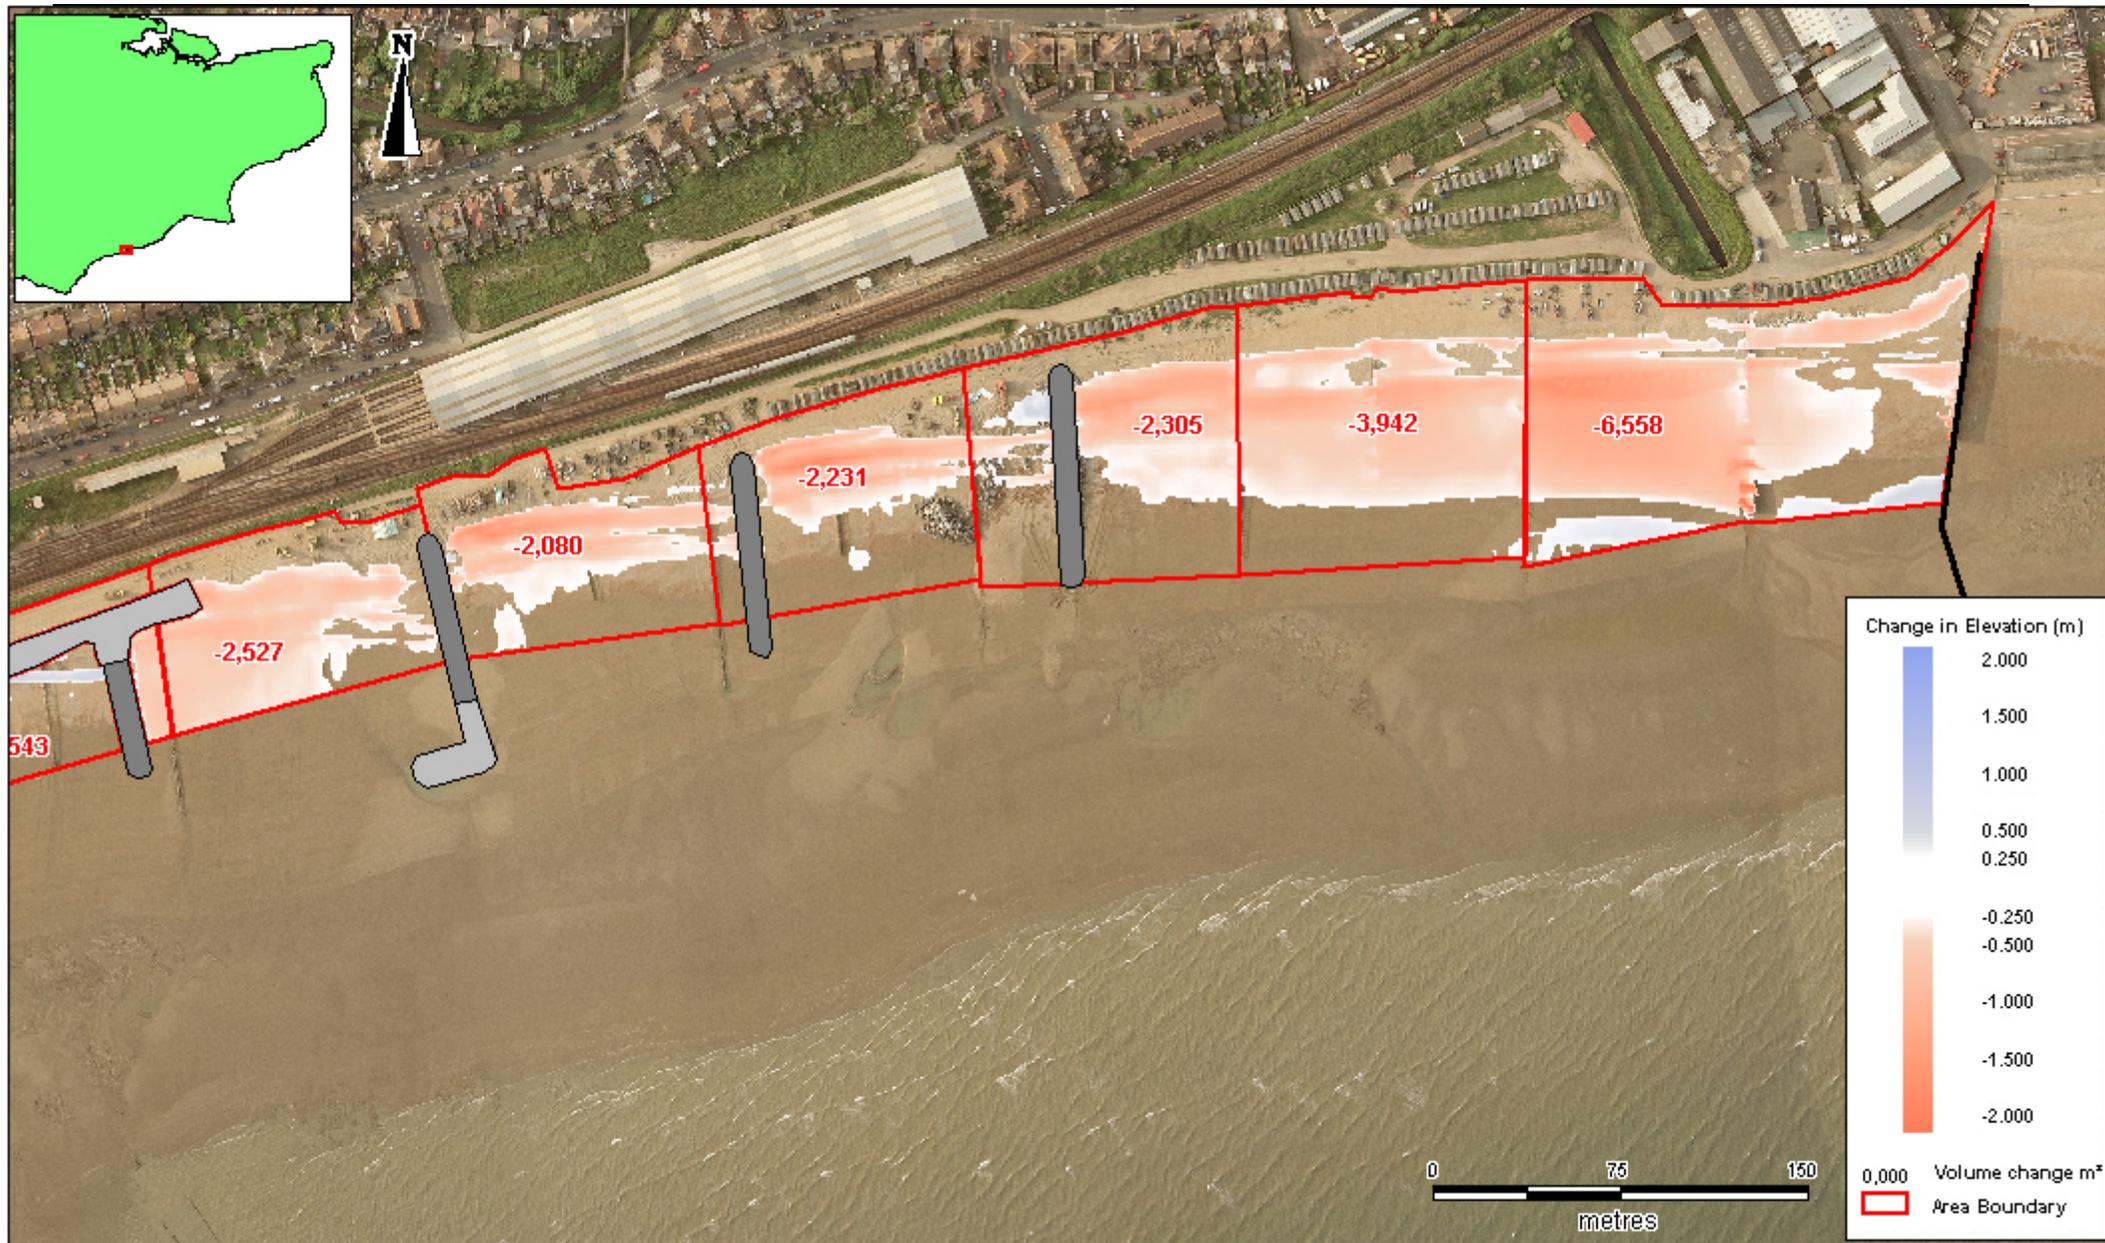
Now that the 2008 BMP data set has been compiled, it is possible to overlay the results of the survey with BMP data from 2007. This enables comparative volumetric analysis to be undertaken to determine change over a given period. Through the use of three-dimensional ground models and ortho-rectified aerial photography, it is possible to create a visual interpretation of the volumetric change that has occurred during each analysis period. This is shown in Plate 1 (1-7), which indicates areas of net erosion or accretion (N.B. a 0.25m difference in elevation is considered as “no change”) and the location of any extraction/deposition sites.

Negative values represent erosion that has occurred between 2007 & 2008, and positive values indicate accretion. Whilst these figures show an overall change in beach volume within each discrete section, it should be recognised that the data is based on the BMP survey, which is undertaken once each year. It is therefore only a snapshot of one moment in time, and the particular dynamics of each frontage need to be taken into account. This ensures that the information shown in the difference models represents the net change rather than capturing a particular extreme variation caused by a large event.
