South East Strategic Regional Coastal Monitoring Programme

BEACH MANAGEMENT PLAN REPORT

Bulverhythe

Document Title: **Beach Management Plan Site Report 2009**

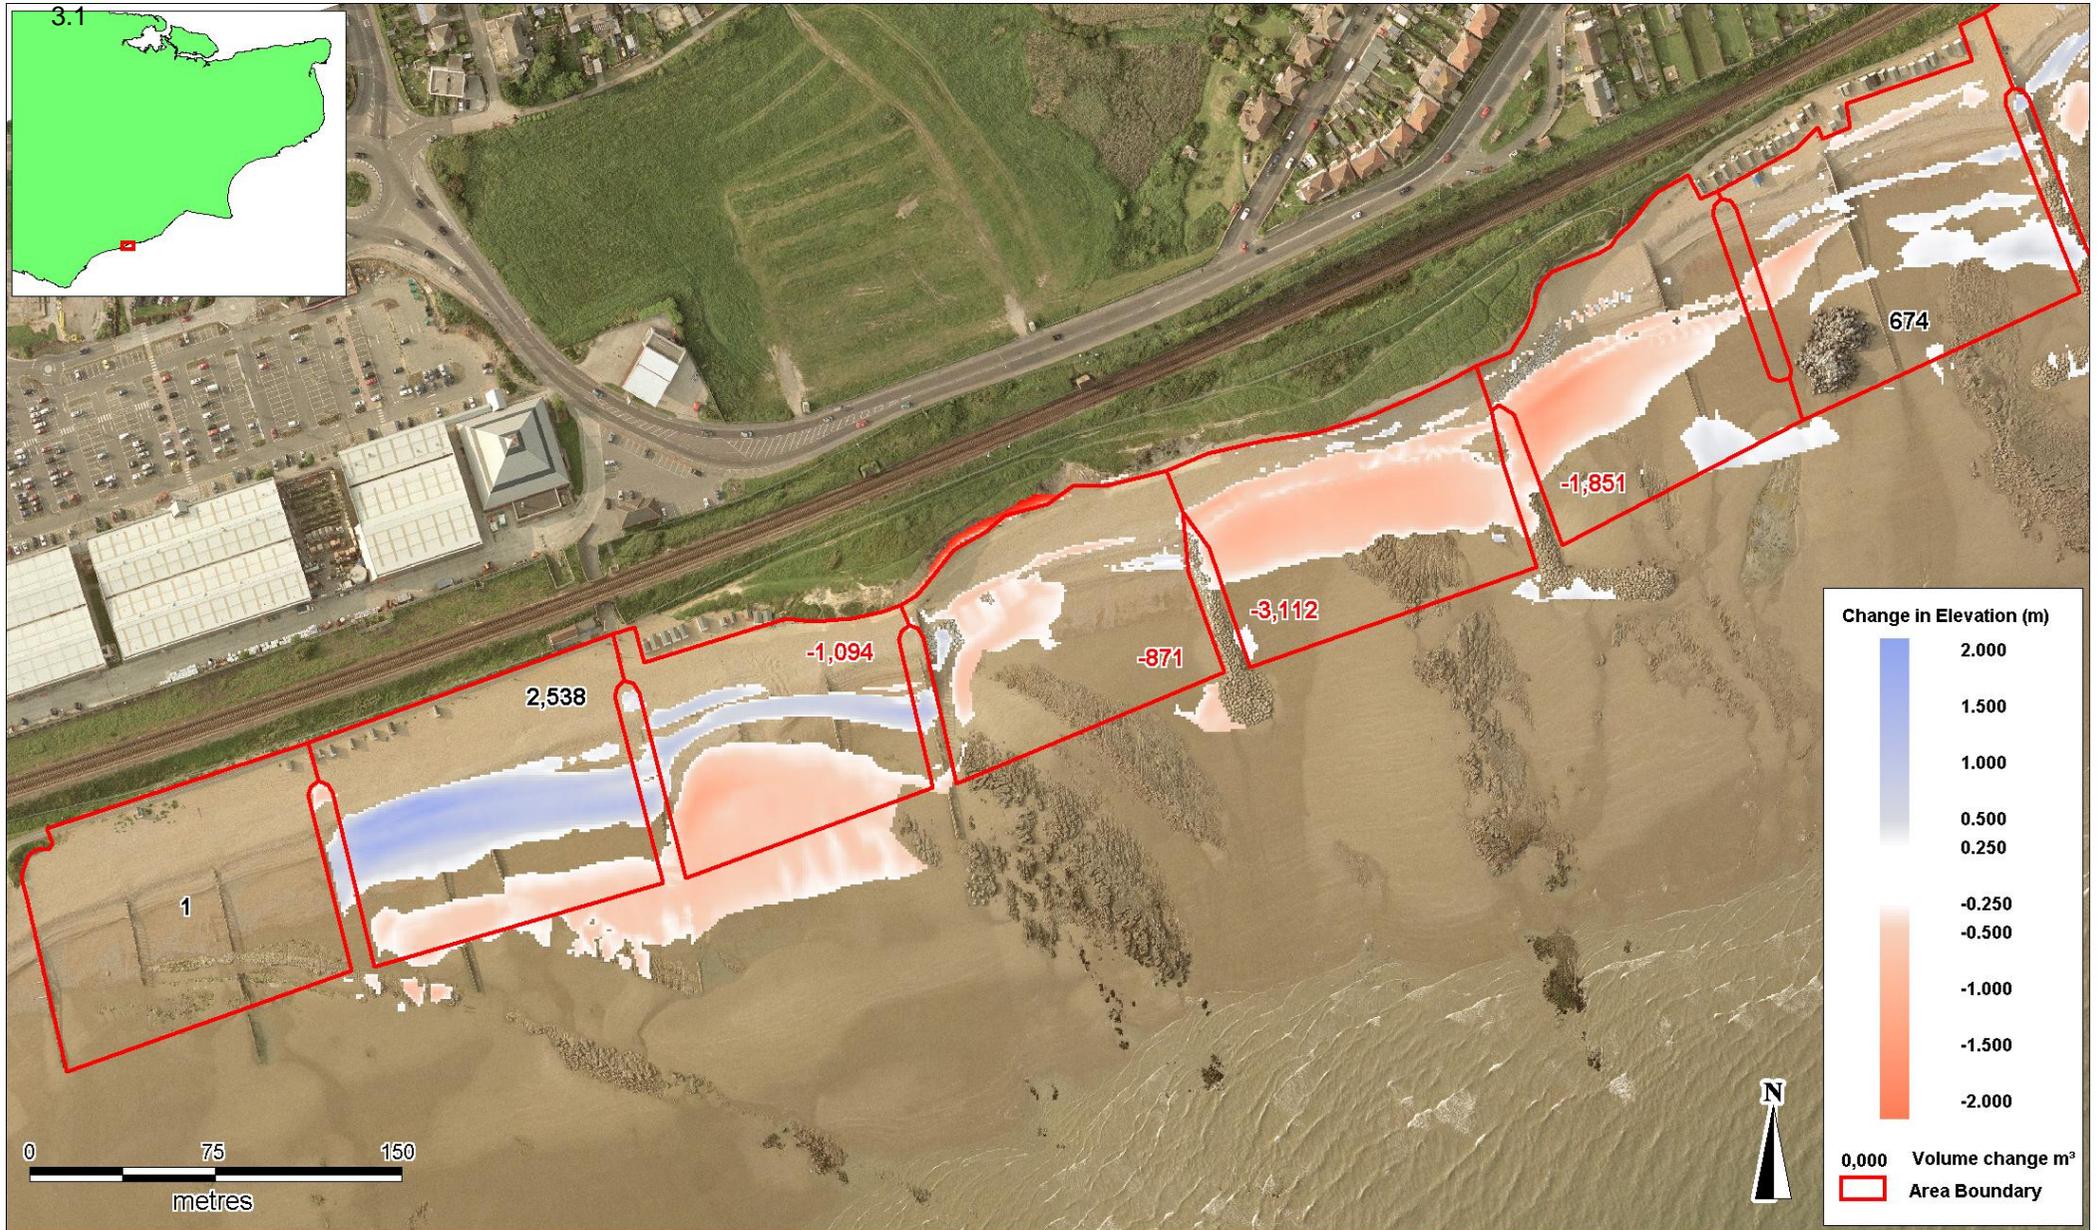
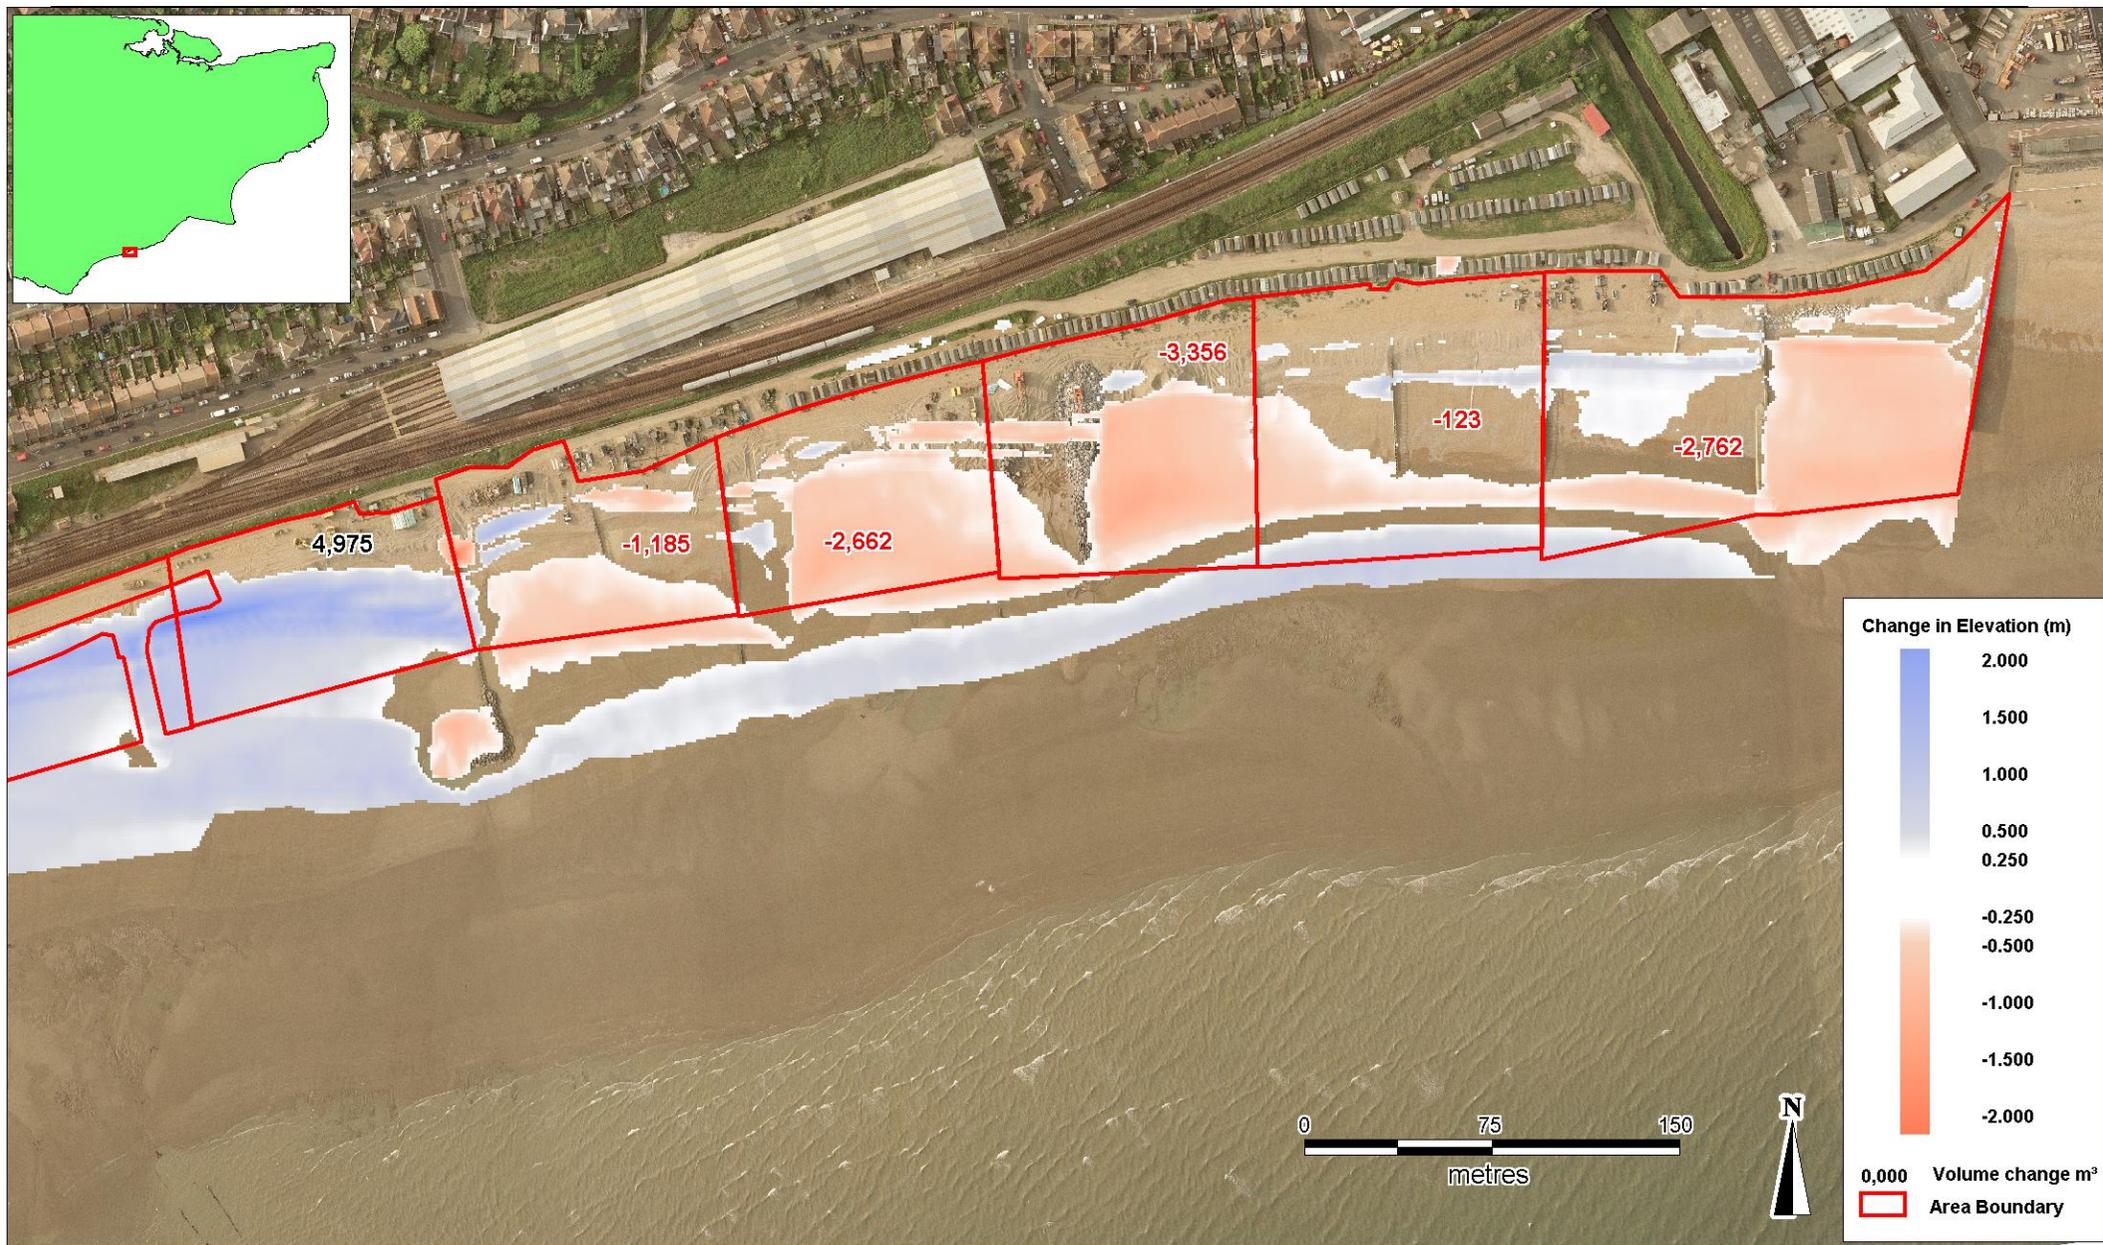
Now that the 2009 BMP data set has been compiled, it is possible to overlay the results of the survey with BMP data from 2008. This enables comparative volumetric analysis to be undertaken to determine change over a given period. Through the use of three-dimensional ground models and ortho-rectified aerial photography, it is possible to create a visual interpretation of the volumetric change that has occurred during each analysis period. This is shown in Plate 1 (1-7), which indicates areas of net erosion or accretion (N.B. a 0.25m difference in elevation is considered as “no change”) and the location of any extraction/deposition sites.

Negative values represent erosion that has occurred between 2008 & 2009, and positive values indicate accretion. Whilst these figures show an overall change in beach volume within each discrete section, it should be recognised that the data is based on the BMP survey, which is undertaken once each year. It is therefore only a snapshot of one moment in time, and the particular dynamics of each frontage need to be taken into account. This ensures that the information shown in the difference models represents the net change rather than capturing a particular extreme variation caused by a large event.
