**Cell 1 Regional Coastal Monitoring Programme
Update Report 2: 'Partial Measures' Survey 2010**

**North Tyneside Council
Final Report**

May 2010

Update Report 2
 'Partial Measures' Survey 2010

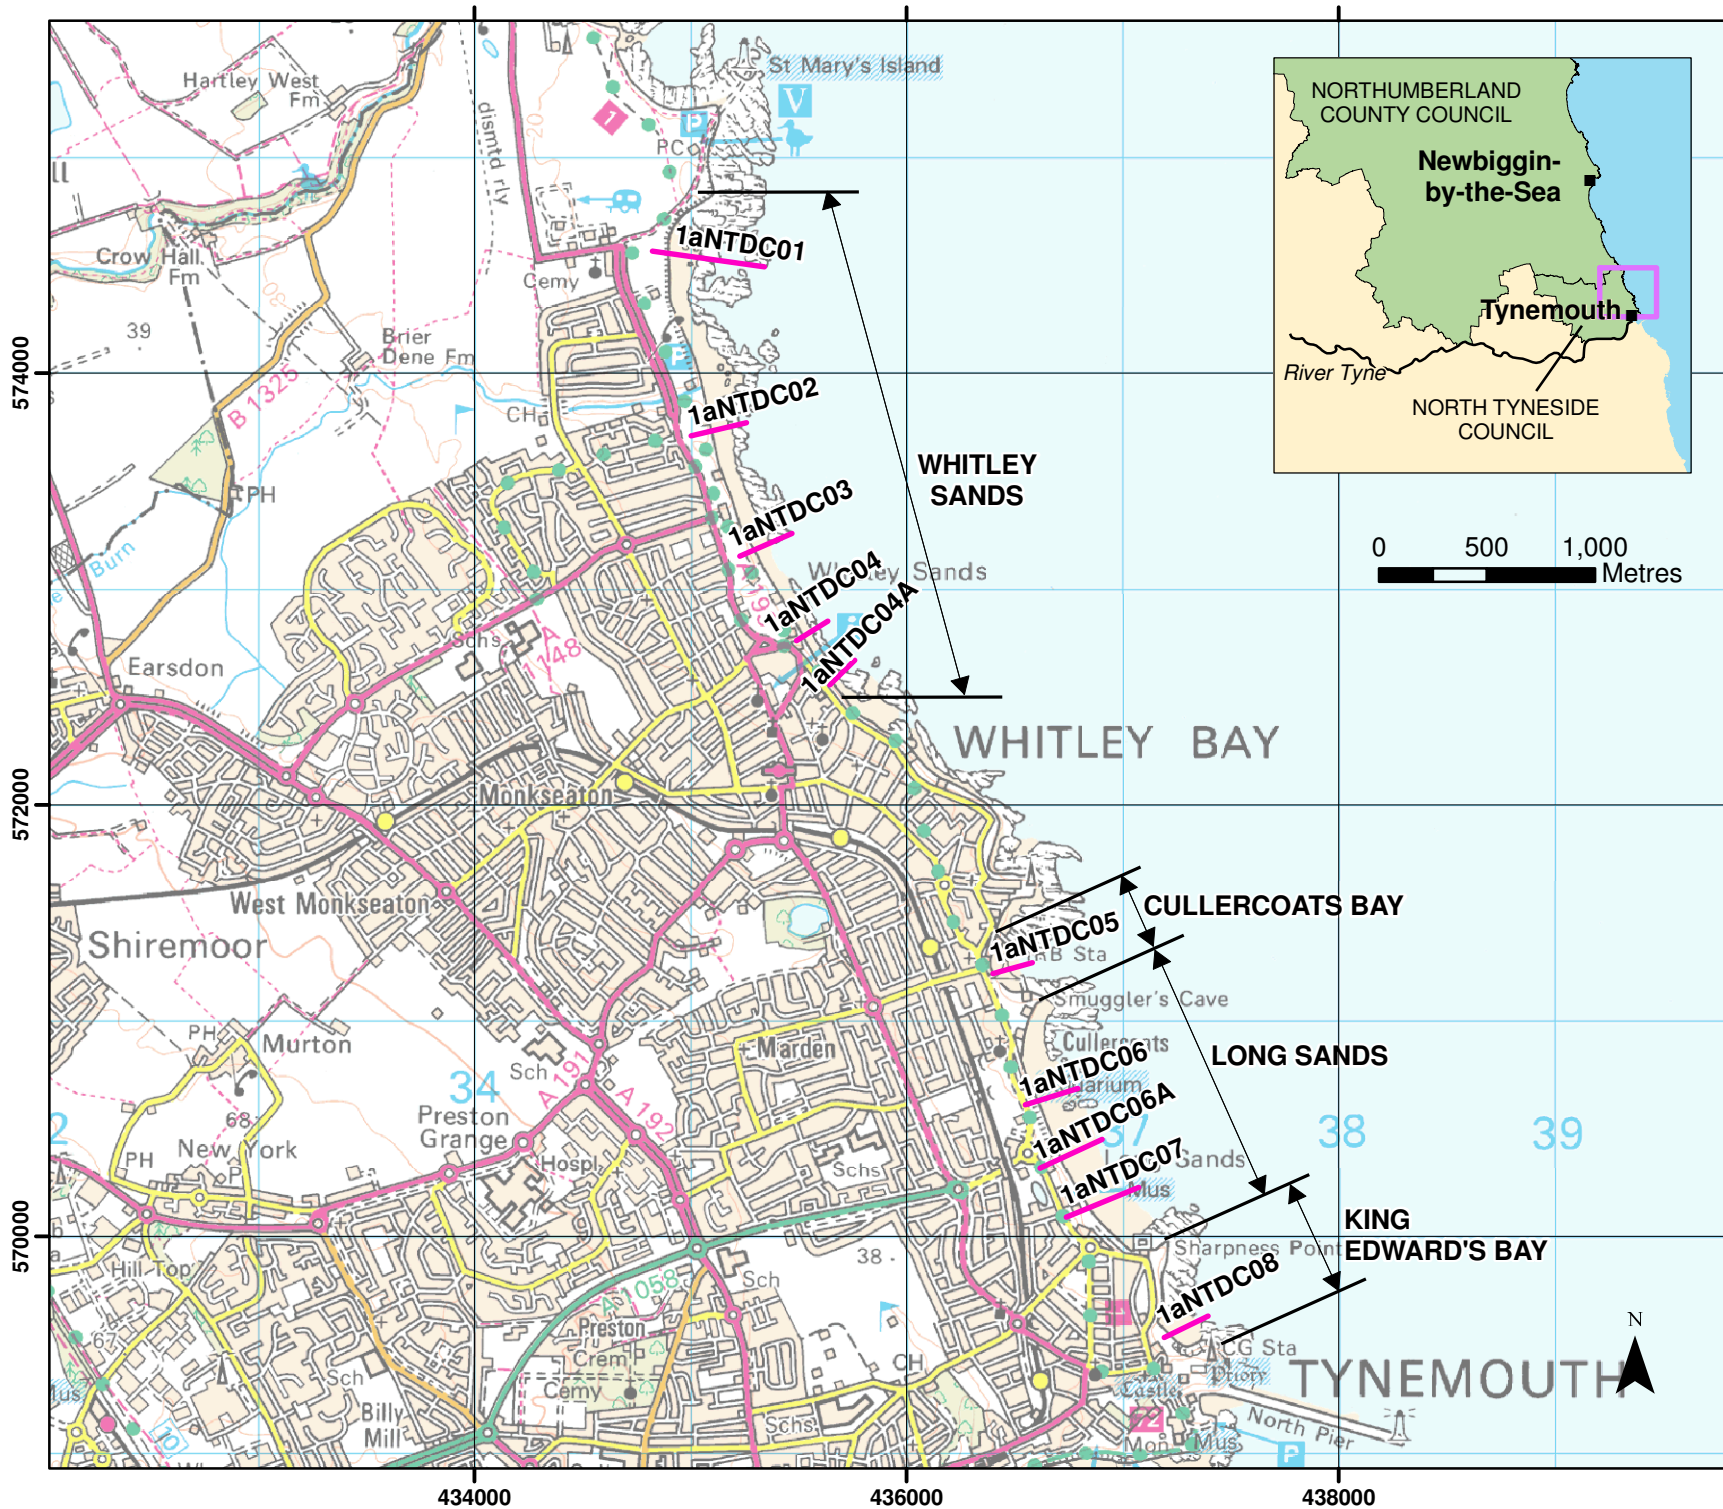
**Figure 1 - Map 1
 North Tyneside Council Frontage**

SURVEY LOCATIONS

Topographic Profiles

- Annual
- Bi-Annual

Topographic Surveys

- 6 monthly
- yearly
- 5 yearly
- Cliff Top Edge Survey
(Indicative Survey Extents shown)

The location of these surveys is shown in Figure 1. They have also previously been provided on a digital file which can be opened in Google Earth showing the locations of the surveys.

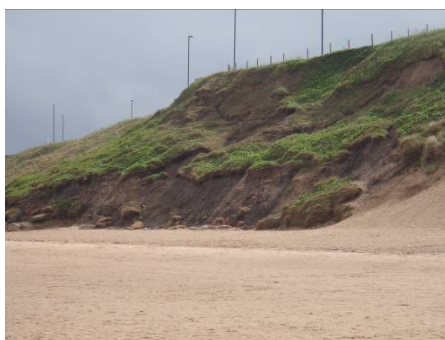
- The low levels recorded along the upper beach also resulted in measurable erosion of the dune toe throughout Tynemouth Longsands, particularly along transect NTDC06.

Profile NTDC06 – Measurable erosion of the dune toe

- The historic profile from April 2002 along NTDC07 does show, however, that following storm damage the dunes at Longsands can recover over time and this process is expected to occur progressively over the summer of 2010 (further major storms notwithstanding).
- Along profile NTDC04, towards the southern end of Whitley Sands by the café, the slope was noted by the surveyors as being unstable, with small landslips and large cracks visible. This frontage may require some remedial attention to prevent a slump; this will be further investigated during the forthcoming walk-over inspections in summer 2010.

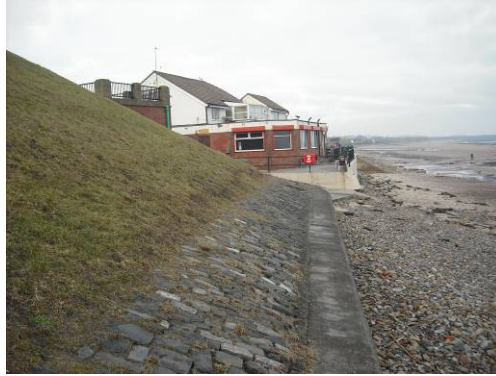
Profile NTDC04 – The surveyors noted an unstable slope, with small landslips and large cracks visible (not seen in photograph)

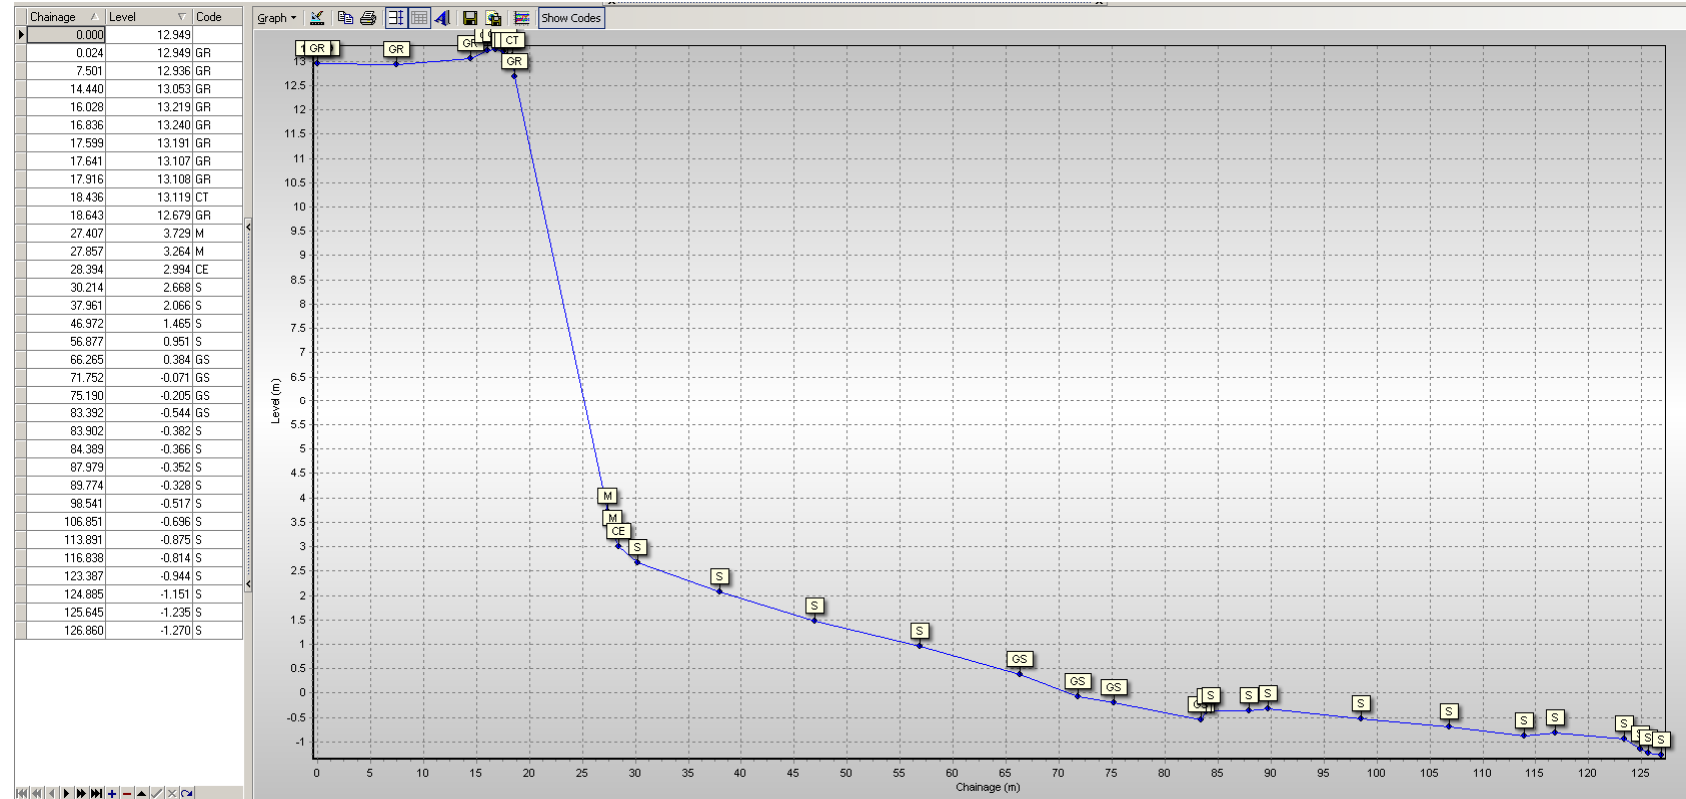
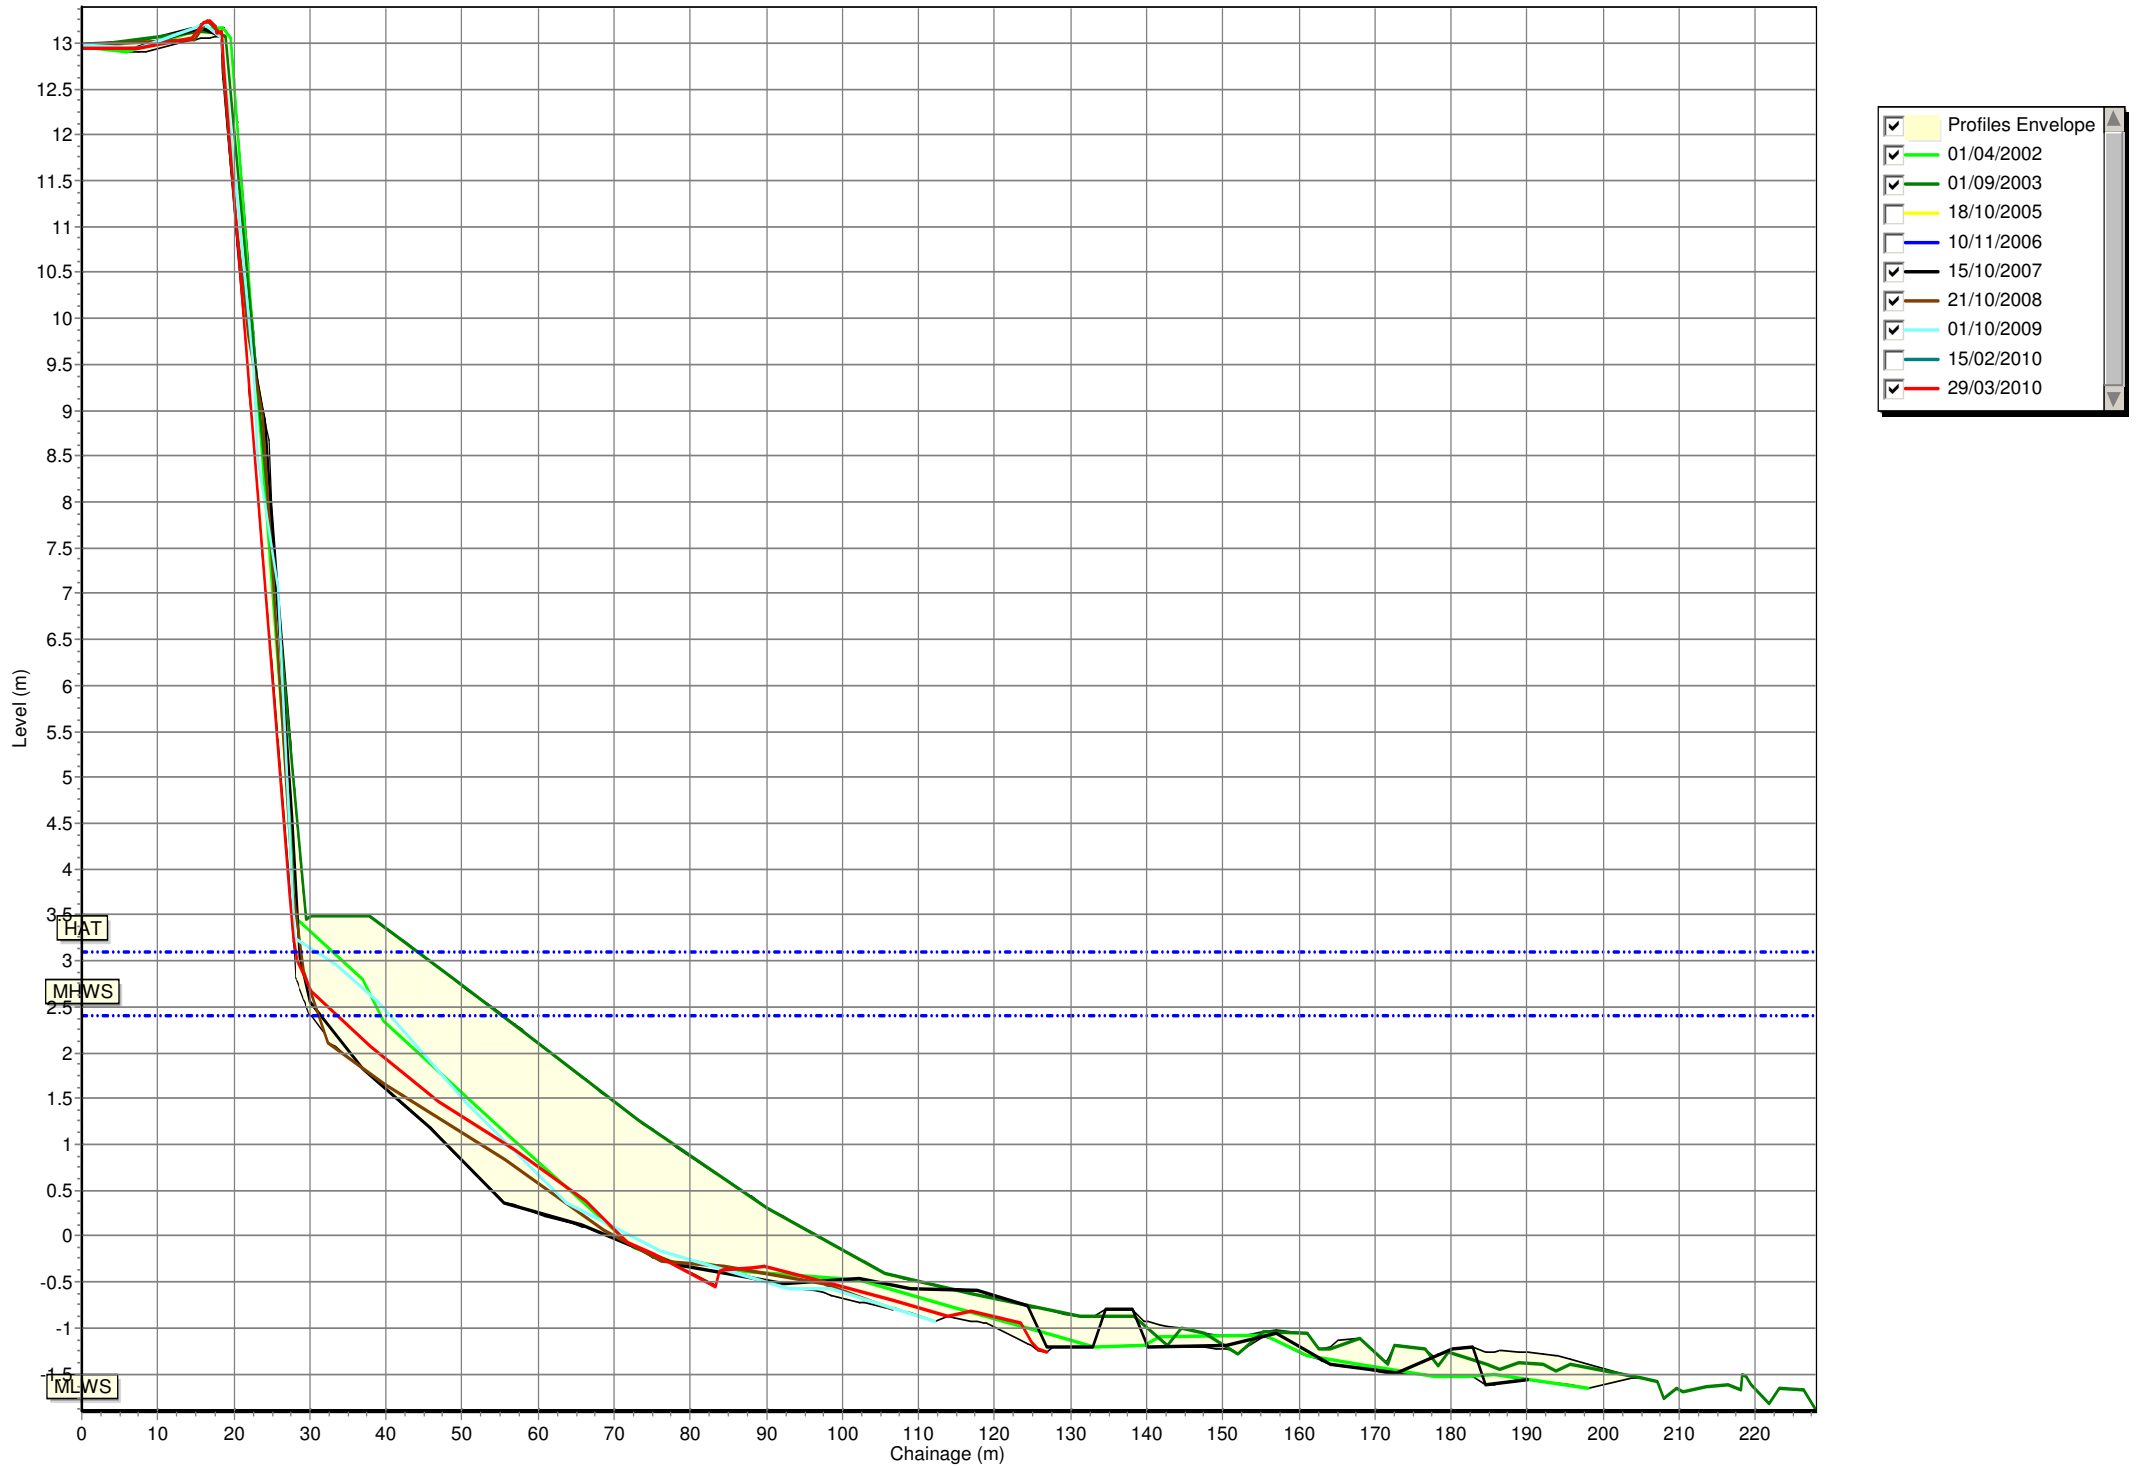
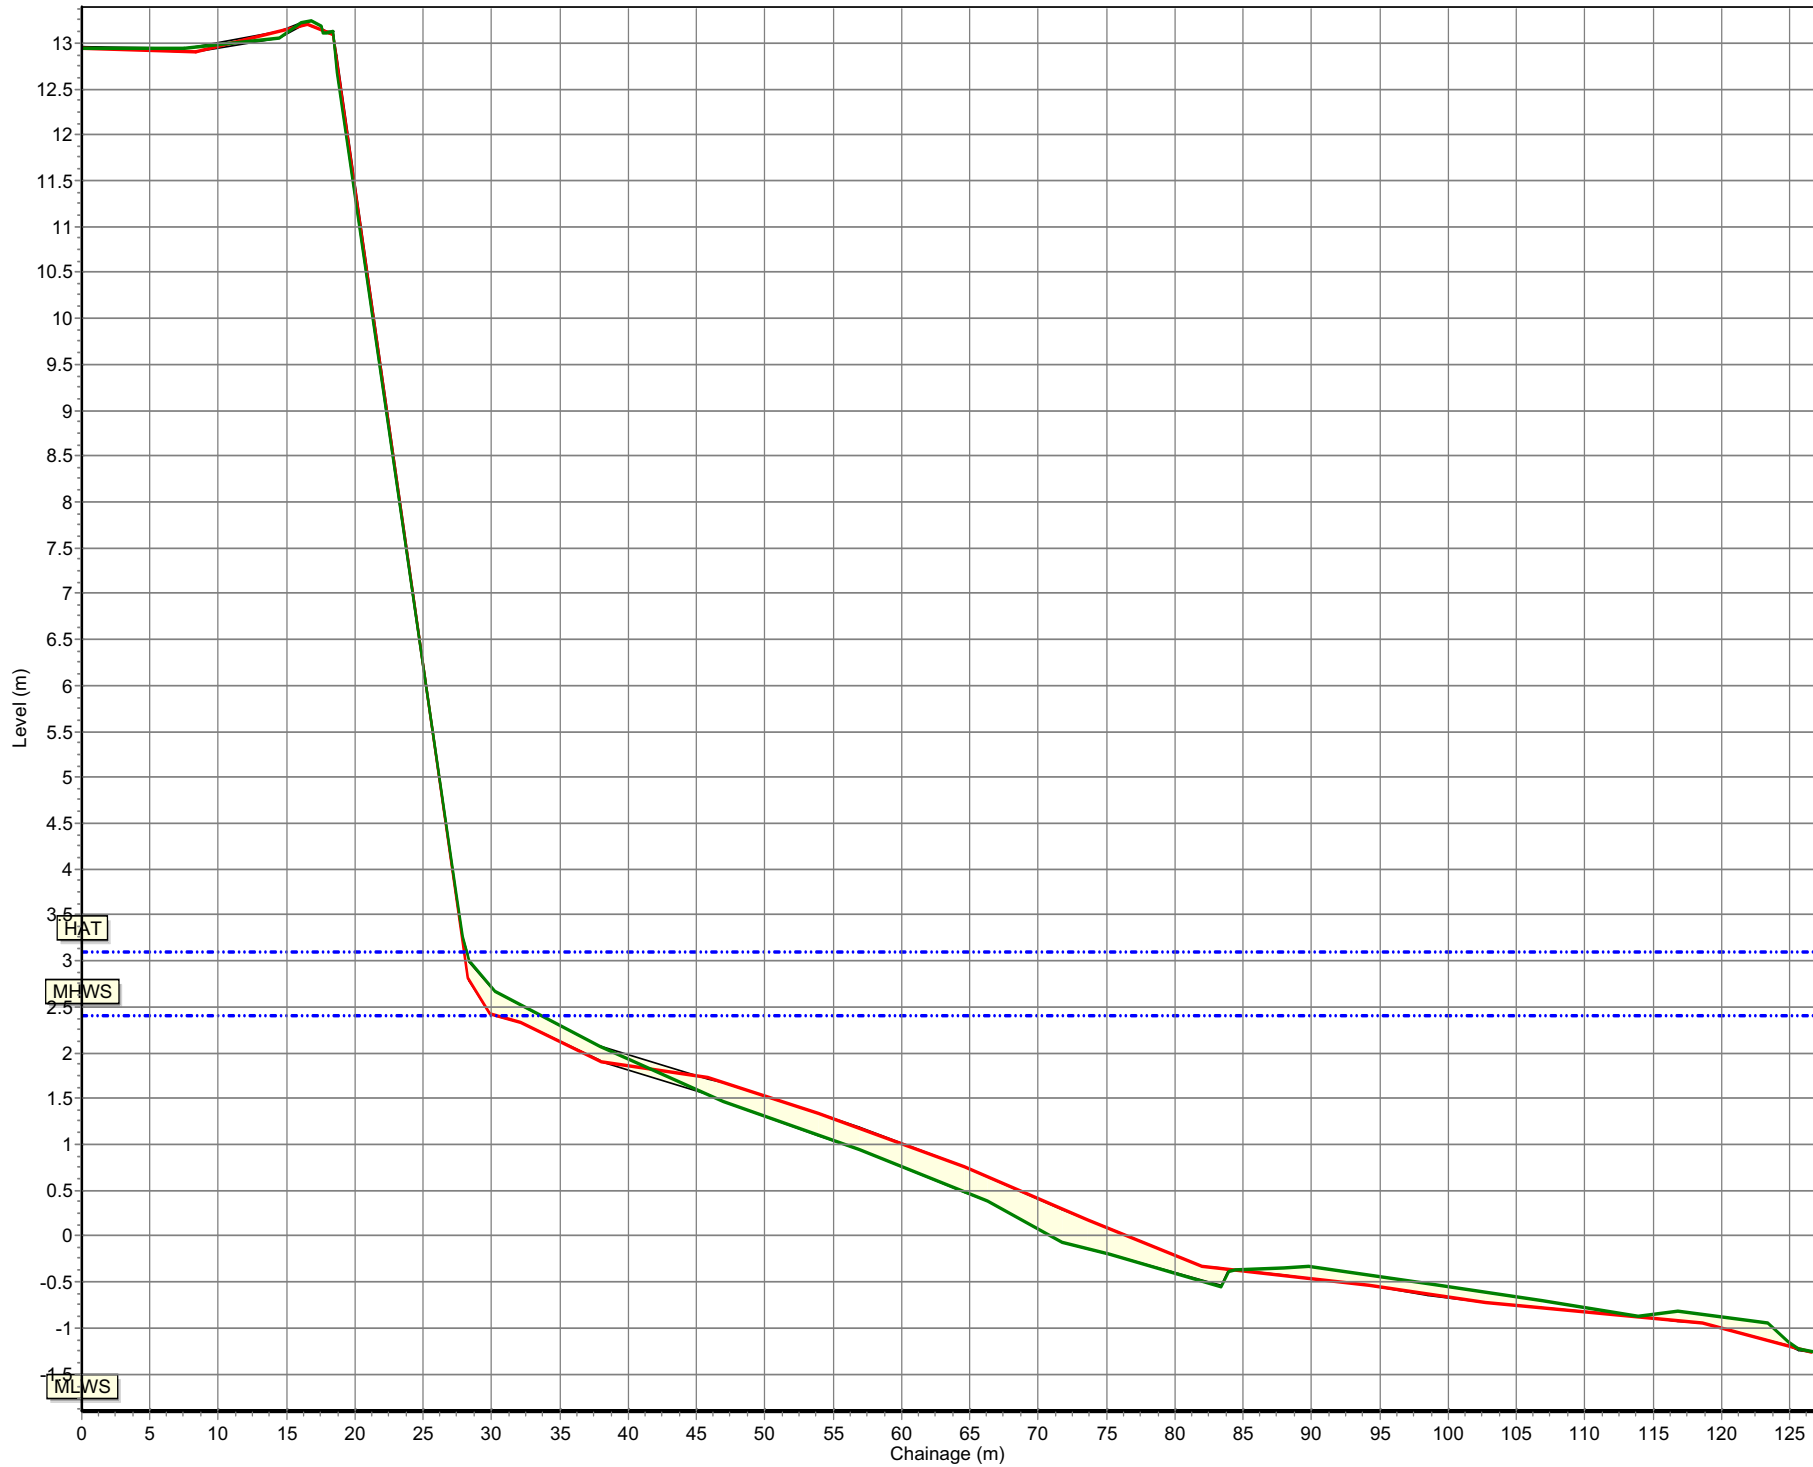
1aNTDC01 - 29/03/2010

- The cliff face retreated by up to 1.5m along transect NTDC01, although the cliff top recession was less than this value. This means, however, that the cliff is now over-steepened in places and local slumping is expected to continue in response.

Beach Profiles: 1aNTDC01

Pre/Post Survey

- Profiles Envelope
- 15/02/2010
- 29/03/2010

Survey Date	Description of Changes Since Last Survey	Interpretation
03-2010	<p>Beach Profiles:</p> <p>Whitley Sands is covered by five beach profile lines (Appendix A). Four of these were initially surveyed annually each autumn between 2002 and 2009. From spring 2010 onwards, they have been surveyed 6-monthly and a fifth profile has been added at the southern end of the frontage.</p> <p>NTDC01 is located in the north of Whitley Sands, along the undefended cliffs just to the south of Trinity Road Car Park. The cliff face has eroded landward by up to 1.5m in places, with a recession of the cliff top position also occurring, albeit at a lesser rate. Between October 2009 and February 2010 foreshore levels immediately at, and 10m seaward of, the cliff toe reduced to match the previous record low values. Between February 2010 and March 2010 material was driven towards this area by the storm, enabling the foreshore here to partially build up again, although further seaward along the profile, between chainages of 40m and 80m, the storm caused foreshore lowering.</p> <p>NTDC02 to NTDC04 extend across the cliffs/slopes, promenade and seawall before progressing across the foreshore towards low water. All three of these profiles show significant changes since the previous surveys.</p> <p>Along NTDC02, material was flattened from the large berm that was evident along this transect in October 2009 and drawn down the profile to become deposited on the lower foreshore, with some export to the sub-tidal zone, by February 2010. Levels at a chainage of 60m along equalled the previous record low values.</p> <p>Along NTDC03, the massive berm that was evident in October 2009 had been totally flattened by mid-February 2010. This resulted in a lowering of beach levels by 1.8m at a chainage of 30m (where the crest of the berm had previously been located) and 0.6m at the toe of the sea wall.</p>	<p>The general trend between 2002 and 2008 along NTDC01 was that the cliff form remained relatively stable, despite fluctuations in beach levels at the cliff toe and upper to mid beach commonly occurring. Changes, indicative of a small slump in the cliff face, with erosion debris being deposited on the foreshore, were then observed between October 2008 and October 2009. More marked changes have since been observed to February 2010 with up to 1.5m cut-back in the cliff face. The cliff top does not seem to have eroded as much as the cliff face, leading to over-steepened conditions that made it unsafe for the surveyors to approach the cliff edge in late March 2010. This suggests that a further slump in the cliff top could be imminent. Foreshore levels here can be volatile, with an envelope of up to 2m variation in beach level being recorded a short distance from the toe of the cliff along this profile.</p> <p>Along the defended sections of Whitley Sands, as measured by NTDC02 to NTDC04, there has been a history of successive berm formation and removal on the upper beach with associated foreshore lowering and recovery, respectively. This has previously been interpreted as storm-related changes in the foreshore and this trend has continued to the current survey. The berms that were present along the foreshore in October 2009 no doubt provided some (temporary) buffering against the winter storms but ultimately this material was removed, causing upper beach lowering and lower foreshore deposition, resulting in the flatter profile more typically associated with stormy winter wave climates.</p>

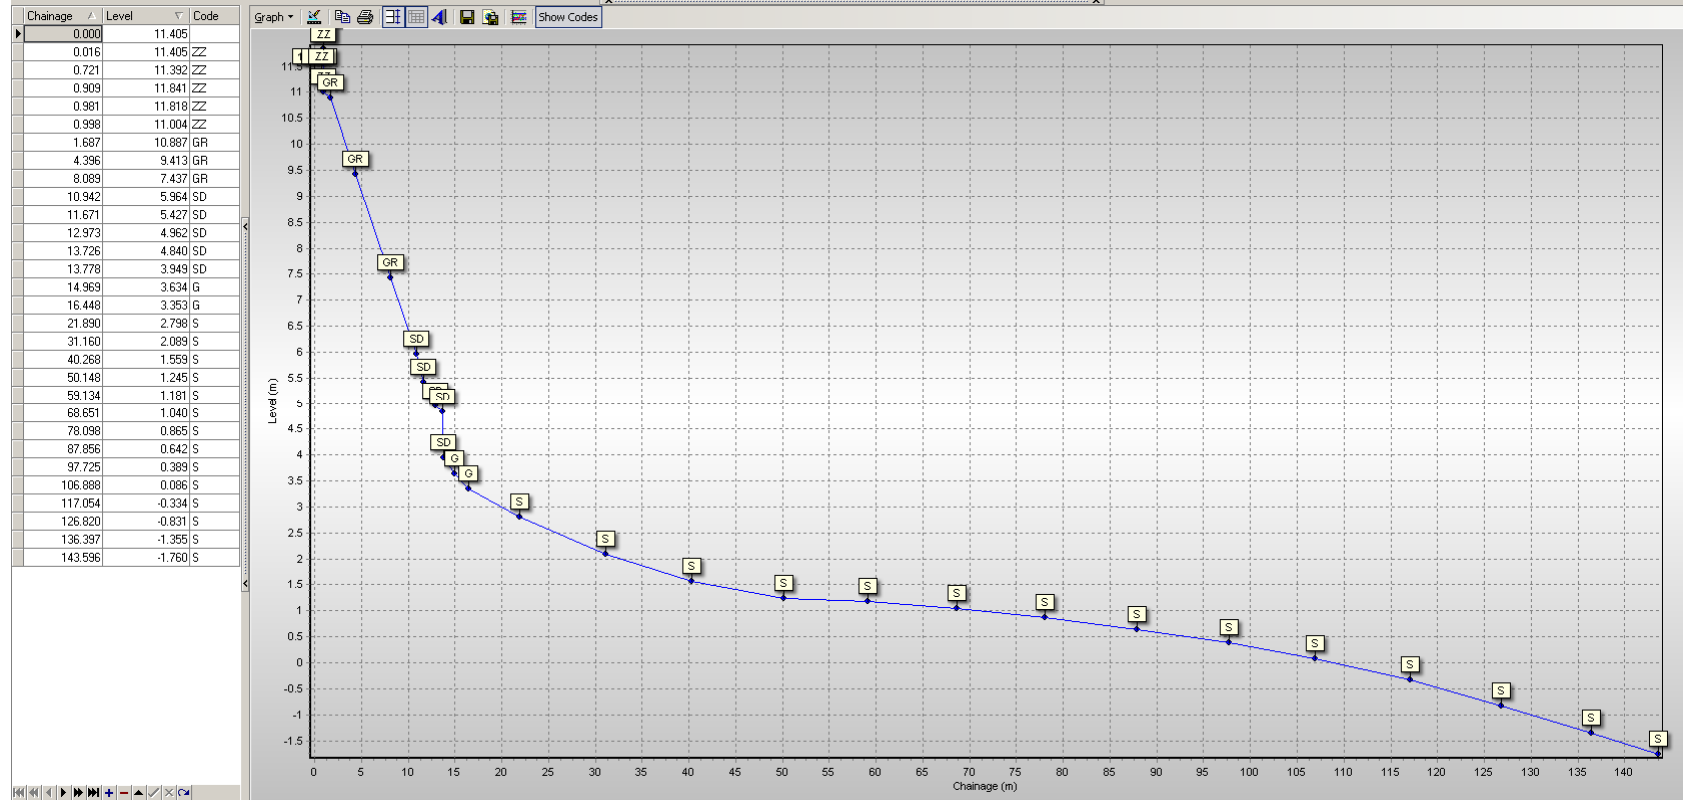
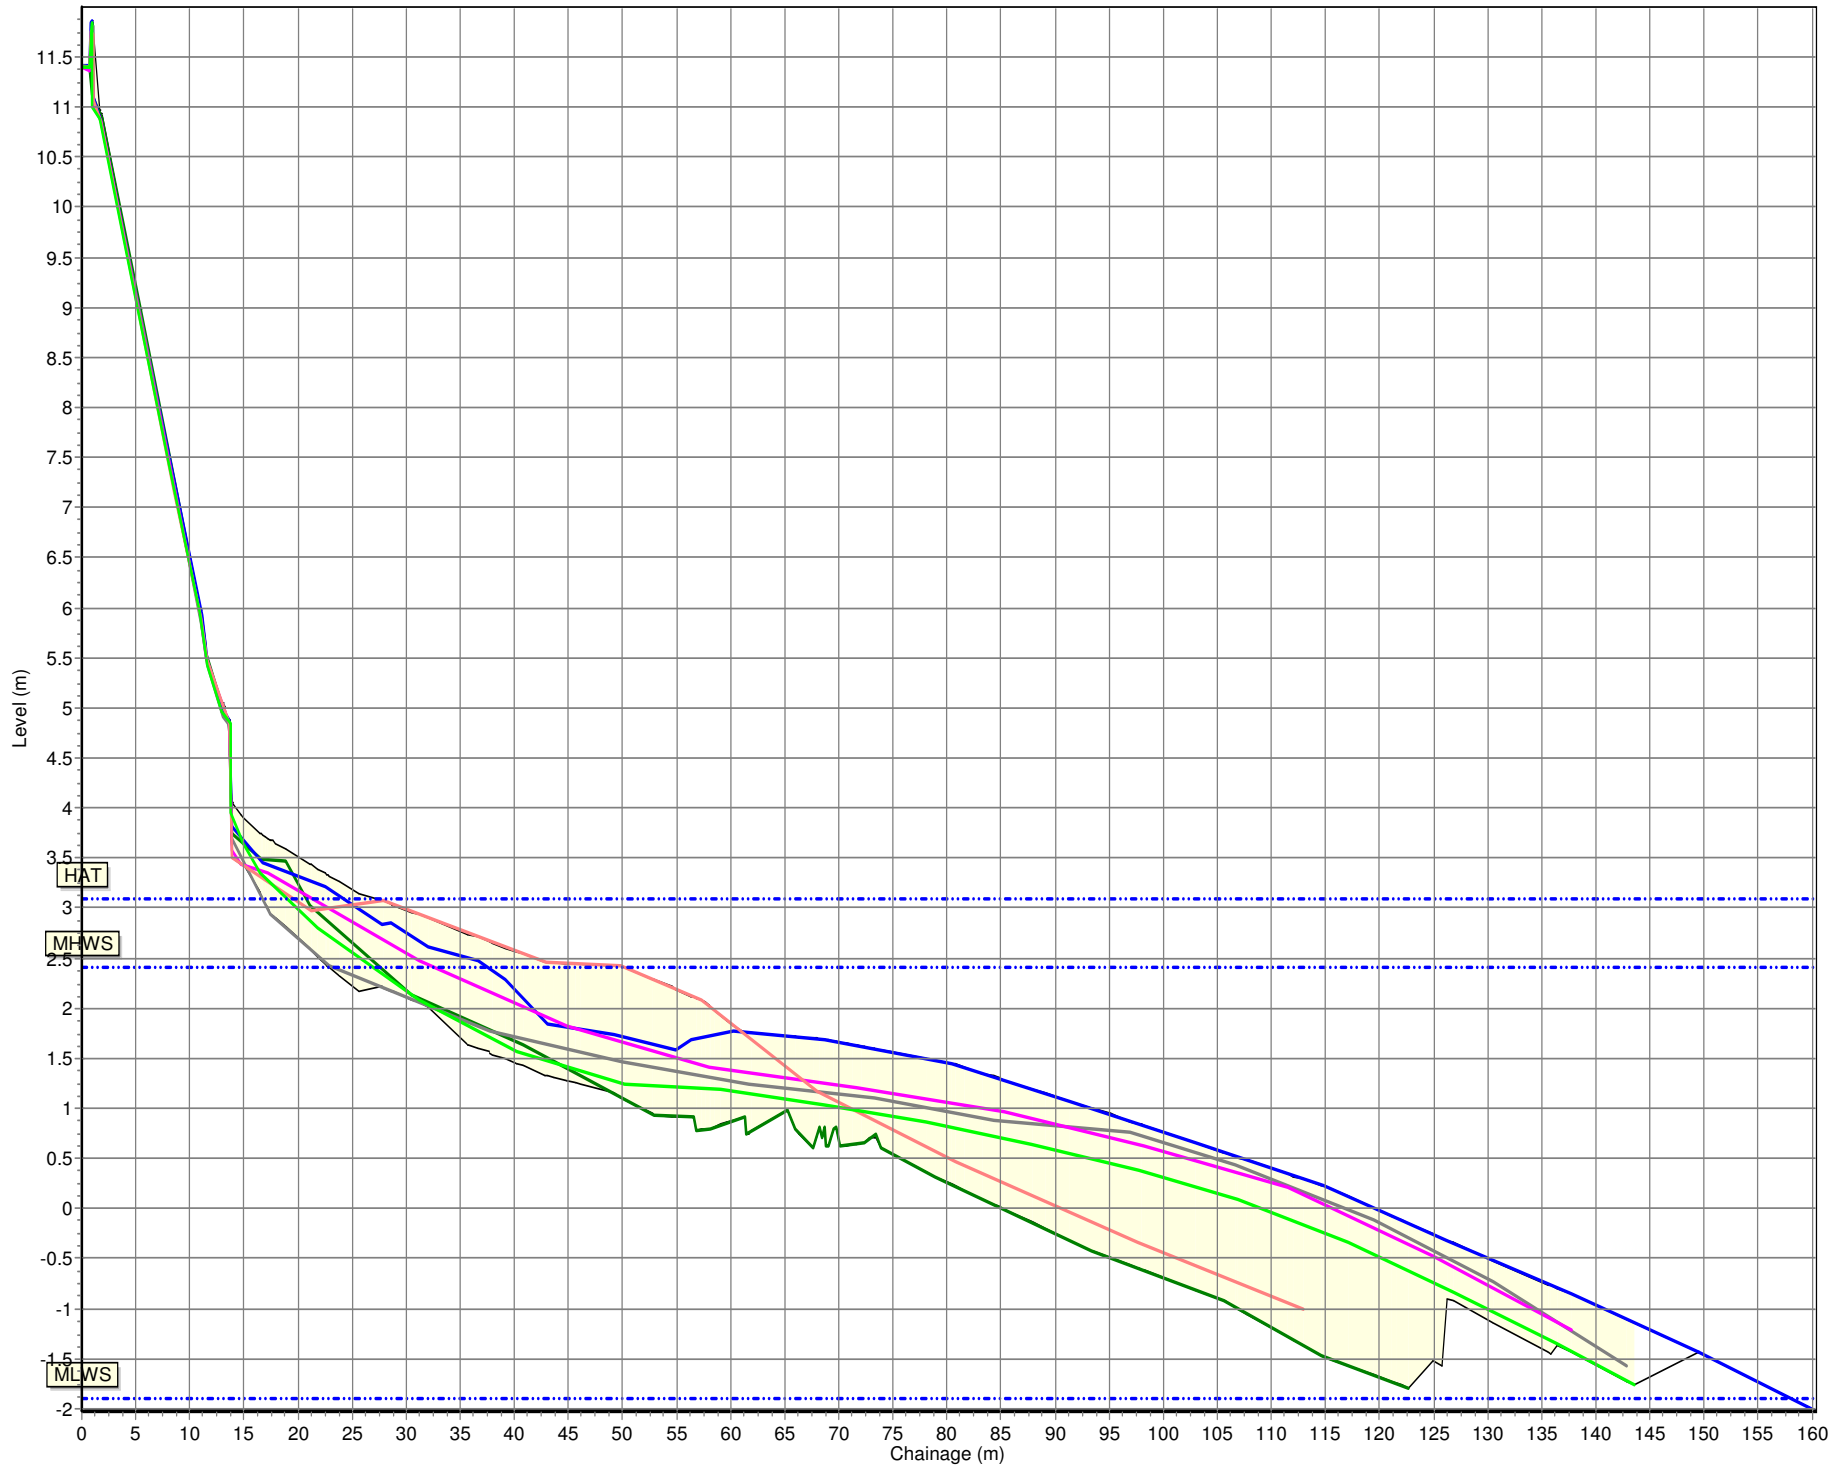
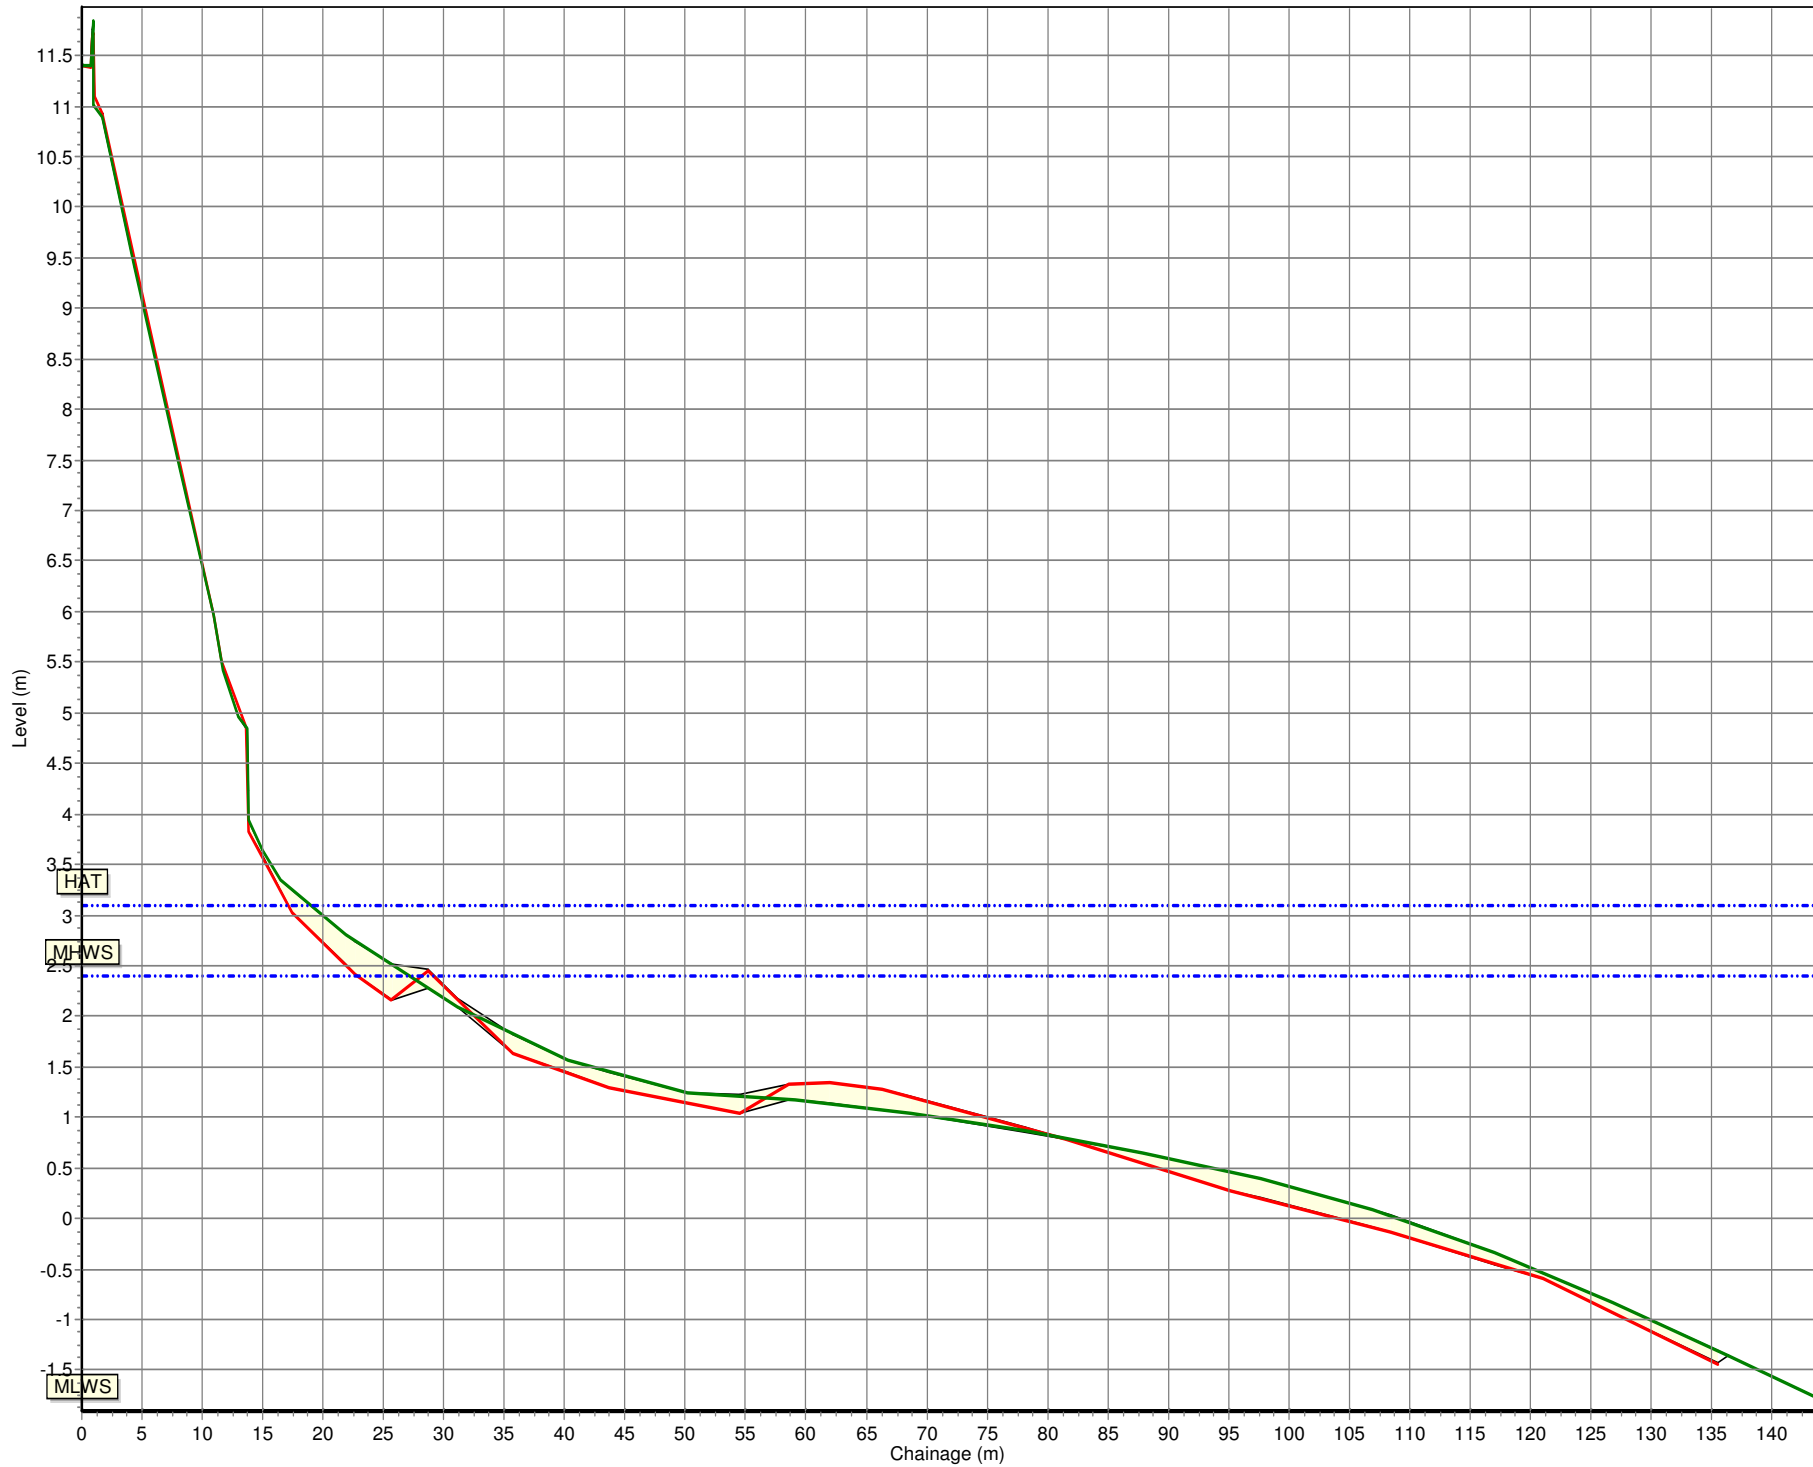
1aNTDC04 - 29/03/2010

Beach Profiles: 1aNTDC04

- Profiles Envelope
- 01/04/2002
- 01/09/2003
- 15/10/2004
- 18/10/2005
- 10/11/2006
- 15/10/2007
- 21/10/2008
- 01/10/2009
- 15/02/2010
- 29/03/2010

Pre/Post Survey

- Profiles Envelope
- 15/02/2010
- 29/03/2010

Survey Date	Description of Changes Since Last Survey	Interpretation
03-2010	<p>A similar trend to above, with flattening of the upper berm and lower foreshore accretion, was observed along NTDC04, although here two small berms remained evident by mid-February 2010; one at around MHWS and the other at around MHWN.</p> <p>Between mid-February and end-March 2010, material along NTDC02 and NTDC03 transects had become partially moved from the lower beach (from around or below MSL) and pushed up the profile to the mid and upper beach in the form of a fairly evenly spread deposition rather than a single large berm which often occurs along Whitley Sands. In contrast, along NTDC04 material from the two small berms that were still apparent in mid-February 2010 was redistributed down the profile where it became thinly deposited below around MSL by end-March 2010.</p> <p>Profile NTDC04A was recorded for the first time during the March 2010 survey. It is located at the southern end of the Whitley Sands frontage and extends from the promenade, some 3m down the face of the sea wall to its toe, and then across the predominantly sandy foreshore.</p>	<p>Along NTDC04, the surveyors' notes record that the slope was considered unstable, with both local landslips and large cracks visible. This will be investigated further during the 2010 walk-over inspections of this frontage.</p> <p>The March 2010 survey along the new transect NTDC04A provides a baseline against which future 6-monthly surveys will be compared.</p> <p>Future Full Measures surveys (starting in autumn 2010) will also include a topographic survey of Whitley Sands to help inform understanding of the seasonal and storm-related changes that have been observed.</p>
