**Cell 1 Regional Coastal Monitoring Programme
Update Report 2: 'Partial Measures' Survey 2010**

**North Tyneside Council
Final Report**

May 2010

Update Report 2
 'Partial Measures' Survey 2010

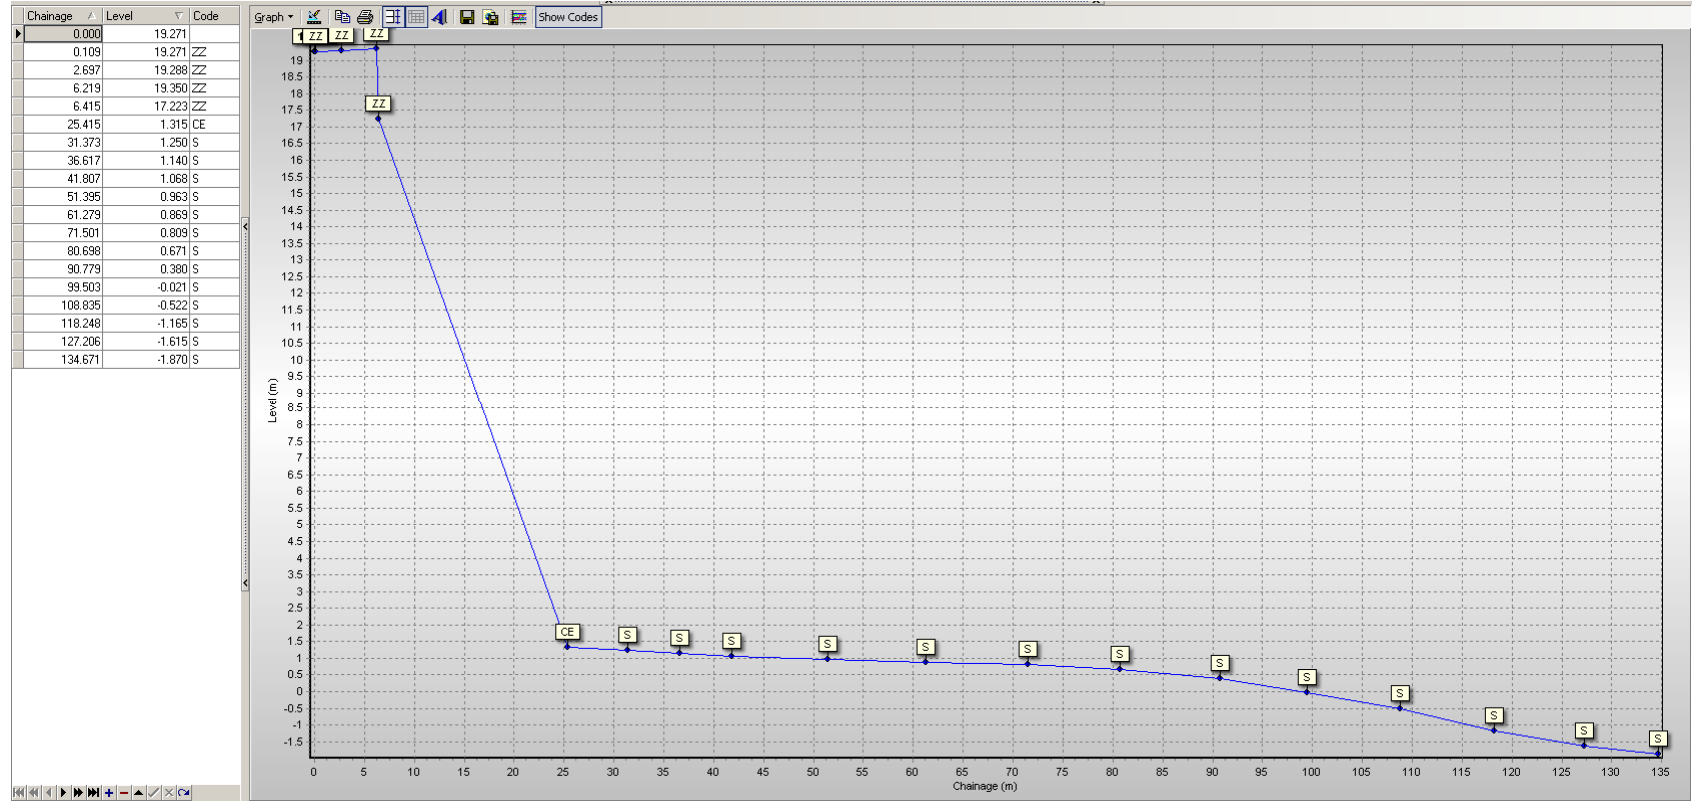
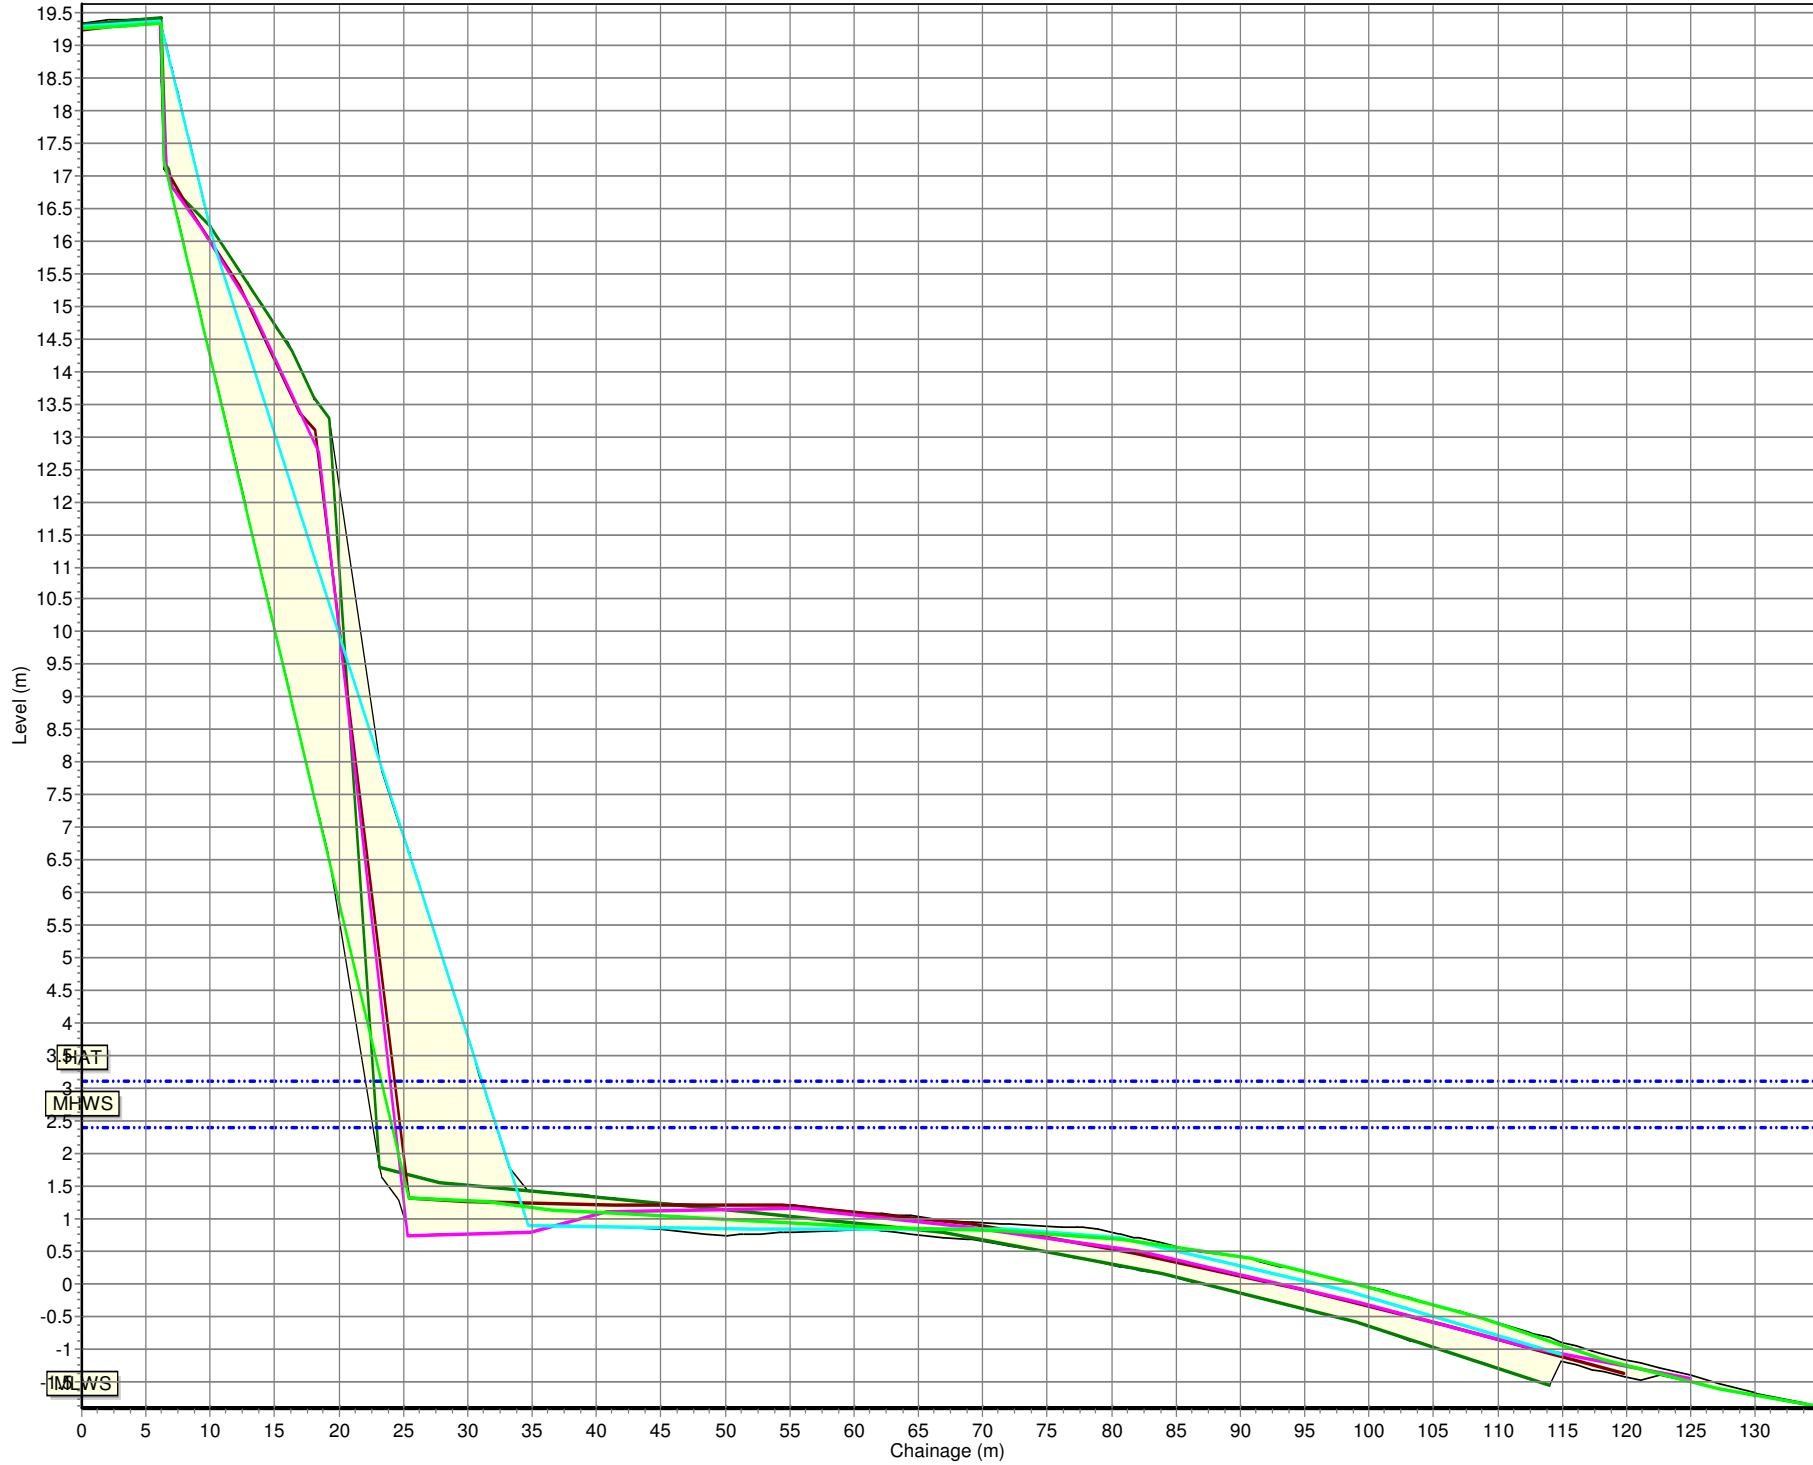
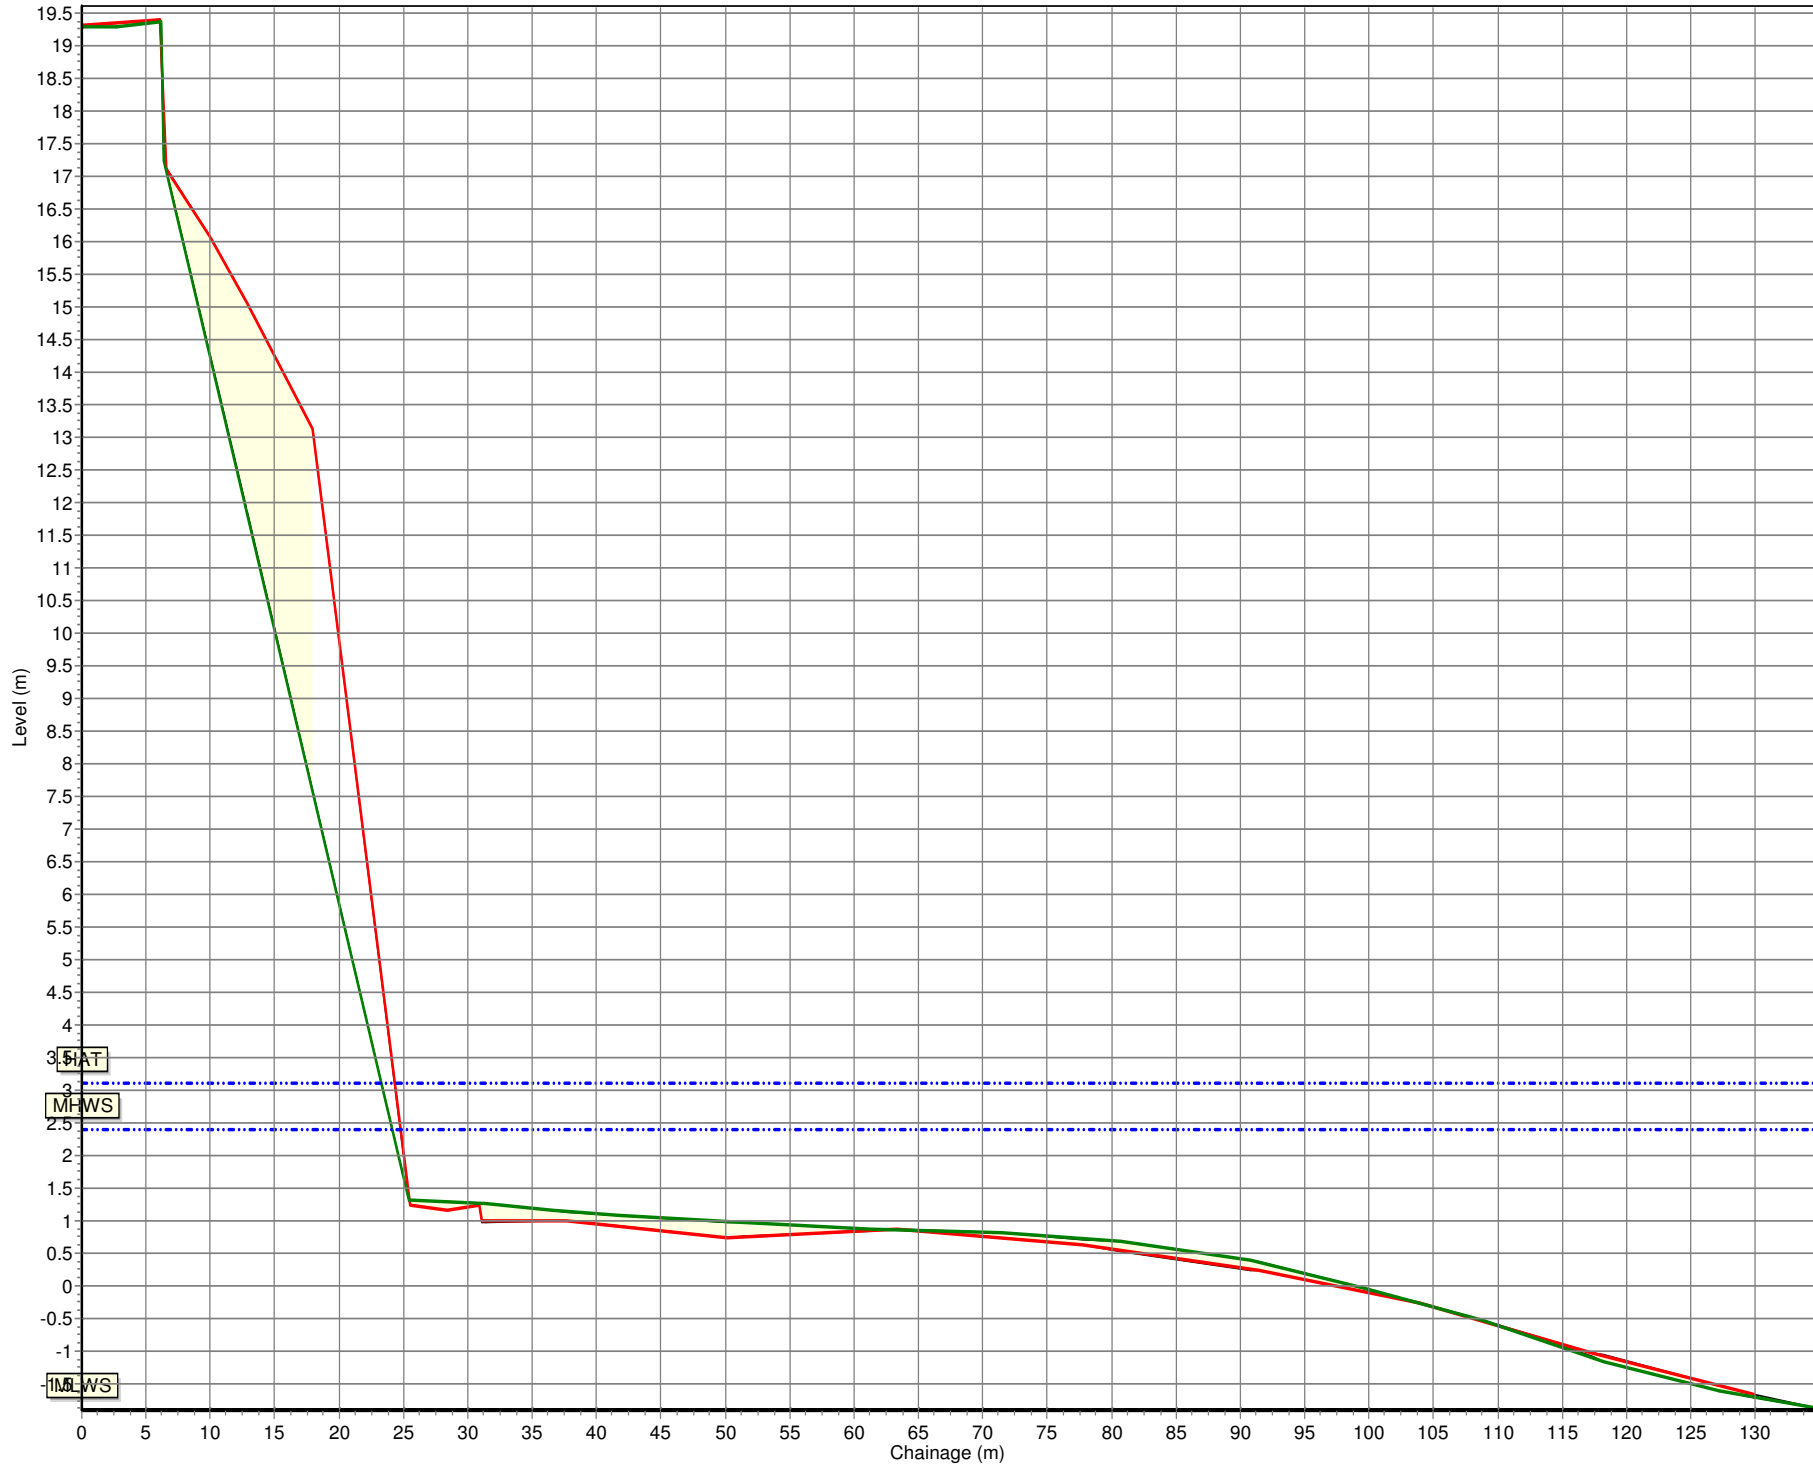
1aNTDC05 - 29/03/2010

Along profile NTDC05 in Cullercoats Bay, the cliff face was not surveyed in March 2010 due to wet and slippery footing associated with the foul weather on the day of the survey.

Beach Profiles: 1aNTDC05

- Profiles Envelope
- 01/04/2002
- 01/09/2003
- 15/10/2004
- 18/10/2005
- 10/11/2006
- 15/10/2007
- 21/10/2008
- 01/10/2009
- 15/02/2010
- 29/03/2010

Pre/Post Survey

- Profiles Envelope
- 15/02/2010
- 29/03/2010

Survey Date	Description of Changes Since Last Survey	Interpretation
03-2010	<p>Beach Profiles:</p> <p>Cullercoats Bay is covered by one beach profile line (Appendix A). This was surveyed annually each autumn between 2002 and 2009. From spring 2010 onwards, it has been surveyed 6-monthly.</p> <p>Between October 2009 and mid-February 2010, there was relatively little change in the cliff face and foreshore along profile NTDC05. In late March 2010, when the post-storm survey was undertaken, the cliff face was not surveyed on Health and Safety grounds as it was wet and slippery. This leads to the profile having experienced an 'apparent' recession, but in fact this is due to the steep and jutting cliff face not being surveyed. The foreshore accreted slightly between mid-February and late March 2010.</p>	<p>Whilst the foreshore and cliffs remained relatively stable to February 2010, the surveyors did not attempt the cliff section of the survey in March 2010 because the weather conditions on the day were wet and slippery.</p>

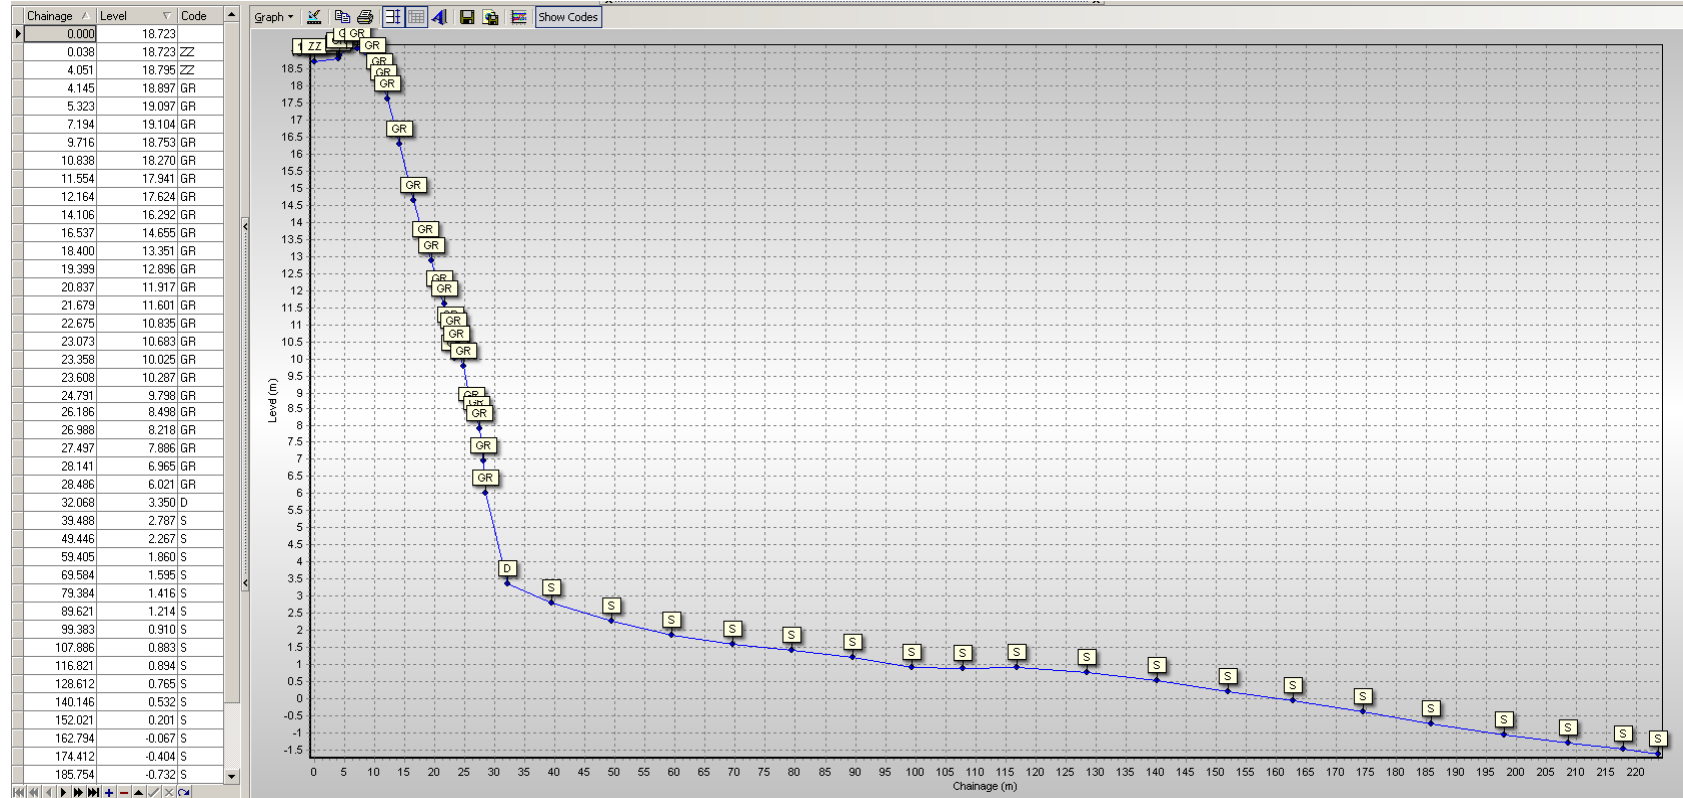
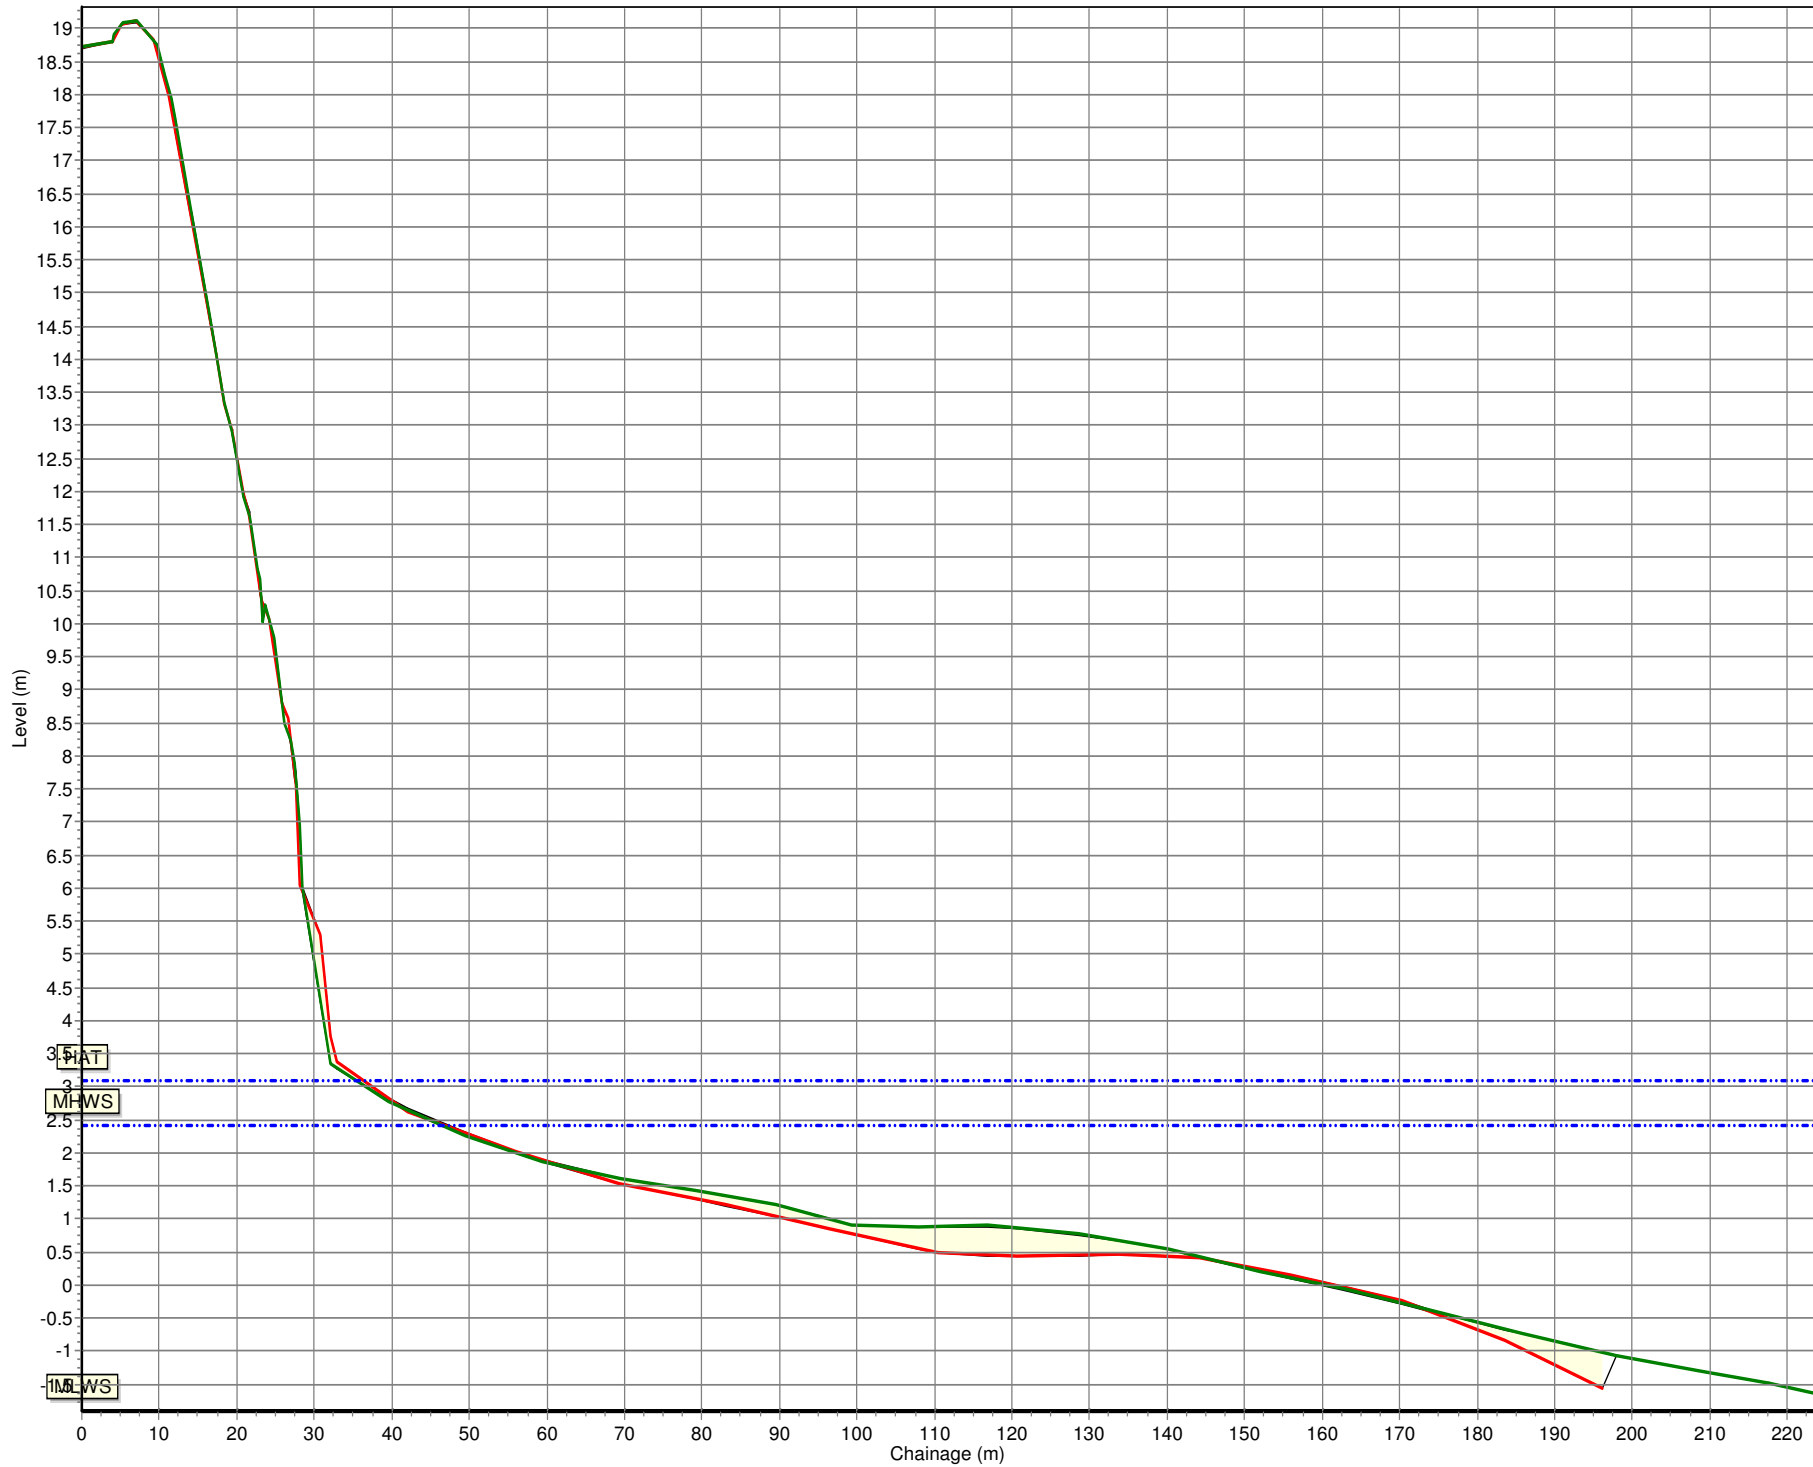
1aNTDC06 - 29/03/2010

- The low levels recorded along the upper beach also resulted in measurable erosion of the dune toe throughout Tynemouth Longsands, particularly along transect NTDC06.

Beach Profiles: 1aNTDC06

Pre/Post Survey

- Profiles Envelope
- 15/02/2010
- 29/03/2010

Survey Date	Description of Changes Since Last Survey	Interpretation
03-2010	<p>Beach Profiles:</p> <p>Tynemouth Longsands is covered by three beach profile lines (Appendix A). Two of these were initially surveyed annually each autumn between 2002 and 2009. From spring 2010 onwards, they have been surveyed 6-monthly and a third profile has been added in the centre of the frontage.</p> <p>NTDC06 is located approximately 150m south of the access road/ramp towards the north of the bay. Here, the profile cut back severely at the toe of the dunes between October 2009 and mid-February 2010, resulting in the lowest recorded beach levels since monitoring began in April 2002. Foreshore levels remained low some 75m seaward of the dune toe, but then increased further seaward, setting record high levels along the lower foreshore and down to low water. Between mid-February 2010 and late March 2010, some further cut-back occurred at the dune toe, but the foreshore levels, started to recover through a modest, evenly distributed increase across most of the profile length.</p> <p>A new profile, NTDC06A, was added to the surveys for the first time and will provide a baseline against which future surveys will be compared. It extends from the dune crest, at an elevation of around 21mODN, down the dune face to its toe at a level of around HAT and then extends across the sandy foreshore down to low water.</p> <p>Profile NTDC07 is located approximately 50m south of the access route through the dunes towards the southern end of the bay. Here, the surveyors did not attempt access to part of the profile because dune vegetation was being re-seeded and the area was fenced off. Along the profile, beach levels reached record low values at levels of around HAT and MHWS, and remained relatively low along the remainder of the profile until a chainage of around 210m.</p>	<p>The storms across winter 2009/2010 caused measurable damage along Tynemouth Longsands.</p> <p>This was particularly recorded along transect NTDC06 which exhibited notable erosion at the dune toe and redistribution of the eroded sand seaward across the lower sections of the beach profile. This is representative of 'text-book' dune and beach behaviour in response to storm activity.</p> <p>Along NTDC07, upper beach and dune toe damage similarly occurred, although it is interesting to note that the dune face has previously been recorded in a more landward position, in April 2002, indicating that this frontage can be storm-damaged and then gradually recover over time.</p>

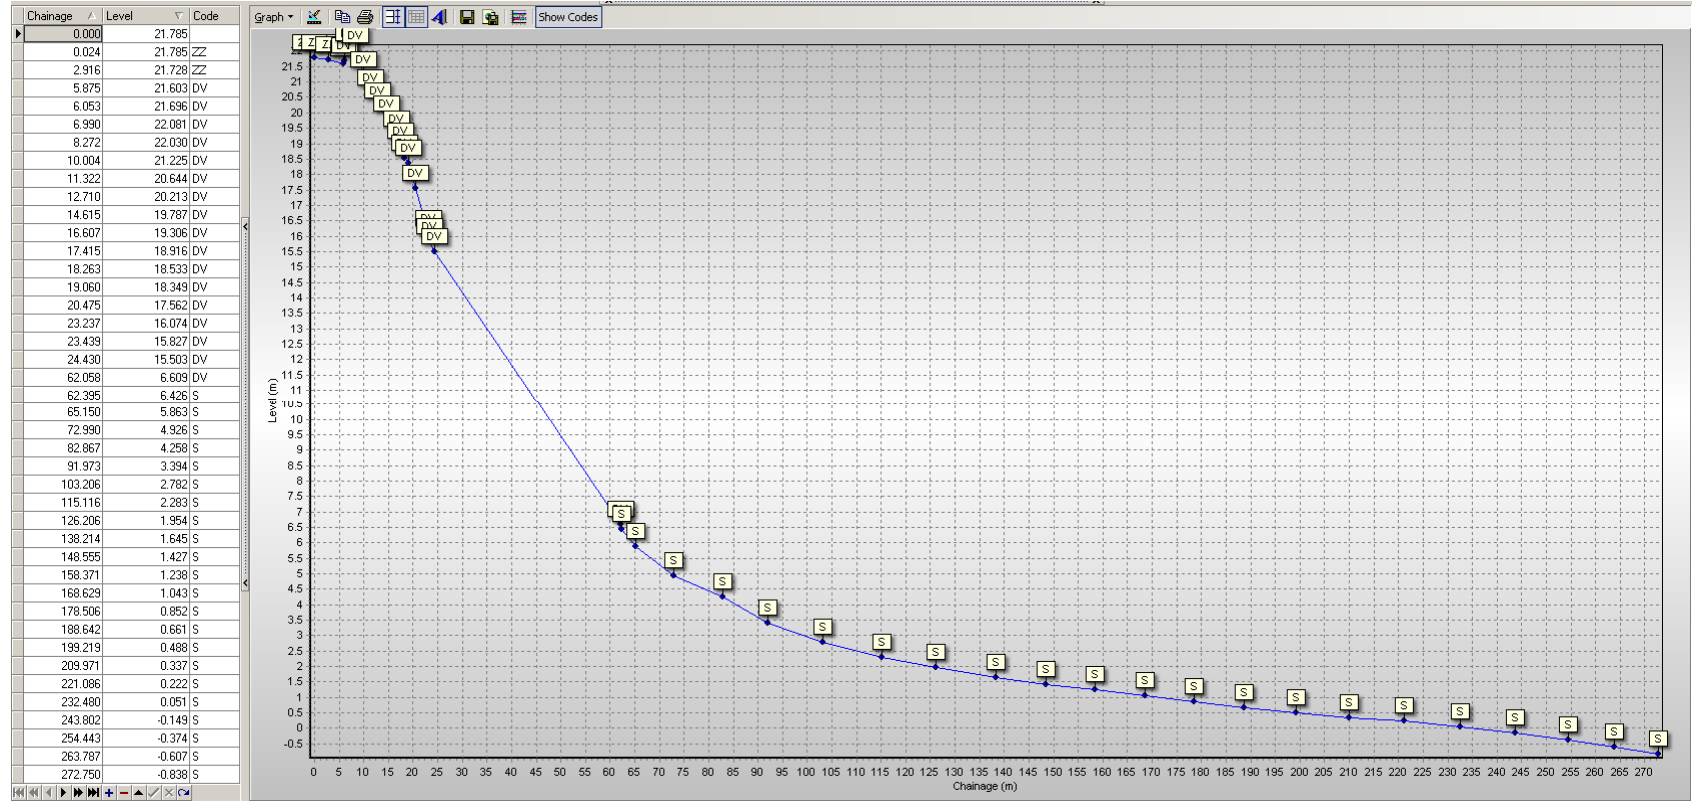
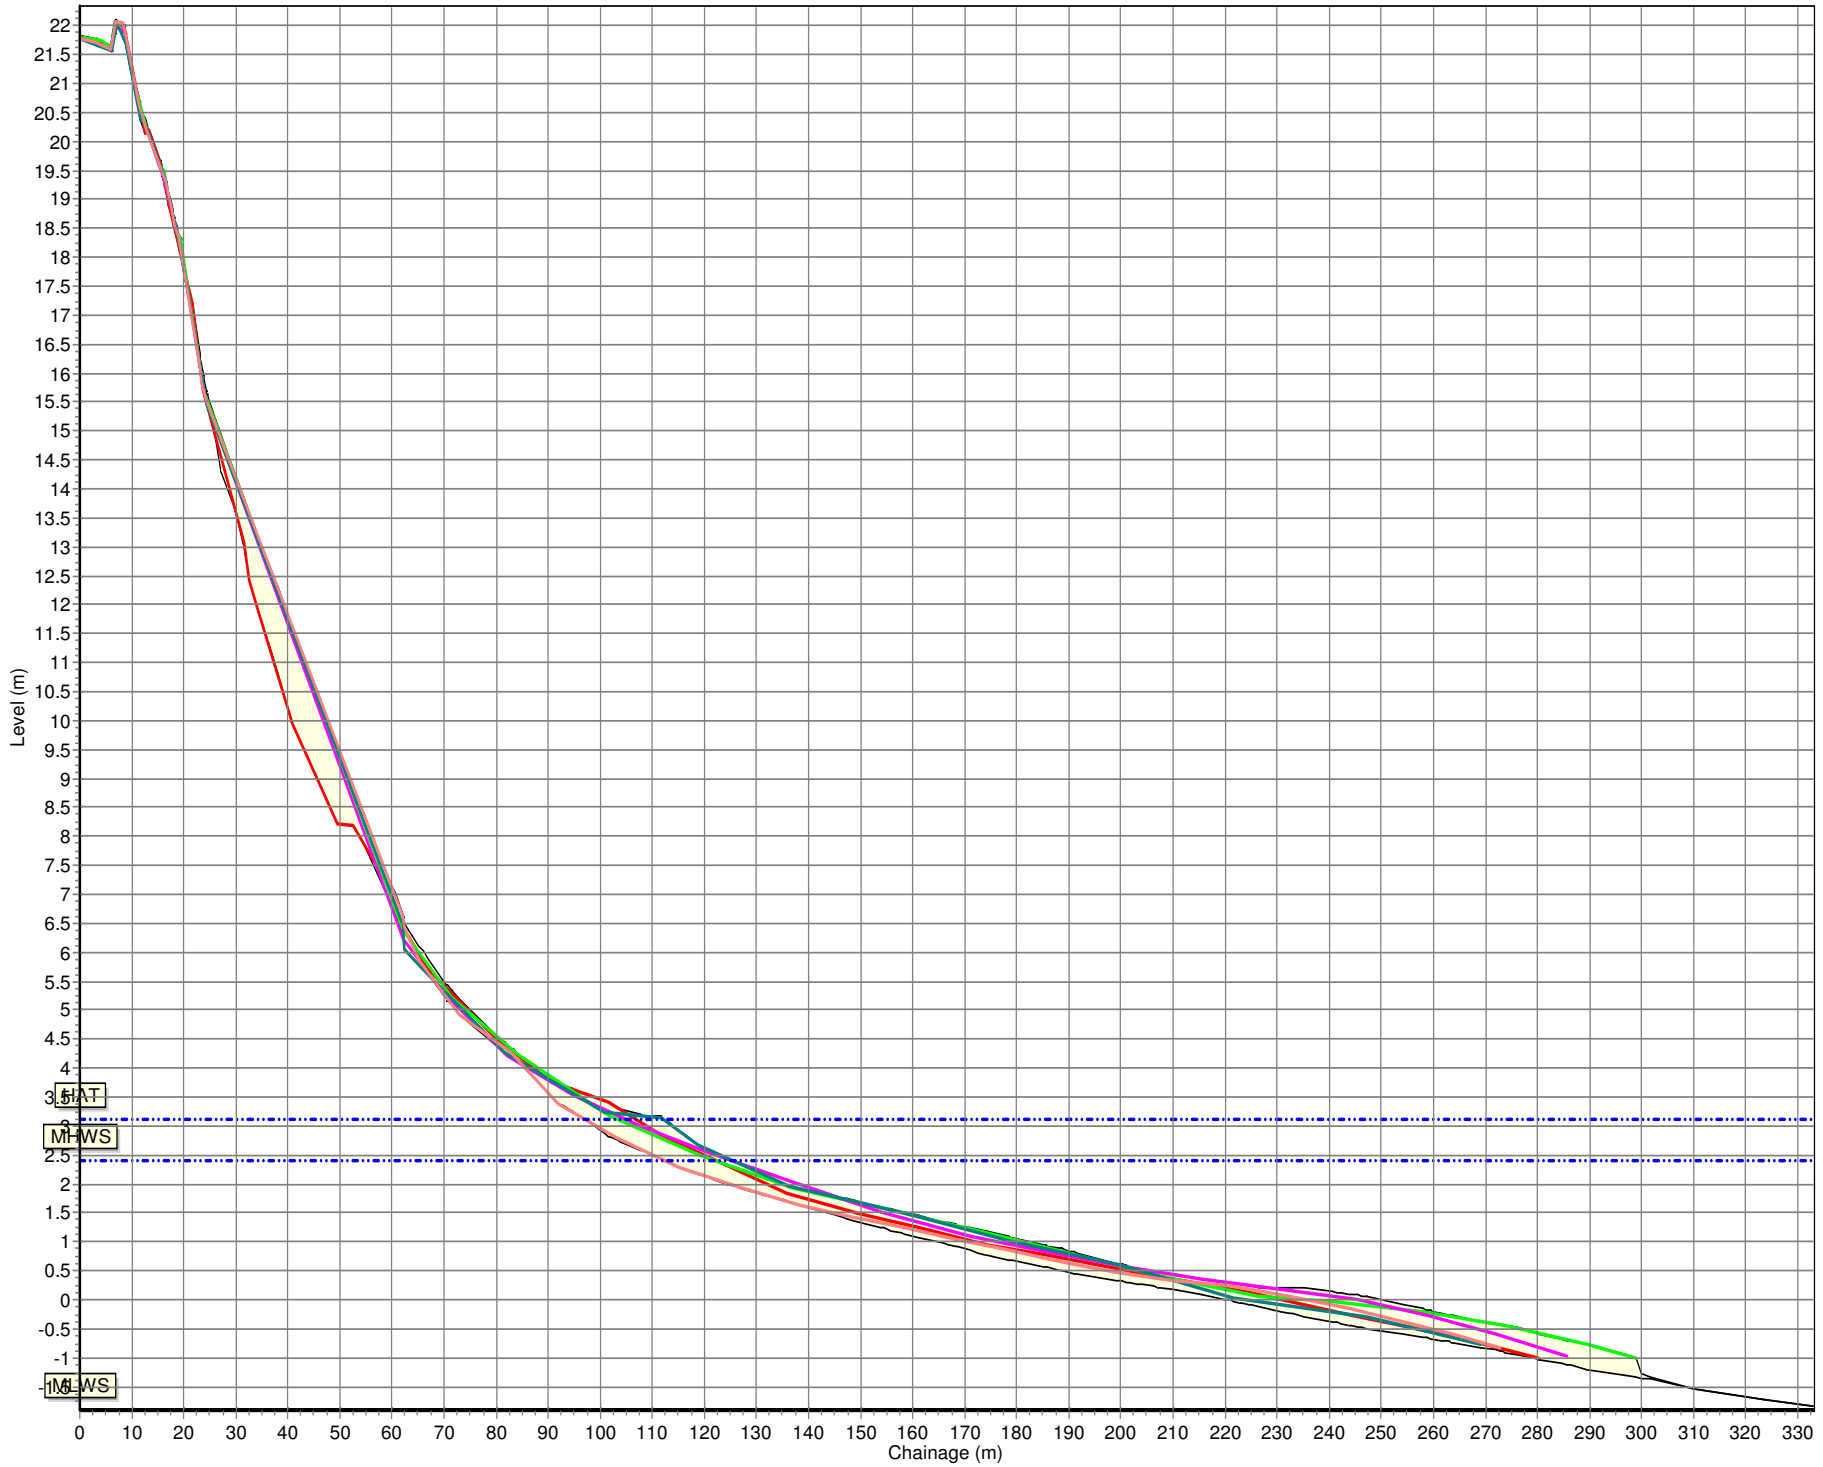
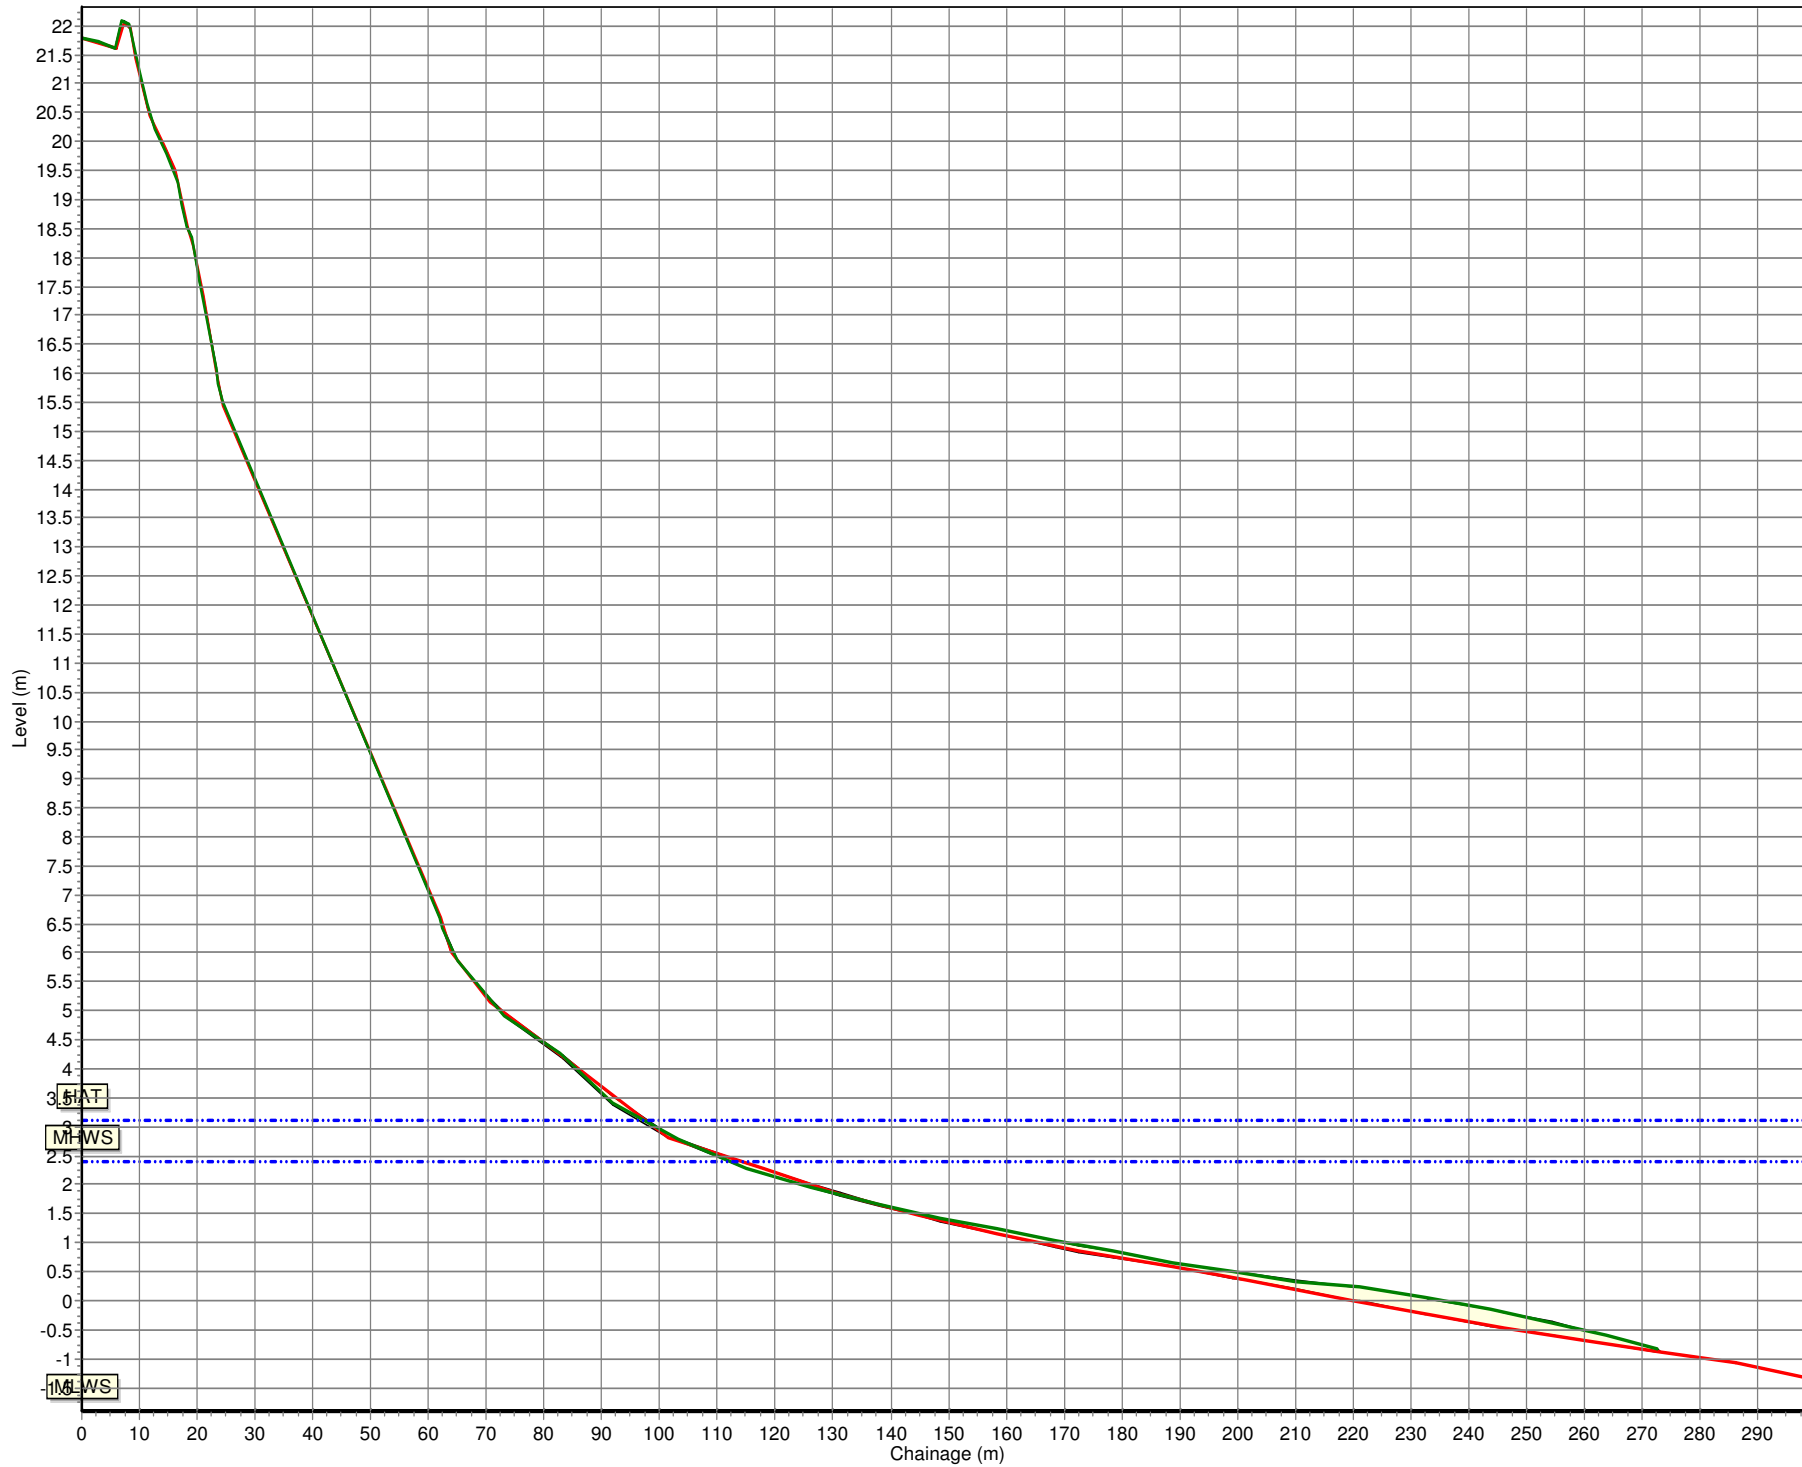
1aNTDC07 - 29/03/2010

Along profile NTDC07 part of the dunes was not surveyed because the area was fenced off in order to attempt to establish dune vegetation.

Beach Profiles: 1aNTDC07

- Profiles Envelope
- 01/04/2002
- 01/09/2003
- 15/10/2004
- 18/10/2005
- 10/11/2006
- 15/10/2007
- 21/10/2008
- 01/10/2009
- 15/02/2010
- 29/03/2010

Pre/Post Survey

- Profiles Envelope
- 15/02/2010
- 29/03/2010

- The historic profile from April 2002 along NTDC07 does show, however, that following storm damage the dunes at Longsands can recover over time and this process is expected to occur progressively over the summer of 2010 (further major storms notwithstanding).
- Along profile NTDC04, towards the southern end of Whitley Sands by the café, the slope was noted by the surveyors as being unstable, with small landslips and large cracks visible. This frontage may require some remedial attention to prevent a slump; this will be further investigated during the forthcoming walk-over inspections in summer 2010.
