**Cell 1 Regional Coastal Monitoring Programme
Update Report 2: 'Partial Measures' Survey 2010**

**North Tyneside Council
Final Report**

May 2010

Update Report 2
 'Partial Measures' Survey 2010

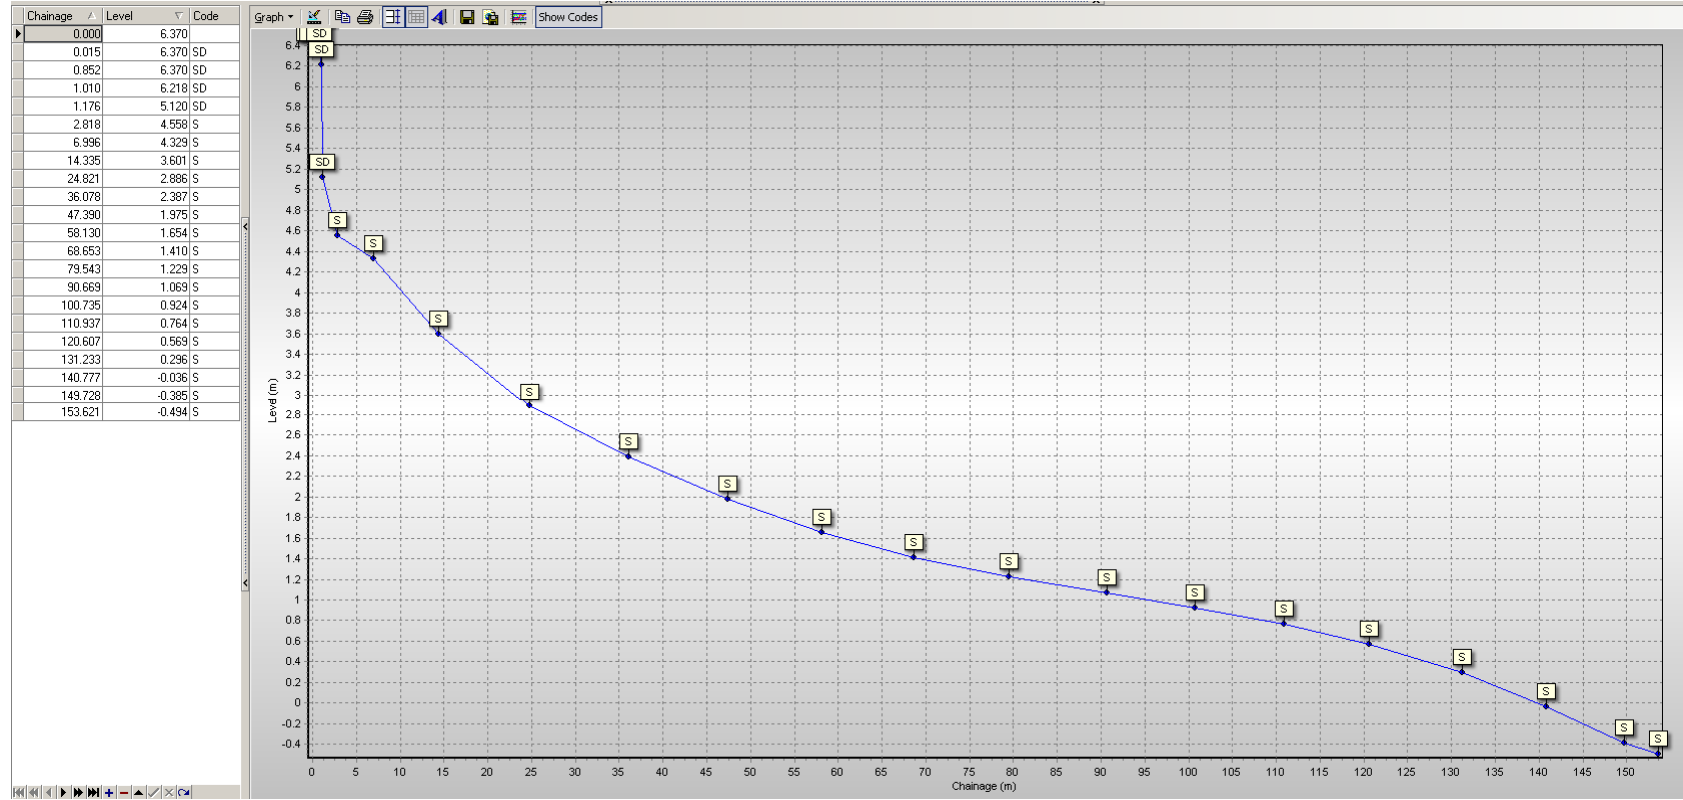
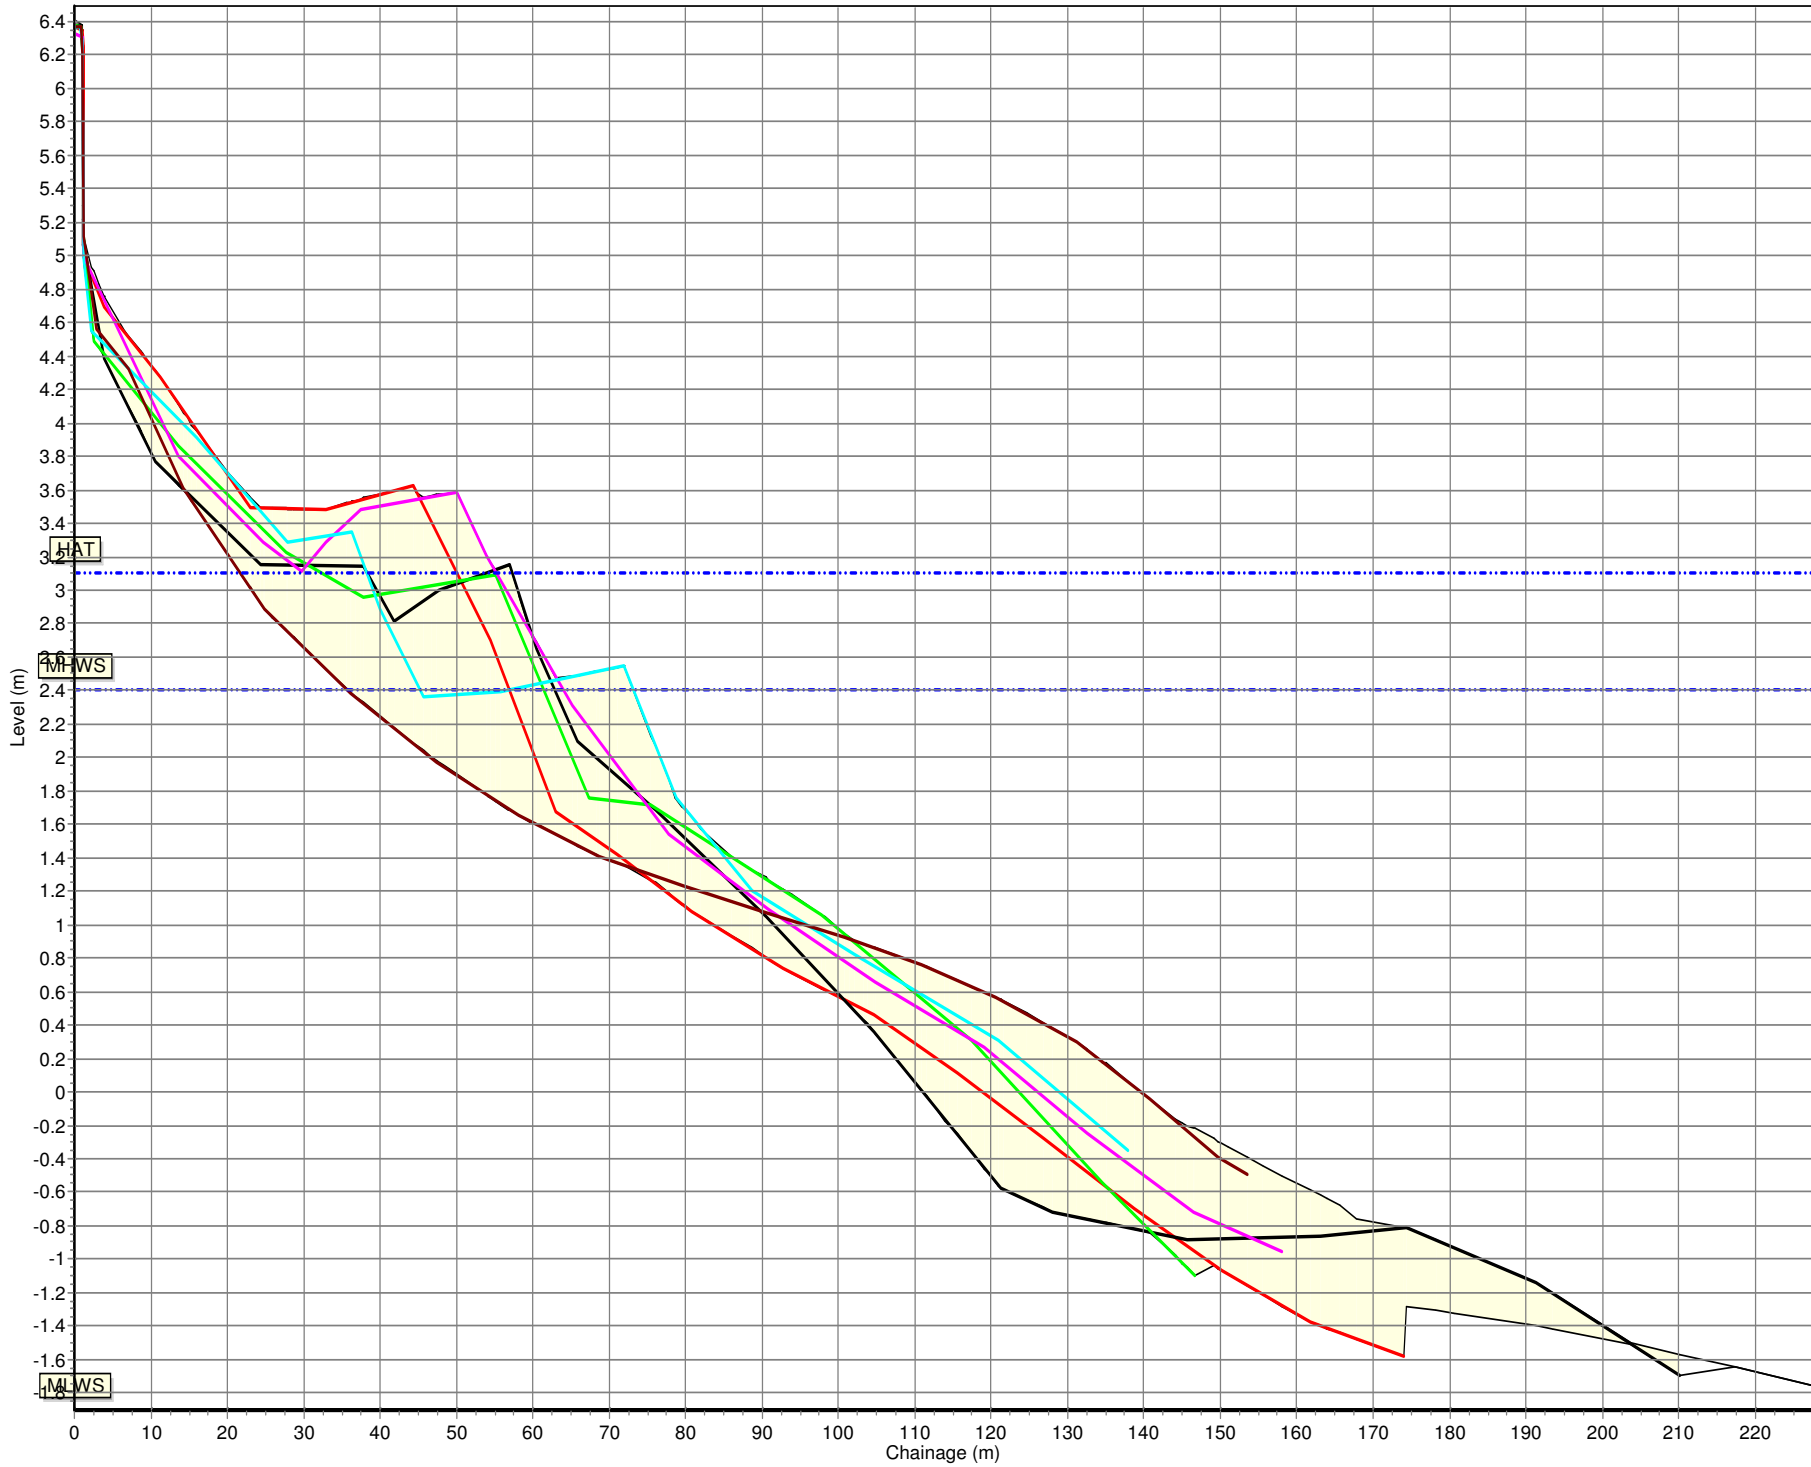
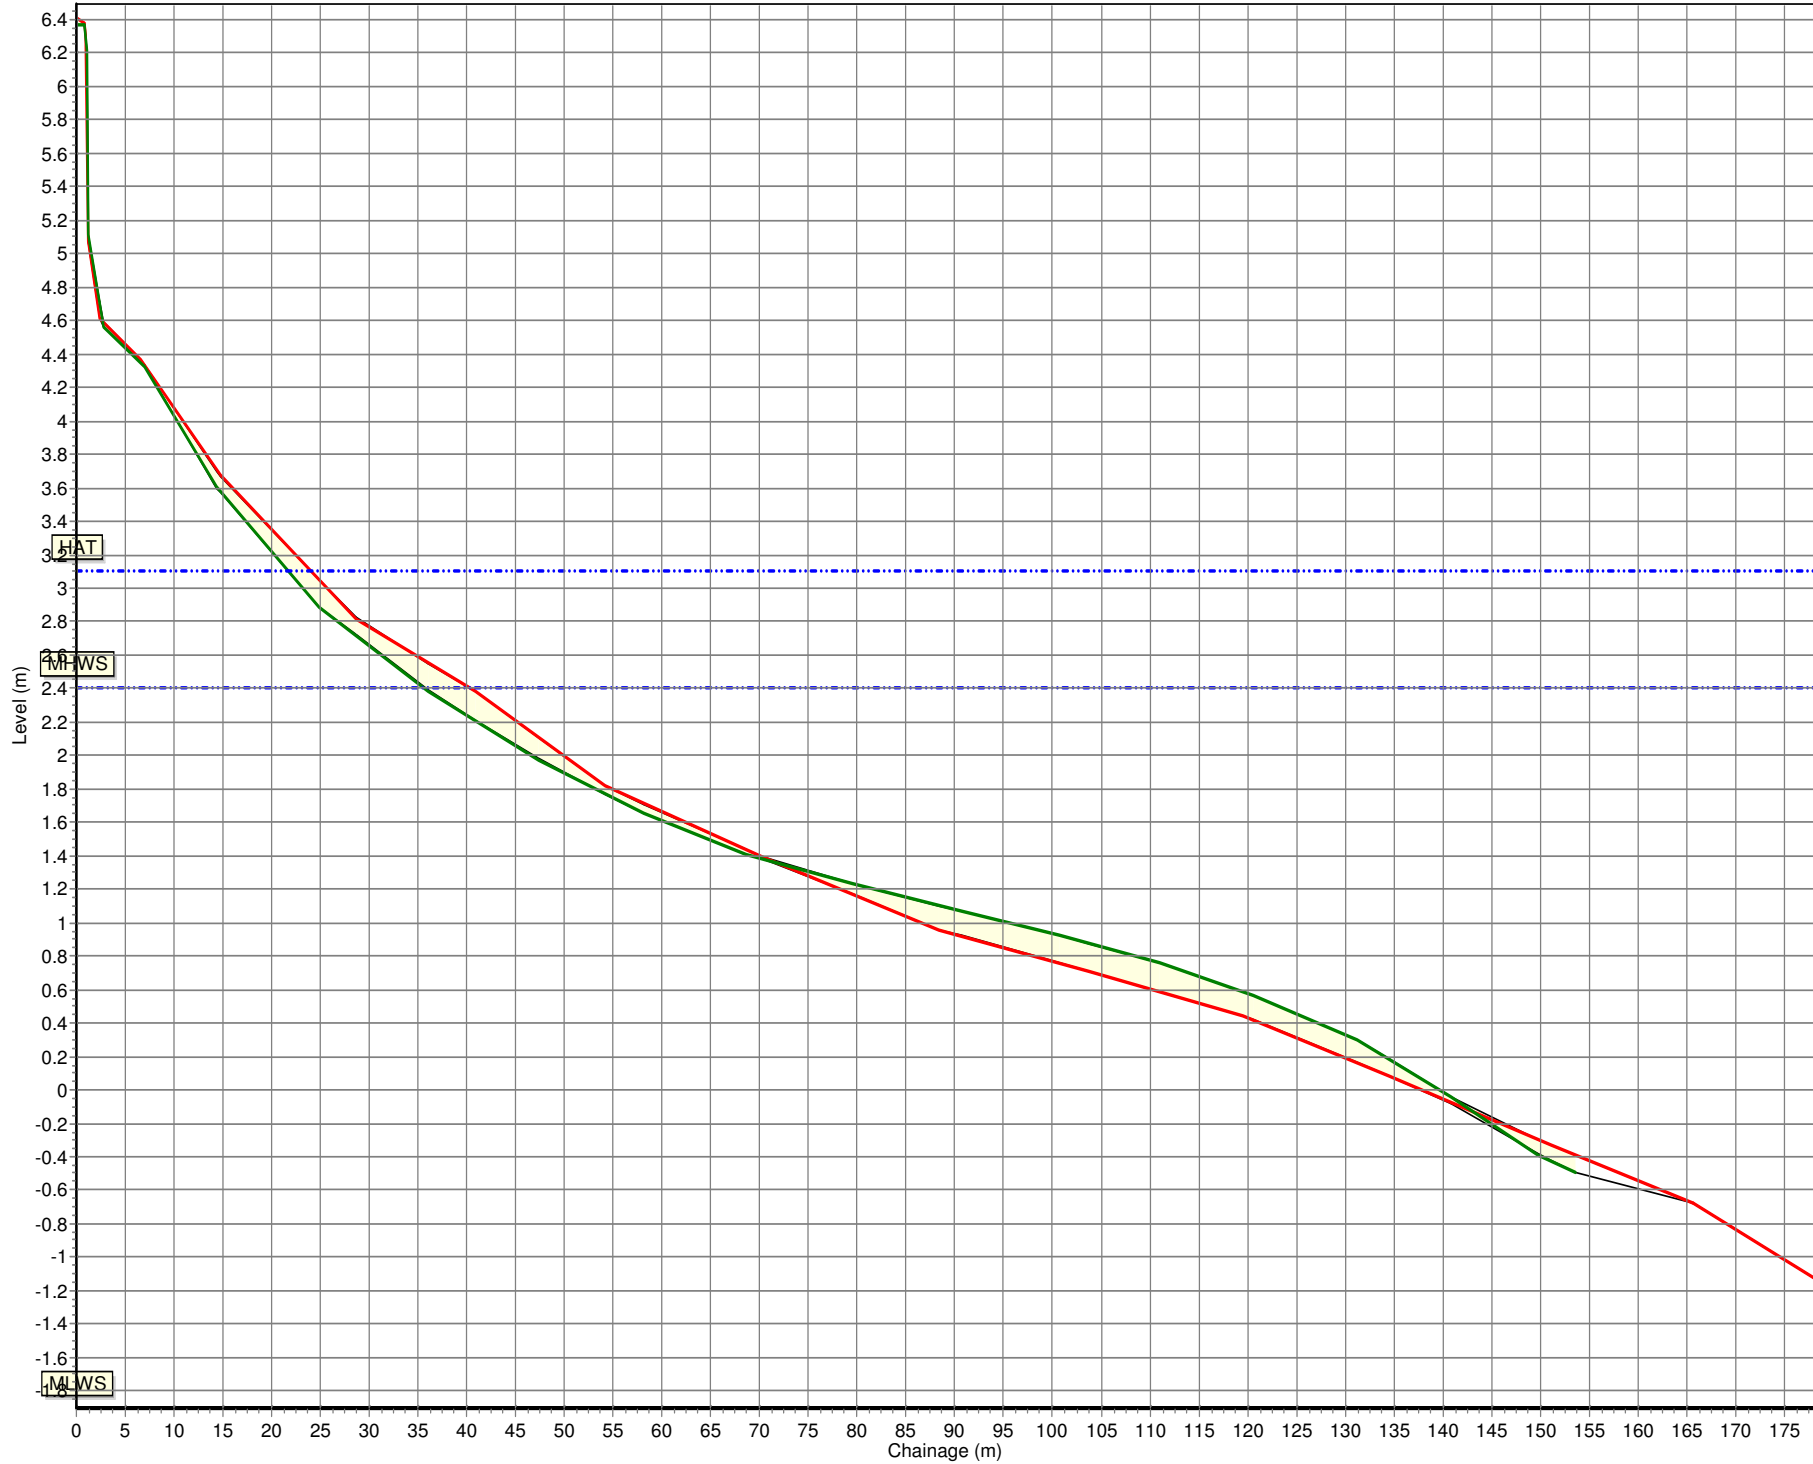
1aNTDC08 - 29/03/2010

Beach Profiles: 1aNTDC08

- Profiles Envelope
- 01/04/2002
- 01/09/2003
- 15/10/2004
- 18/10/2005
- 10/11/2006
- 15/10/2007
- 21/10/2008
- 01/10/2009
- 15/02/2010
- 29/03/2010

Pre/Post Survey

- Profiles Envelope
- 15/02/2010
- 29/03/2010

Survey Date	Description of Changes Since Last Survey	Interpretation
03-2010	<p>Beach Profiles:</p> <p>King Edward's Bay is covered by one beach profile line (Appendix A). This was surveyed annually each autumn between 2002 and 2009. From spring 2010 onwards, it has been surveyed 6-monthly.</p> <p>Profile NTDC08 experienced notable change between October 2009 and February 2010, with the berm previously present being totally removed and the beach above around MHWN severing quite notable lowering, resulting in record low beach levels being recorded. Along the lower foreshore, however, record high beach levels were observed.</p>	<p>King Edward's Bay experienced a notable redistribution of sediment from the upper beach to the lower beach throughout the winter of 2009/2010, with continuation of that trend, albeit on a lesser scale, during the storm that occurred in late February 2010. The foreshore fluctuations do not appear to have caused lowering of beach levels at the toe of the sea wall.</p>
