# BEACH MANAGEMENT PLAN REPORT

## Hythe Ranges

**BMP 161**  
March 2013

Document Title: **Beach Management Plan Site Report 2012**

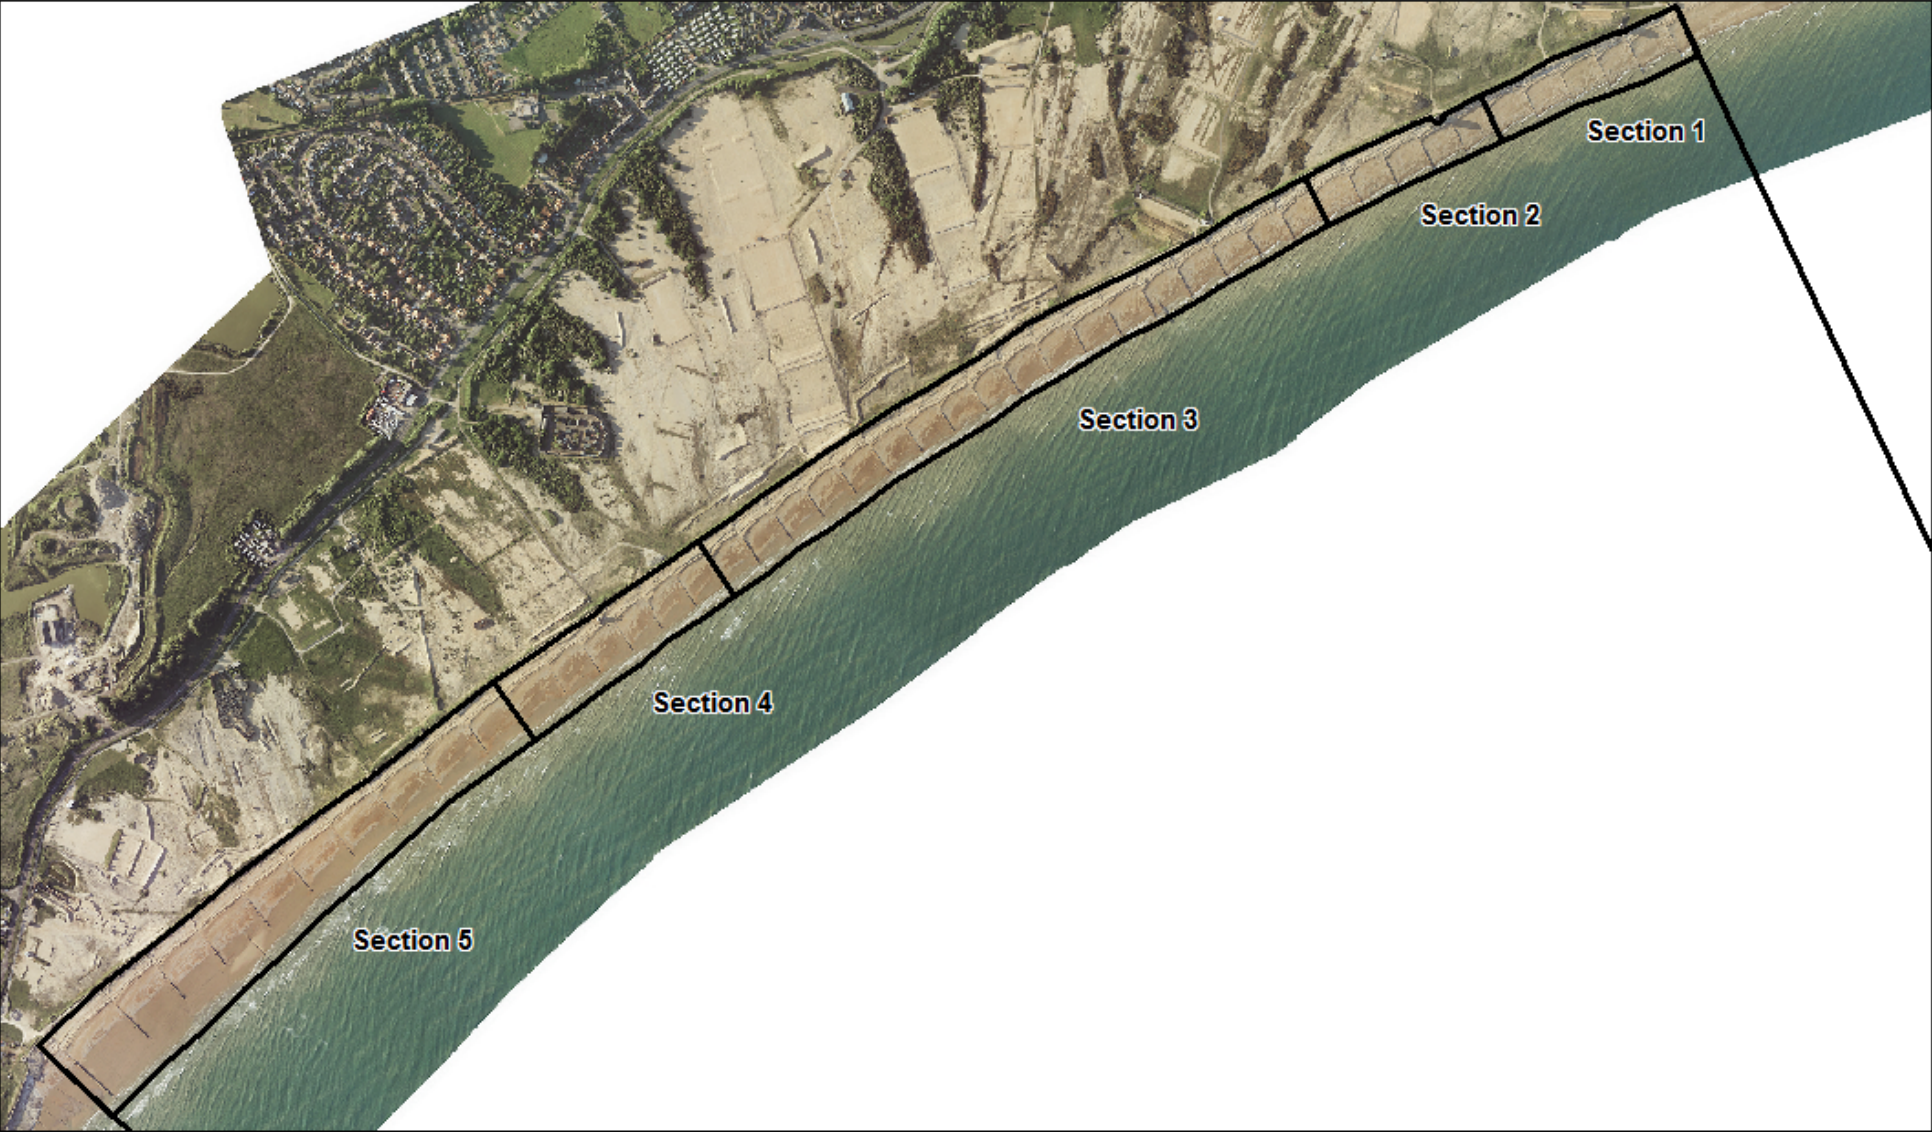
Figure 3.1: 4cSU10 Beach Analysis Sections

The 4cSU10 frontage has been divided up into 44 individual polygons, each representative of a single groyne bay. The numbering system adopted for these polygons is based on the numbering system that is already in use along this frontage for monitoring the condition of the timber groynes. These are numbered from 1 to 45 from east to west and consequently, the numbering for the change polygons follows suit, i.e. Polygon 1 being the bay between Groynes 1 and 2 and Polygon 2 being the bay between Groynes 2 and 3, etc. In addition, the entire unit has been divided into 5 sections in order to aid analysis (Figure 3.1).

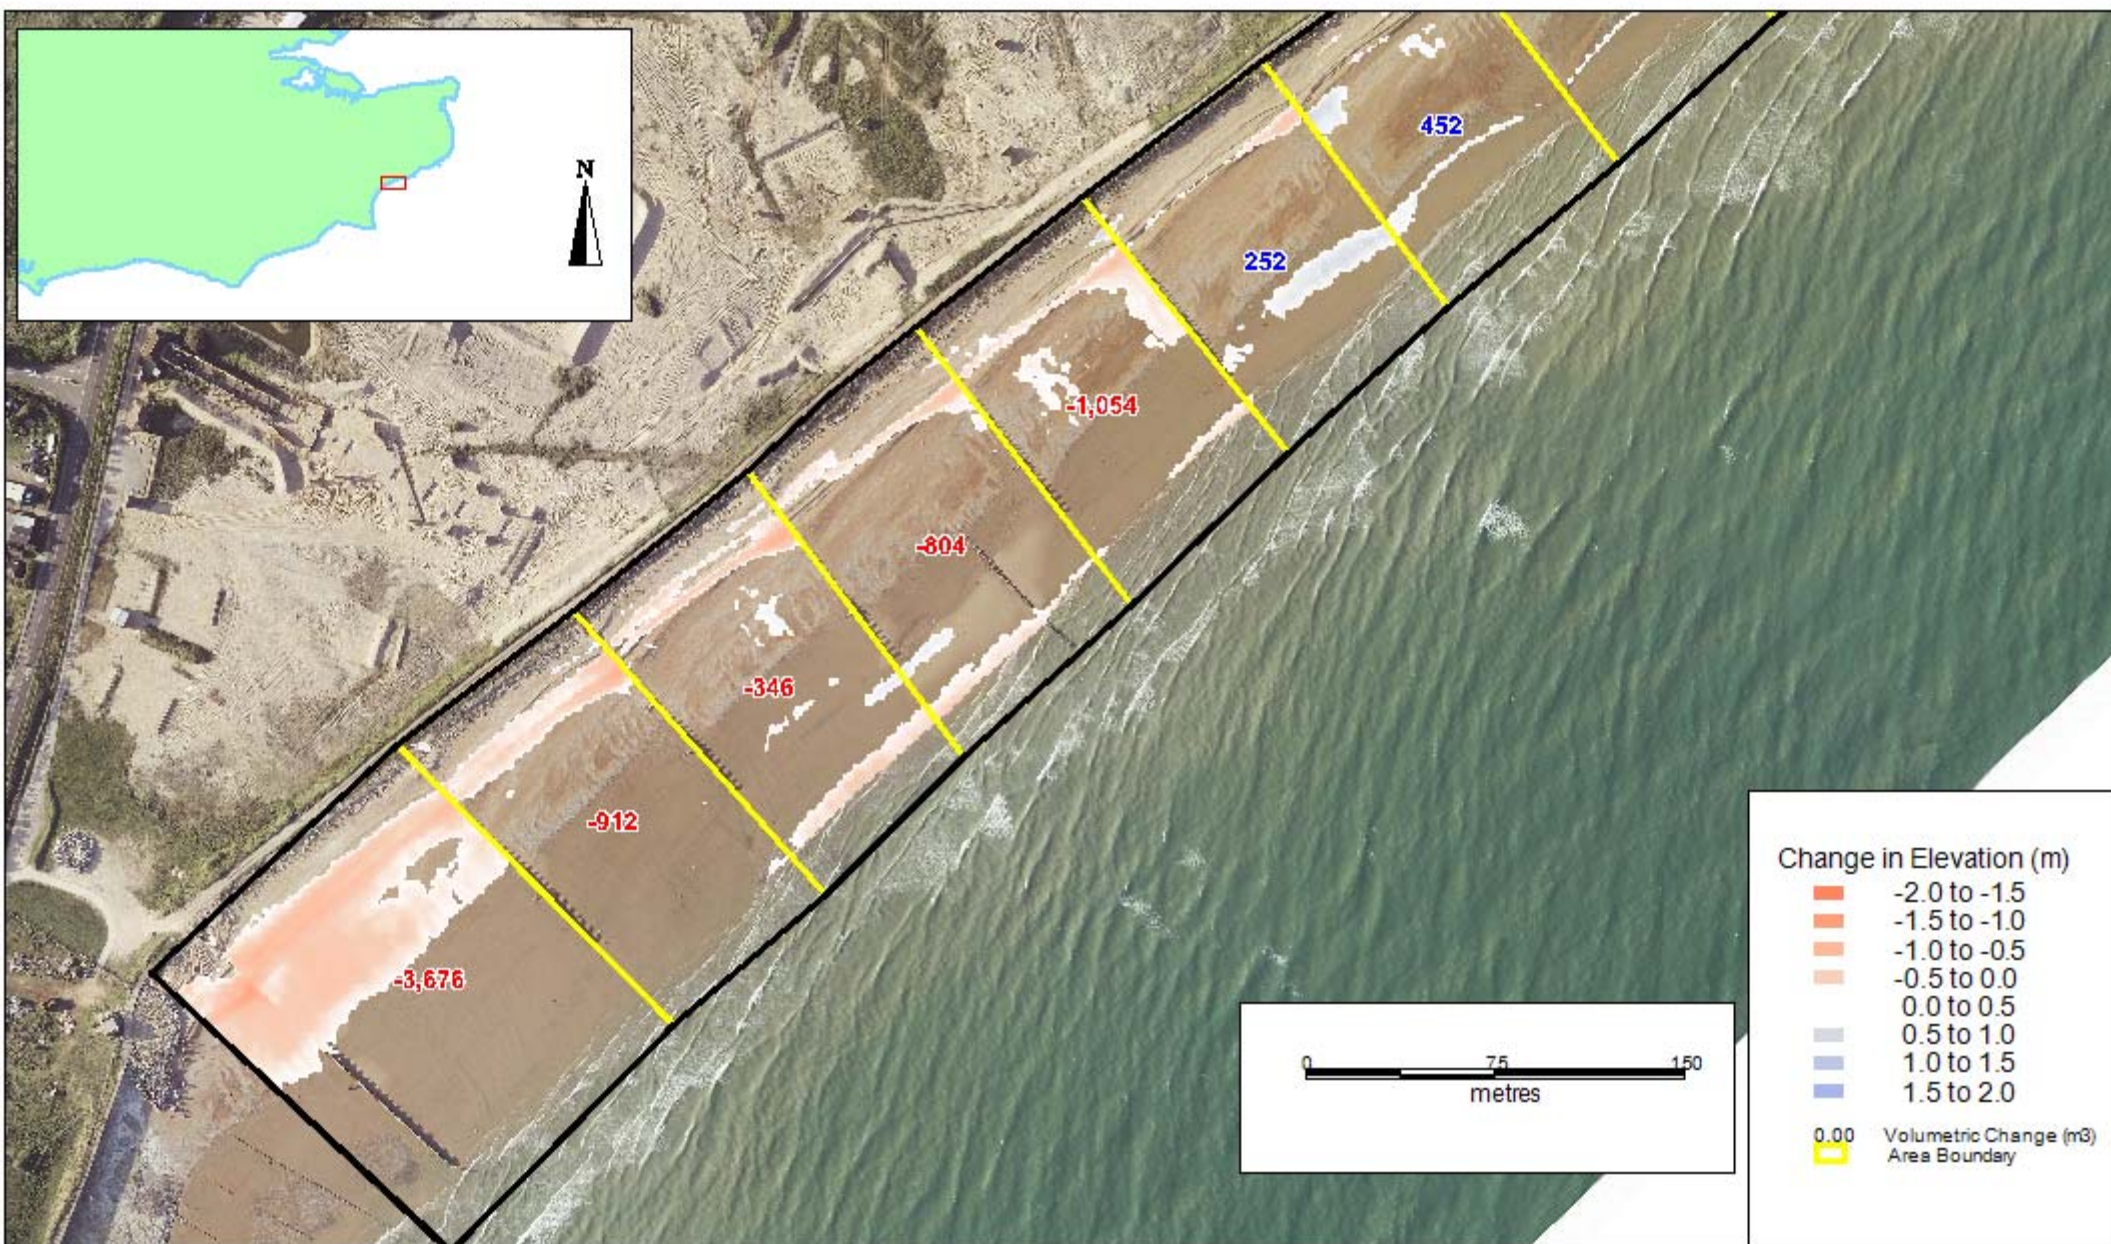
Now that the 2012 BMP data set has been compiled, it is possible to overlay the results of the survey with BMP data from 2011. This enables comparative volumetric analysis to be undertaken to determine change over a given period. Through the use of three-dimensional ground models and ortho-rectified aerial photography, it is possible to create a visual interpretation of the volumetric change that has occurred during each analysis period. This is shown in Plate 1 (1-5), which indicates areas of net erosion or accretion and the location of any extraction/deposition sites (N.B.  $\leq 0.25\text{m}$  difference in elevation is considered as “no change”).

Negative values represent erosion that has occurred between 2011 & 2012, and positive values indicate accretion. Whilst these figures show an overall change in beach volume within each discrete section, it should be recognised that the data is based on the BMP survey, which is undertaken once each year. It is therefore only a snapshot of one moment in time, and the particular dynamics of each frontage need to be taken into account. This ensures that the information shown in the difference models represents the net change rather than capturing a particular extreme variation caused by a large event.

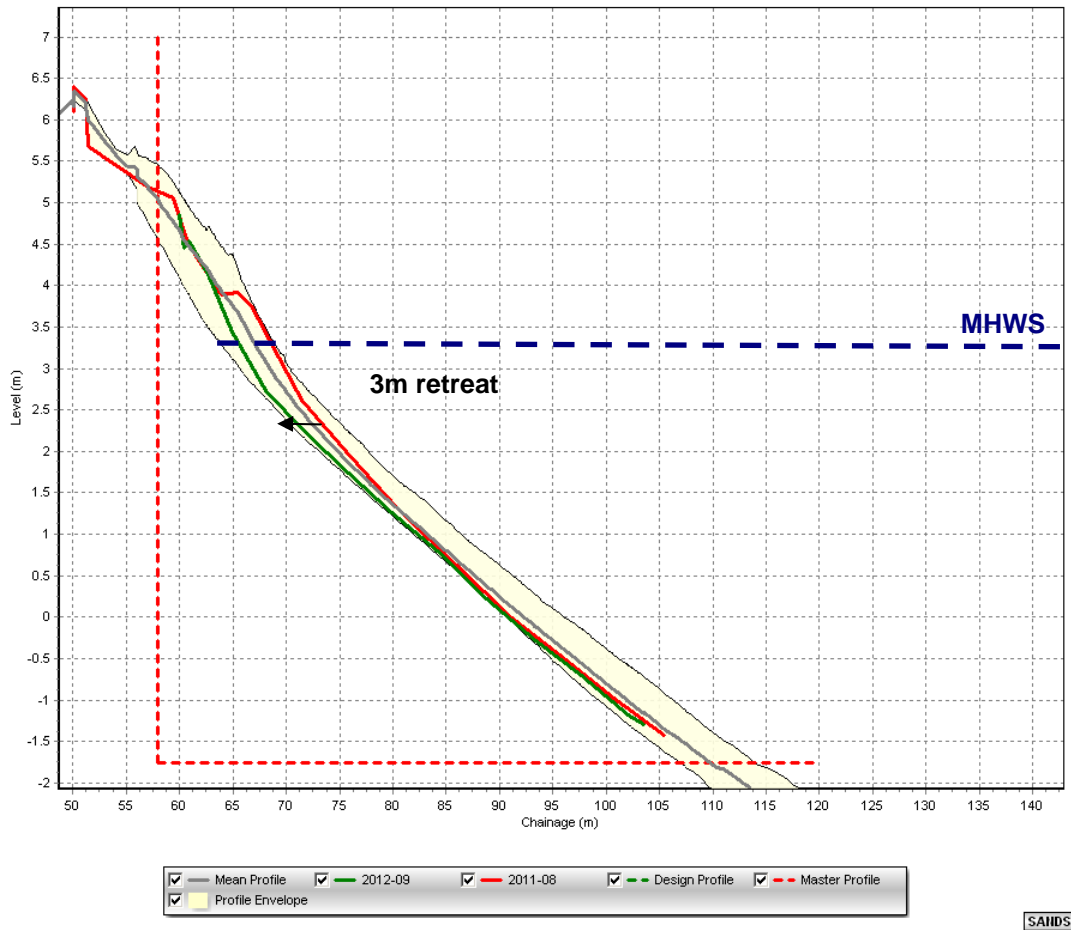
Figure 5.3: Profile 4c00360

Figure 5.3 shows that the 2012 cross sectional profile is partially below the mean profile which is compiled from data since 2003. Despite the 2012 profile being below the mean profile, it is important to recognise that it is a minor retreat and is unlikely to significantly reduce the standard of protection that this section of frontage provides.

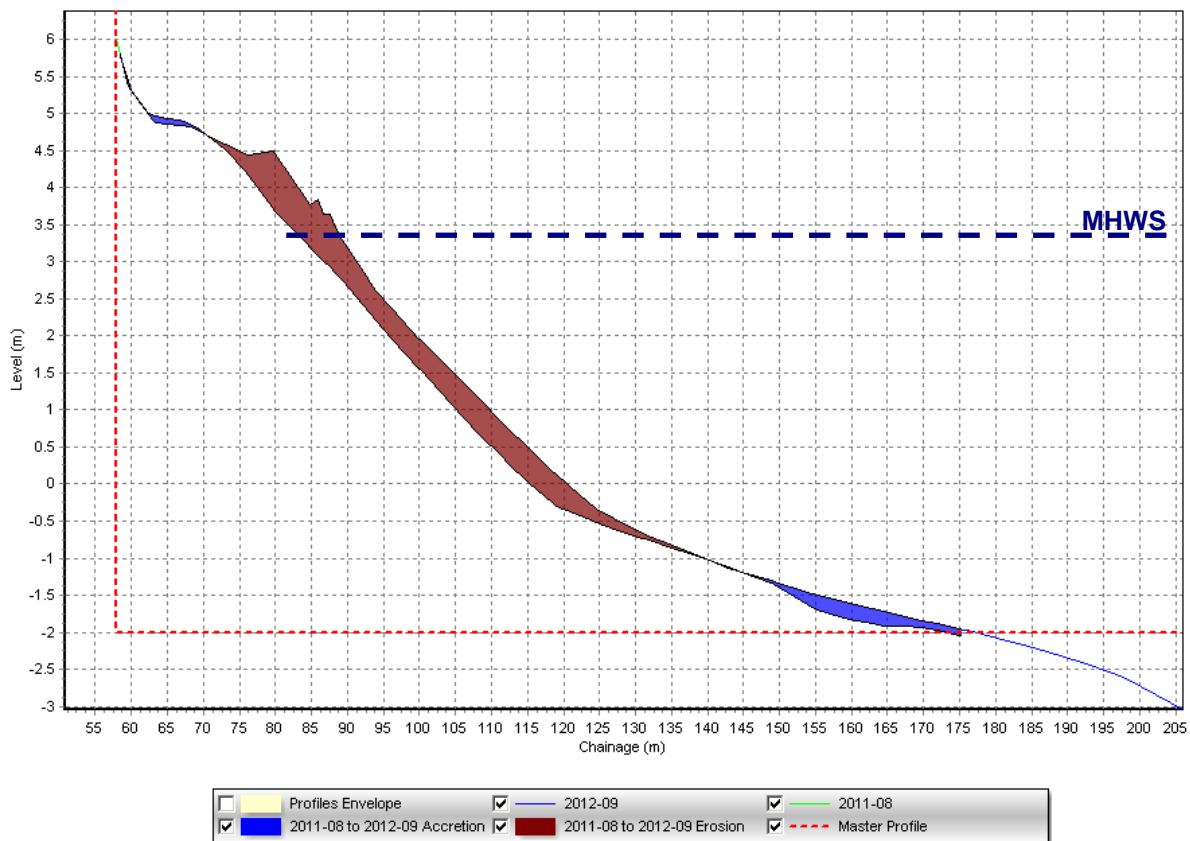
Figure 5.5: Profile Changes Plot for 4c00403

When analysing the difference model it is evident that erosion has mainly occurred in the far western end with Polygon 44 displaying a significant loss of  $3,676\text{m}^3$ . From Figure 5.5 (Profile 4c00403) it is evident that the 2012 profile is significantly lower than in 2011. Erosion is evident throughout the entire slope and crest, which will have a negative impact on the standard of protection this section of frontage provides.

The significant level of erosion displayed in the western part of this section may be due to the material by-passing the groynes and is due to the groynes being in poor condition and having reached their maximum capacity. Only future surveys will determine whether this highly erosive reporting period was a one-off occurrence or whether it will determine a new trend.

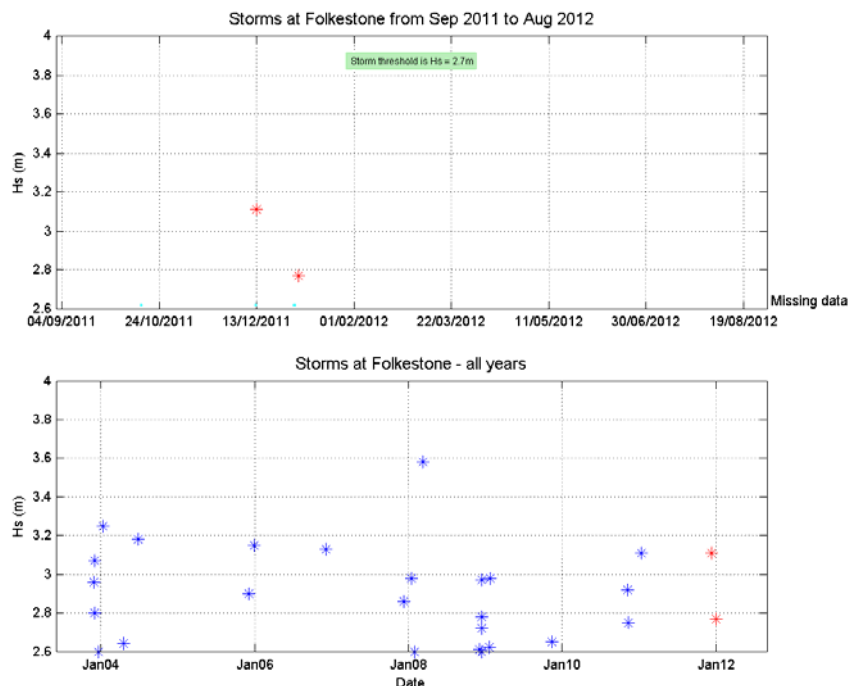
Figure 8.1 Storms at Folkestone 2011-2012

Only two storms exceeded the threshold during this reporting year, concentrated in December and early January (Figure 8.1). Storm wave direction was either S or SbyE. Apart from a few isolated periods of moderate waves, later January, February and March were unusually quiet.
