BEACH MANAGEMENT PLAN REPORT

Jury's Gap & Camber Sands

Document Title: **Beach Management Plan Site Report 2009**

Project Name: **Strategic Regional Coastal Monitoring**

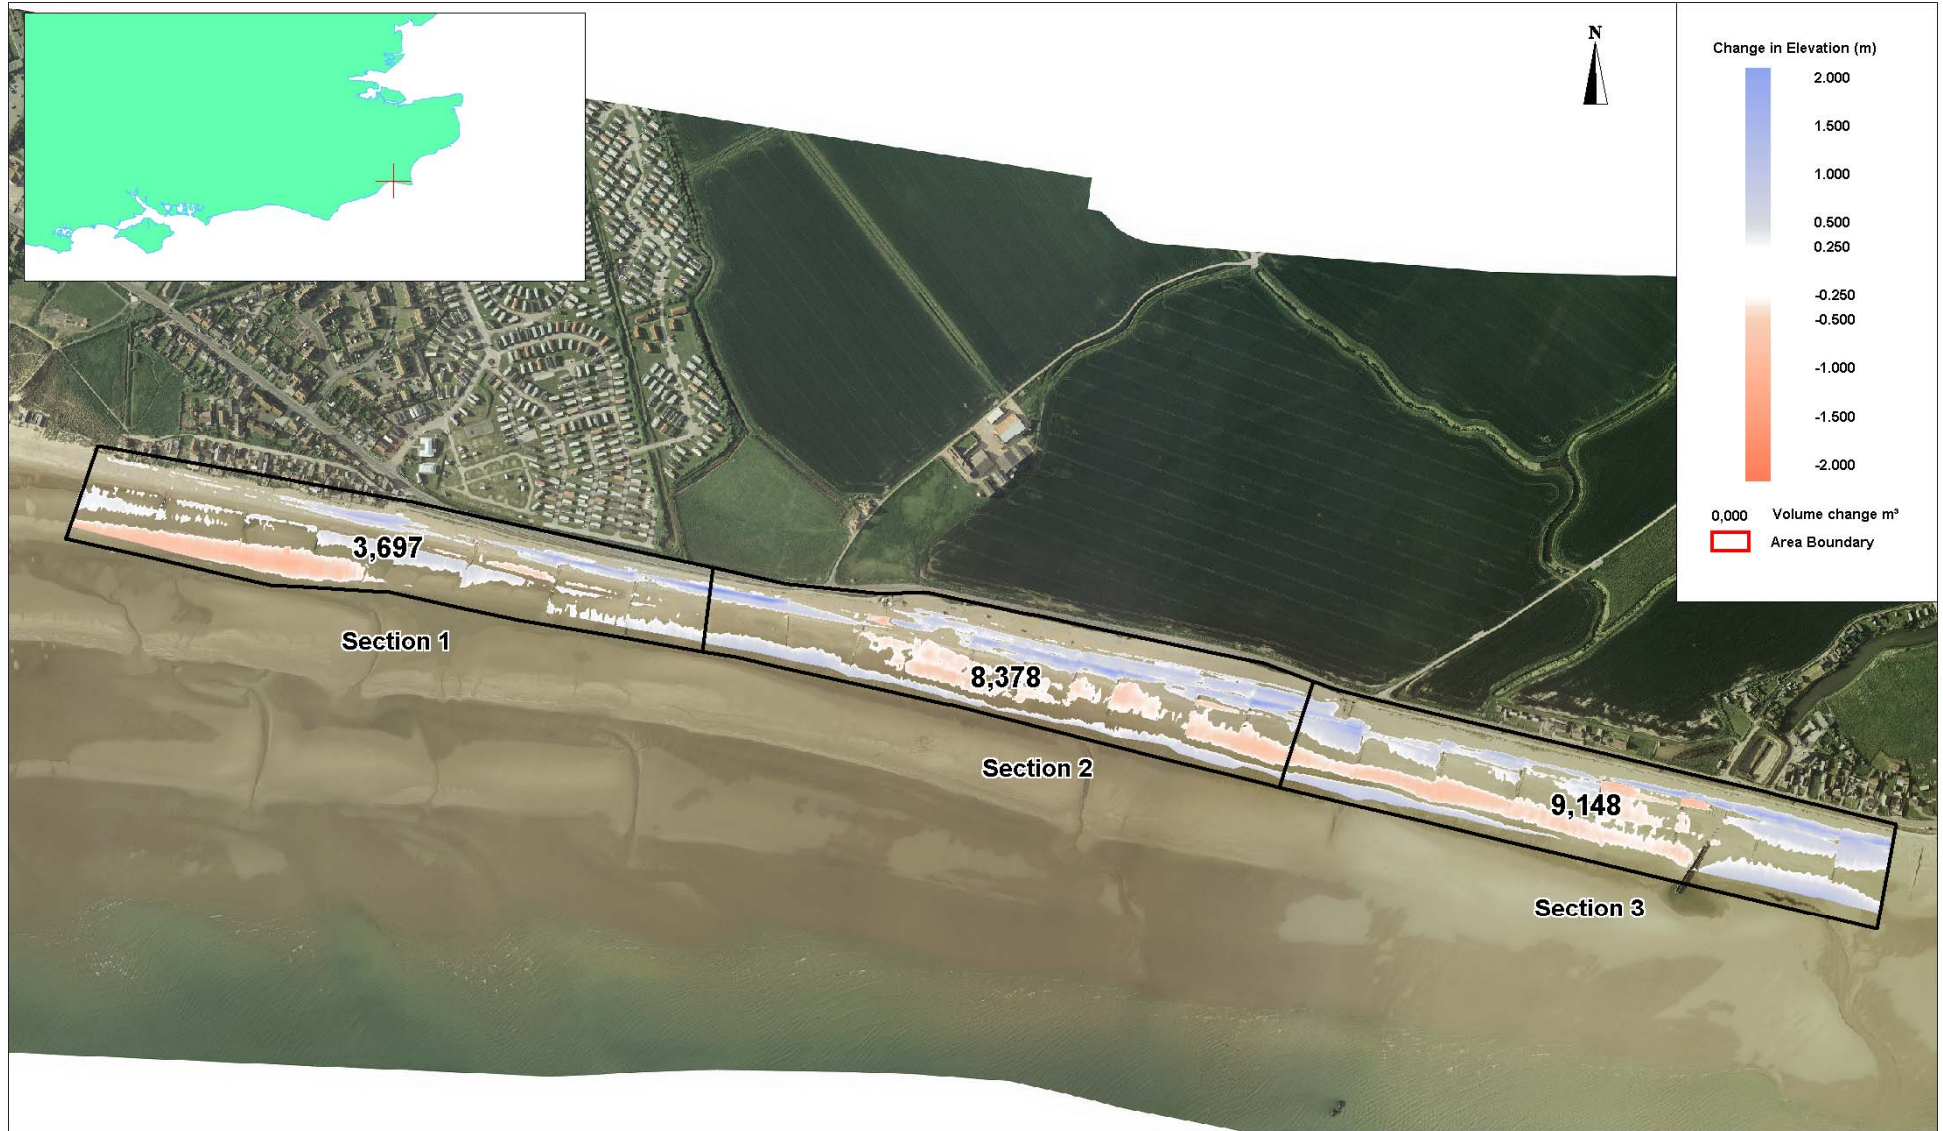
Figure 3.1: Management Unit Section Overview

To aid purposeful analysis the unit has been split into four sections as depicted in Figure 3.1 overleaf. These reflect changes in apparent beach material dynamics as depicted in the difference models (Plate 1, 1-3). In the context of this report, beach change will be described in these three sections; section one extends from the western extent of MU15 to Broomhill Sands, section two covers Broomhill to Jury’s Gap, and section three completes MU15 at the eastern end. However, to ensure all localised changes are fully recognised, volumetric data will also be displayed for each groyne bay in an attempt to identify groyne bay performance.

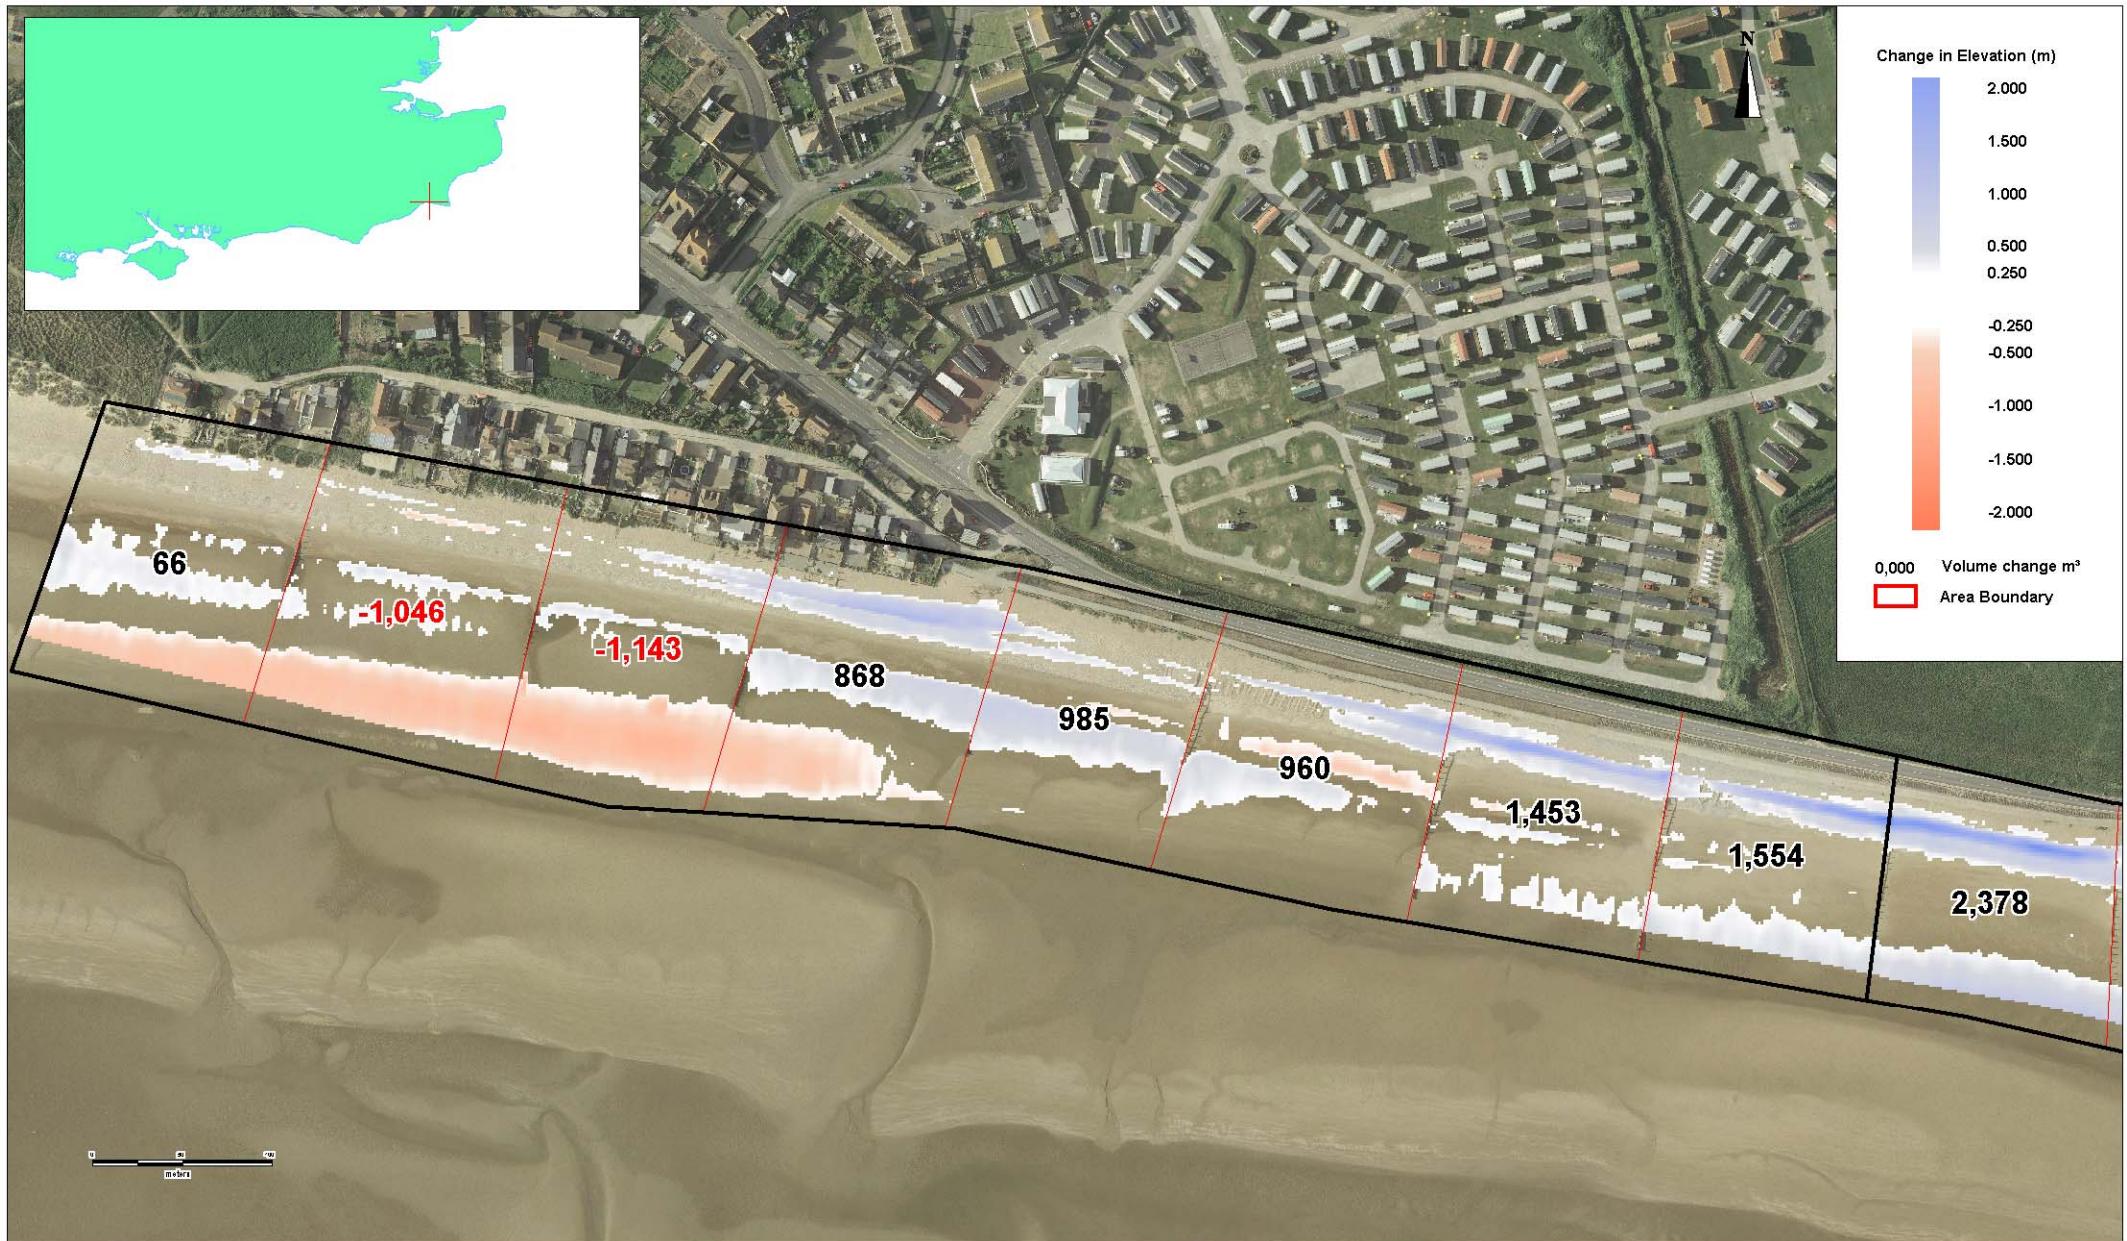
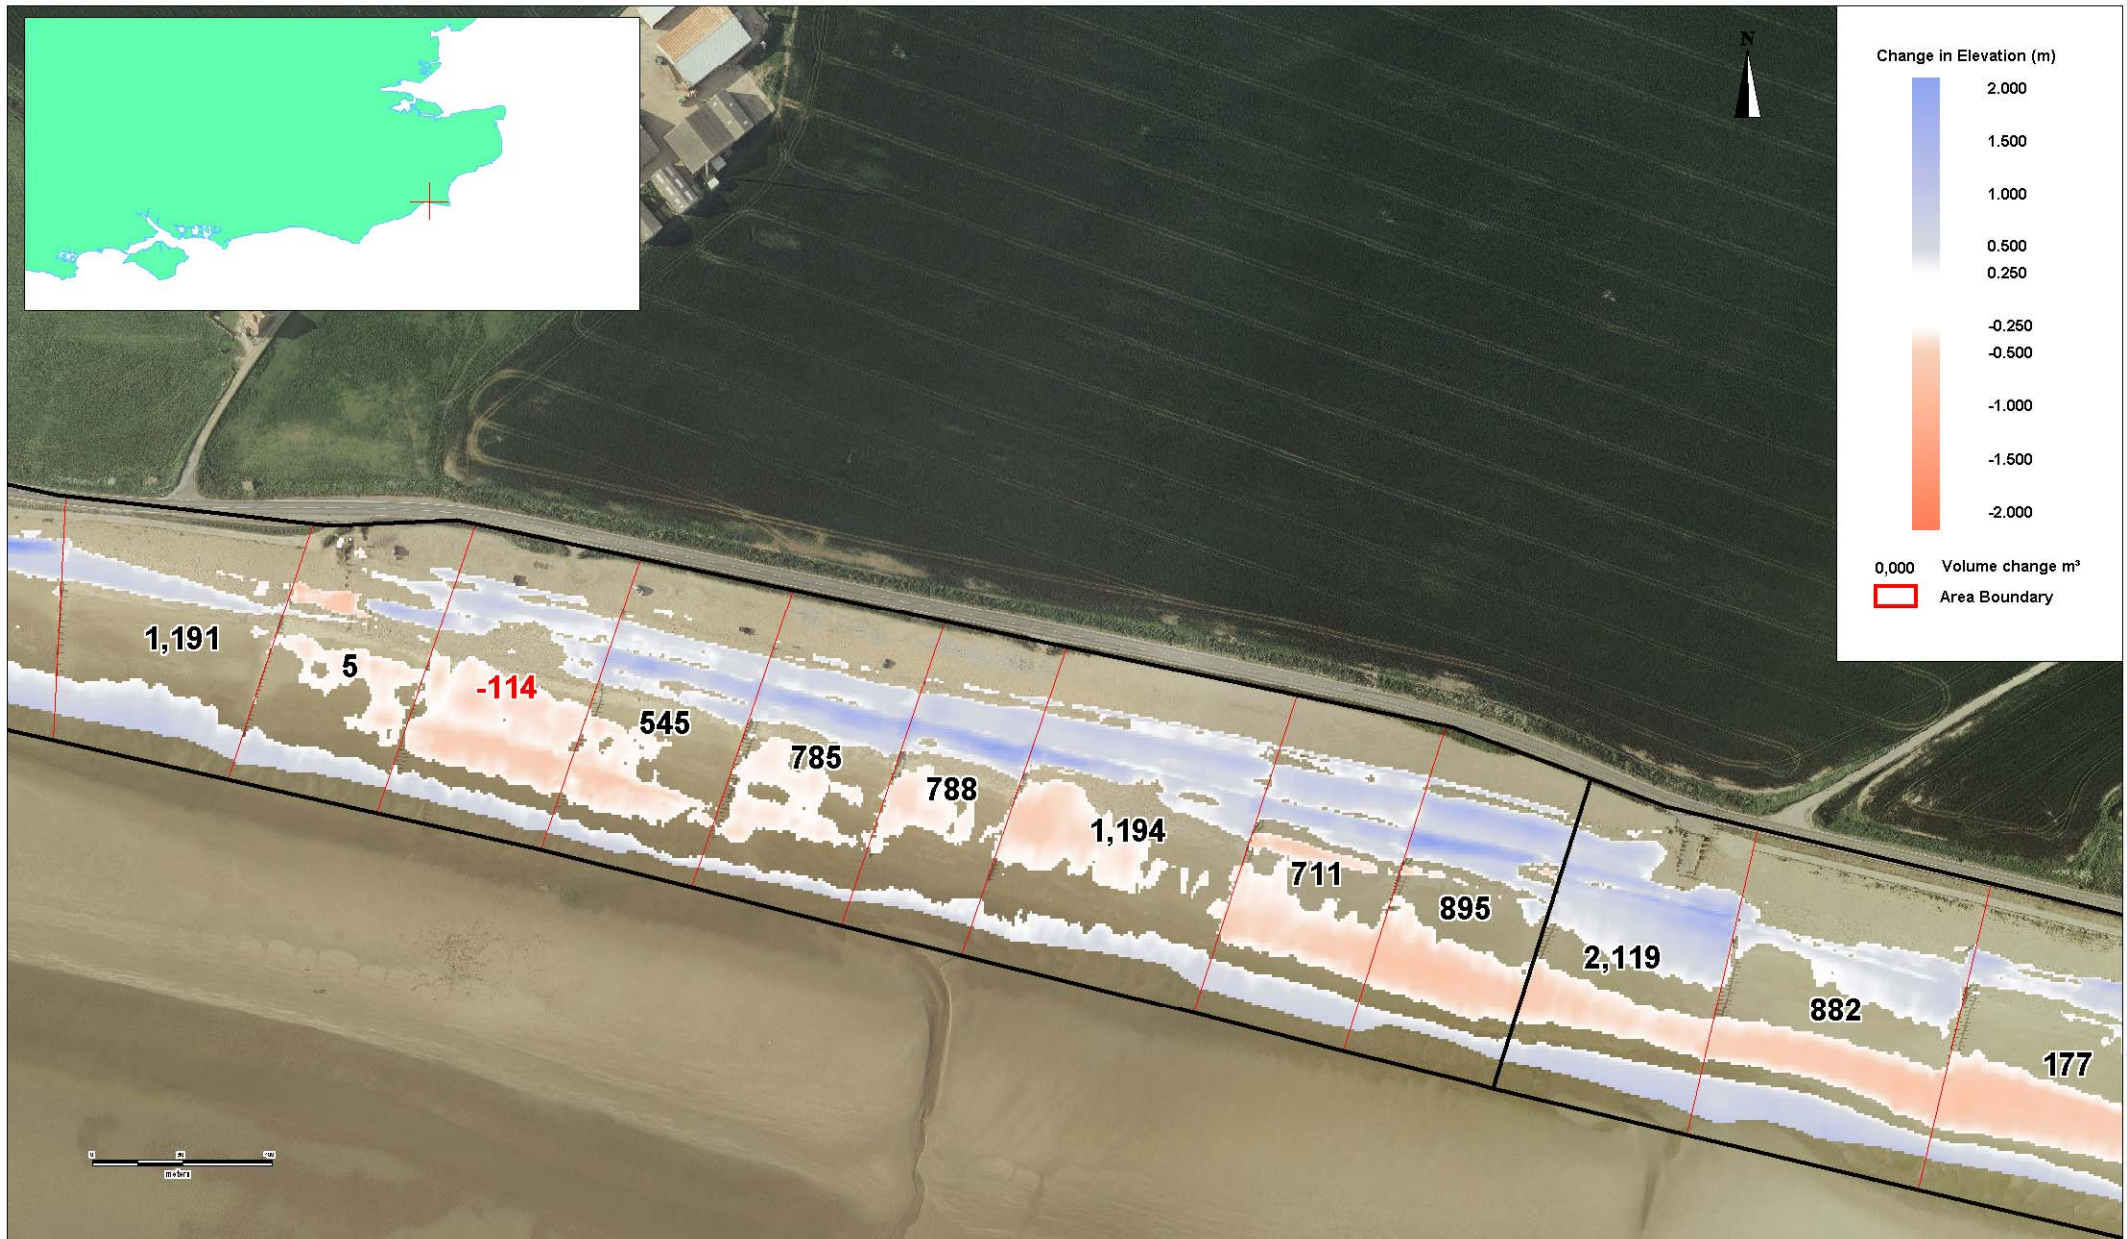
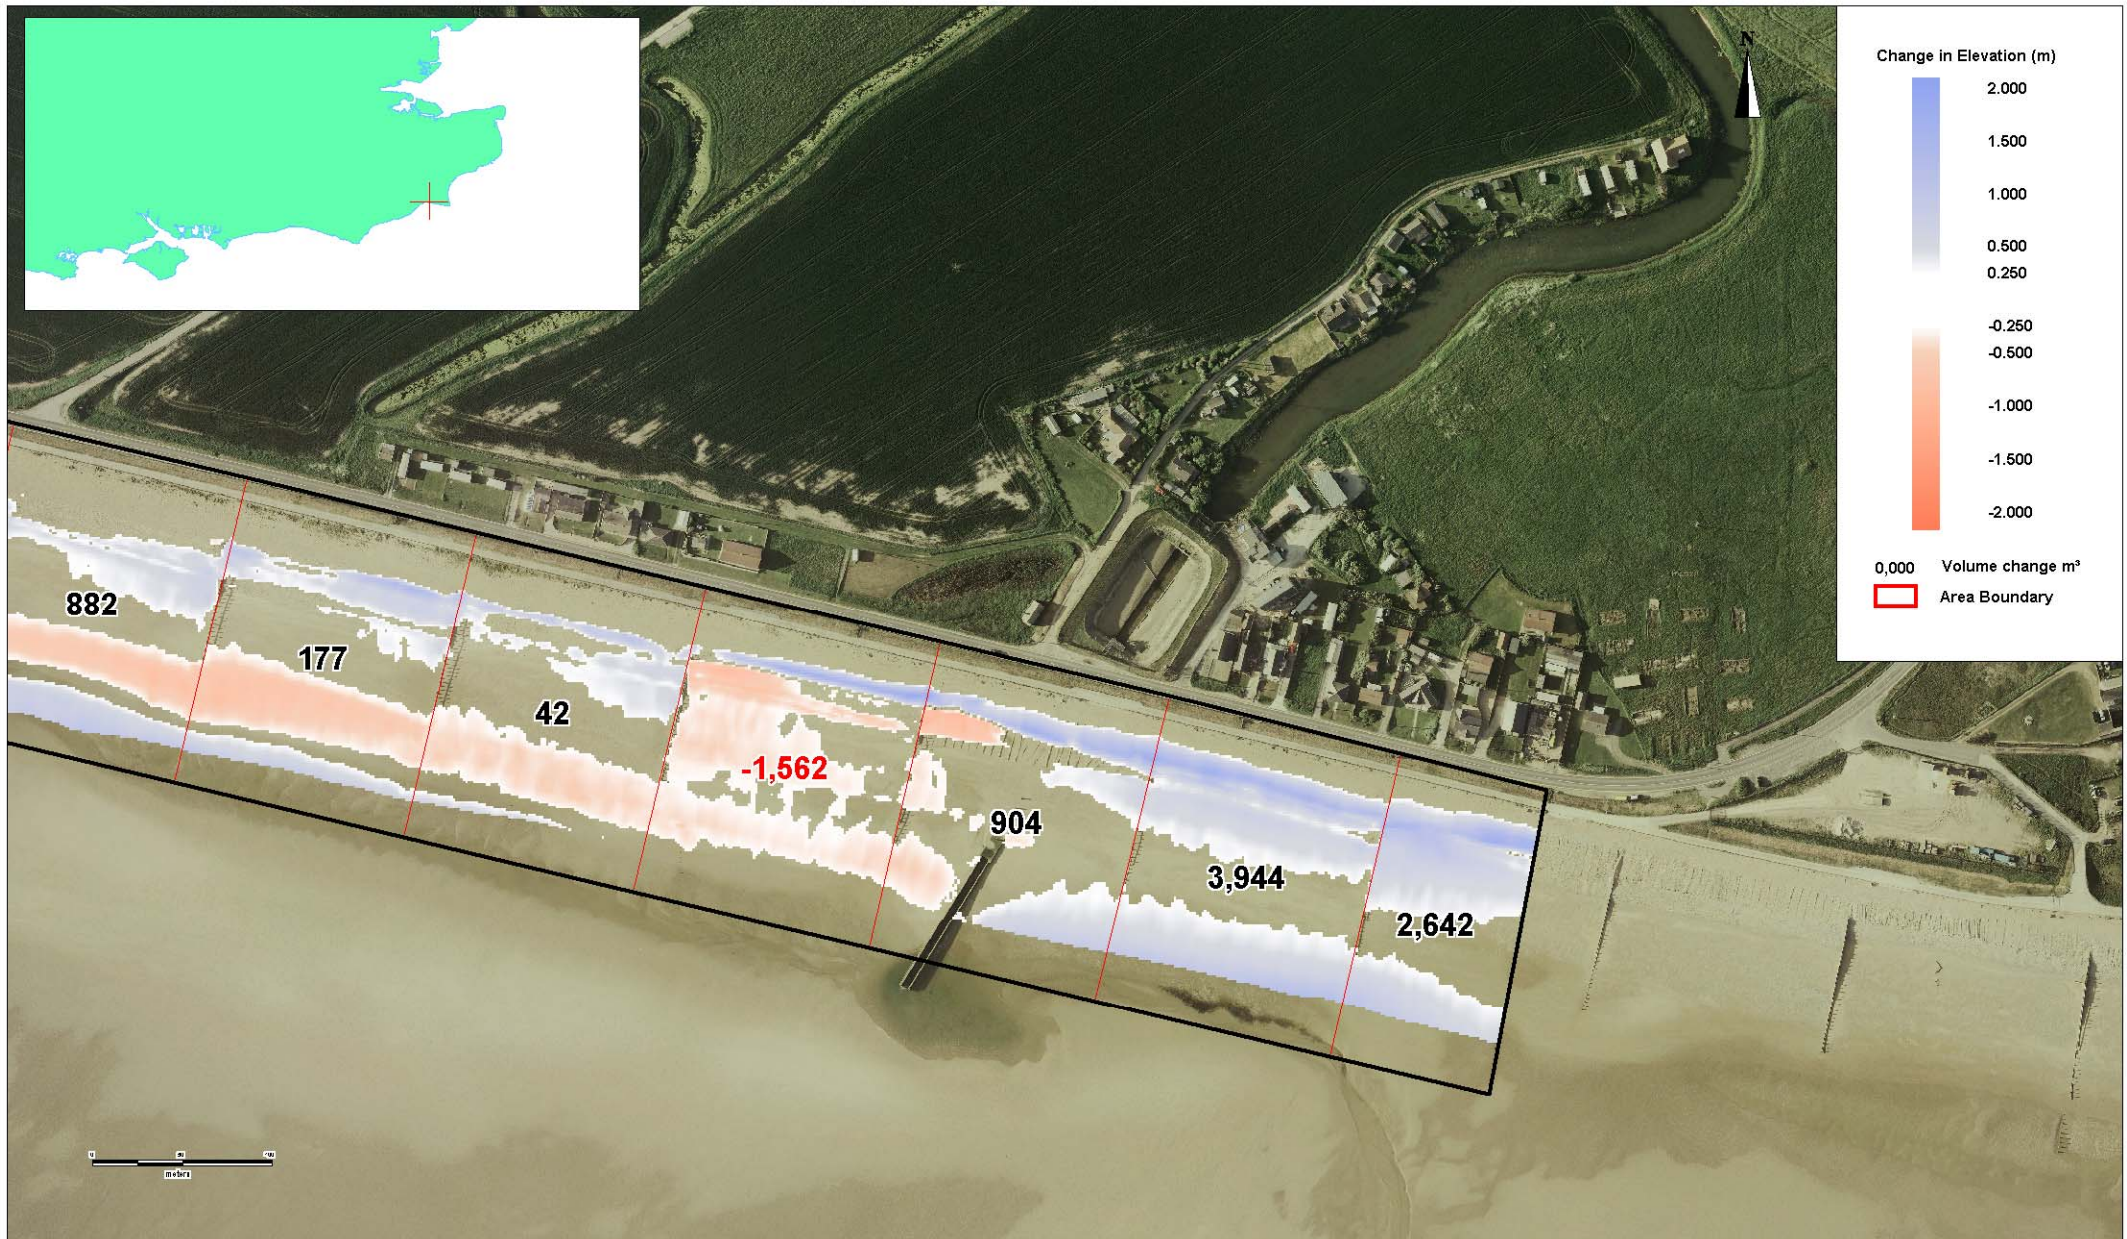
Section 2 covers the central section of this management unit. From the difference model shown in plate 2 (2 of 3), it is clear that this section has accreted overall during the current reporting period with only one out of ten polygons showing overall erosion. The current accretional trend has resulted in a net increase in material for this section with an increase in volume of 8,378m³.

The difference model shown in Plate 2 (3 of 3) clearly shows the key areas of accretion for this section. From this it can be seen that the eastern region of this section has experienced a greater degree of accretion than the central and western regions. Again the difference model shows that a vast majority of accretion has occurred at the beach crest level with a small degree of toe erosion.

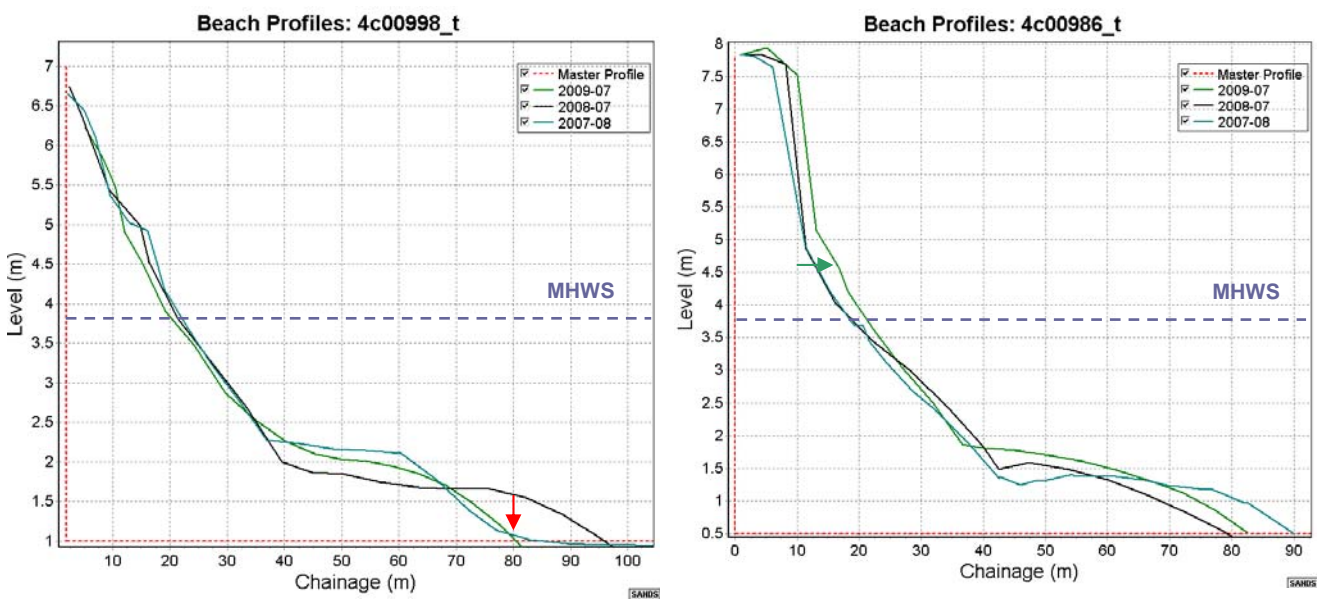
Figure 3.2 - Comparison of beach cross sections

Figure 3.2 below shows a comparison between two beach profiles located within section one. Profile 4c00998 is located within polygon 2, where net erosion has occurred and profile 4c00986 is located within polygon 7, where net accretion has occurred.

From Figure 3.2 it is clear that the western and eastern regions of this management unit are currently experiencing differing cross sectional trends. The western region (profile 4c00998), demonstrates a loss of material at the toe of the beach, with an unchanged beach slope profile. The eastern region (profile 4c00986) conversely shows an increase in toe deposits with an advancement of the beach slope.

From this analysis it is clear that although some degree of erosion has occurred within this section, it is primarily limited to the toe of the beach and therefore does not significantly impact on the standard of protection provided by the beach.

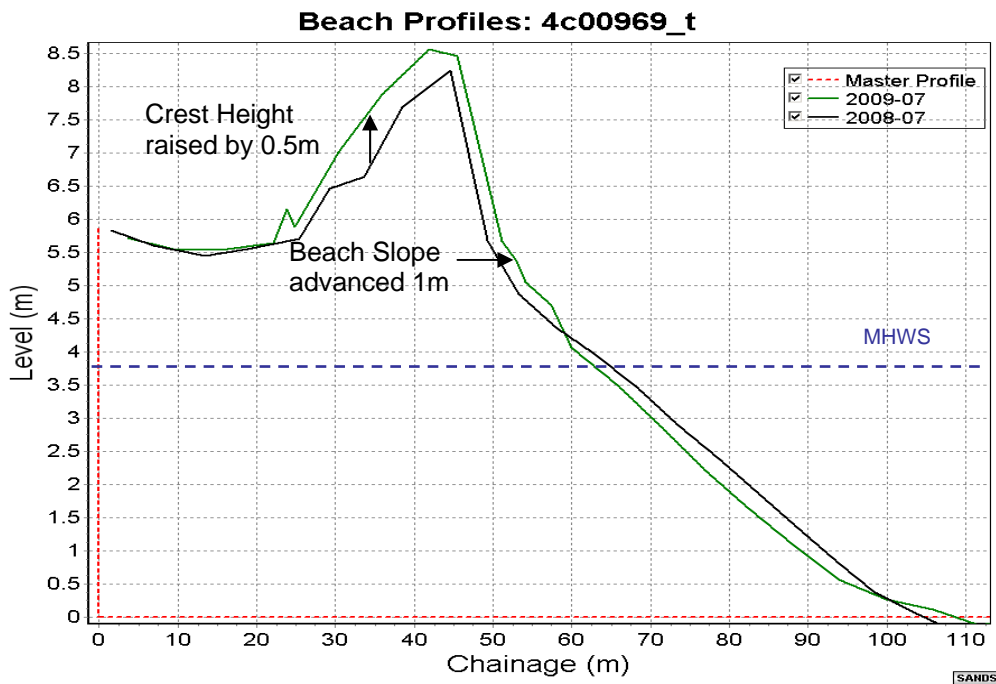
Figure 3.3- Beach cross section improvement

With the beach clearly showing accretional tendencies about the beach crest it remains important to assess how these changes have impacted on the level of protection provided by the beach. Figure 3.3 below represents a typical profile within the section, highlighting the increased level of protection afforded by this section.

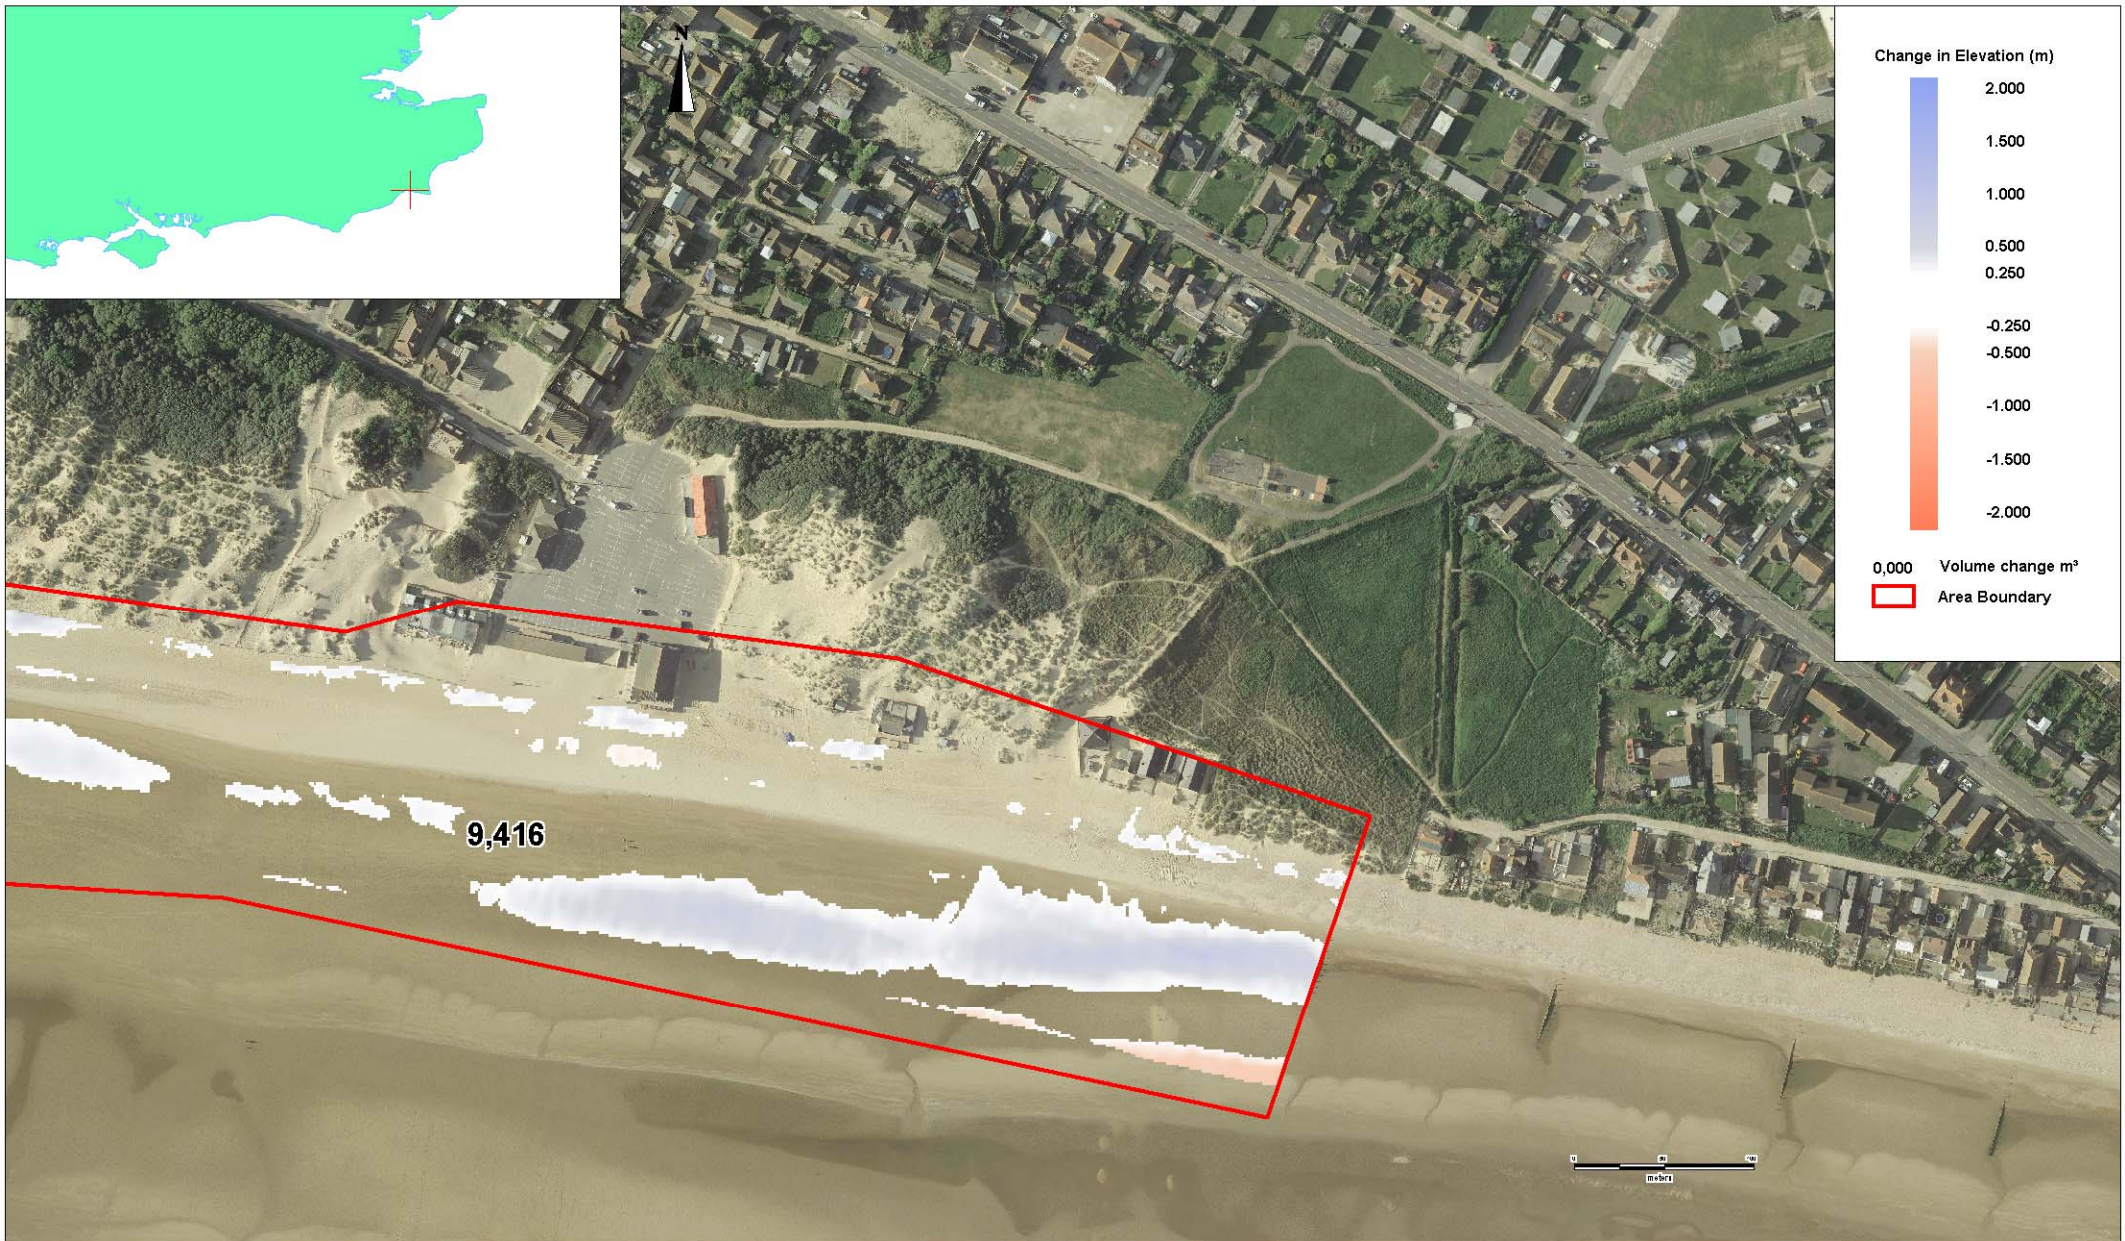
3.4.1 MU16 Section 1 (Profiles 4c01059 – 4c01044)

Located immediately east of the Rye Harbour arm, Section 1 represents the western boundary of Management Unit 16. From the data obtained from the 2009 BMP survey it is evident that this section exhibits a relatively stable trend with the marginal loss of material during the current reporting period.

The difference model for the current reporting period shows a distinct area of accretion some 30m from the toe of the dune, which then changes to an area of erosion 45m from the toe of the dune. It is clear that both erosional and accretional processes are taking place within this section however, in this instance, the erosional processes are of a greater magnitude. It is important to note that at approximately 45m from the toe of the dune the sand deposits become unconsolidated and consequently a semi solid layer of sediment (100-300mm thick) sits above the recorded surface. From this it could be argued that although the current trend represents an overall loss of material, the actual volume of material present in this section may be slightly larger than that shown. Figure 3.5 below shows a comparison of profile photograph located within the band of erosion, and clearly illustrates the difference in levels.

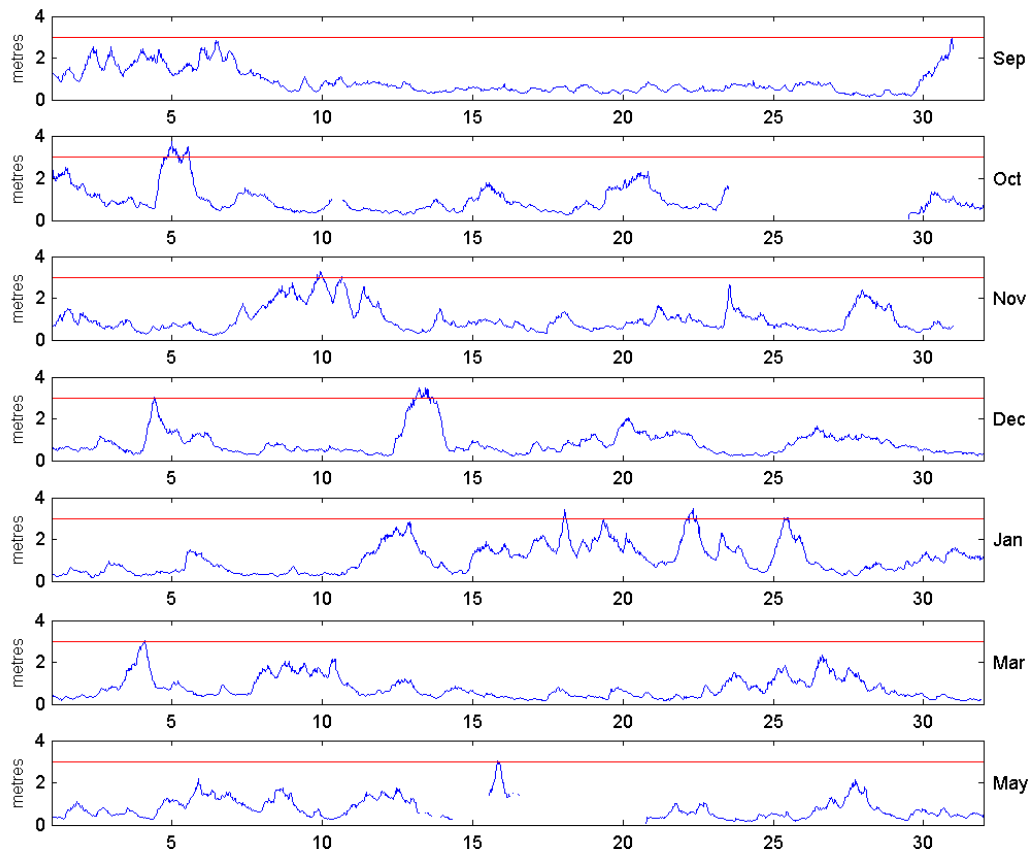
Figure 5.1: Monthly time series of Hs at Folkestone

Blue Line – Significant wave Height (Hs)
Red Line – Storm Threshold (2.5m)

The most significant storm event over the past year (5th October 2008) was marked by a lengthy period of waves exceeding the 3m threshold. Wave height increased steadily over a 12 hour period and peaked at 3.71m H_s. Due to the relatively exposed nature of this site, south-westerly swell can reach this location, as is indicated in the consistent direction of storm wave approach (~210°, SWbS). Storm surge at Dover was negative prior to and at the peak of the storm in Rye Bay.
