WORKINGTON TO MARYPORT**Baseline Information**

Site overview:

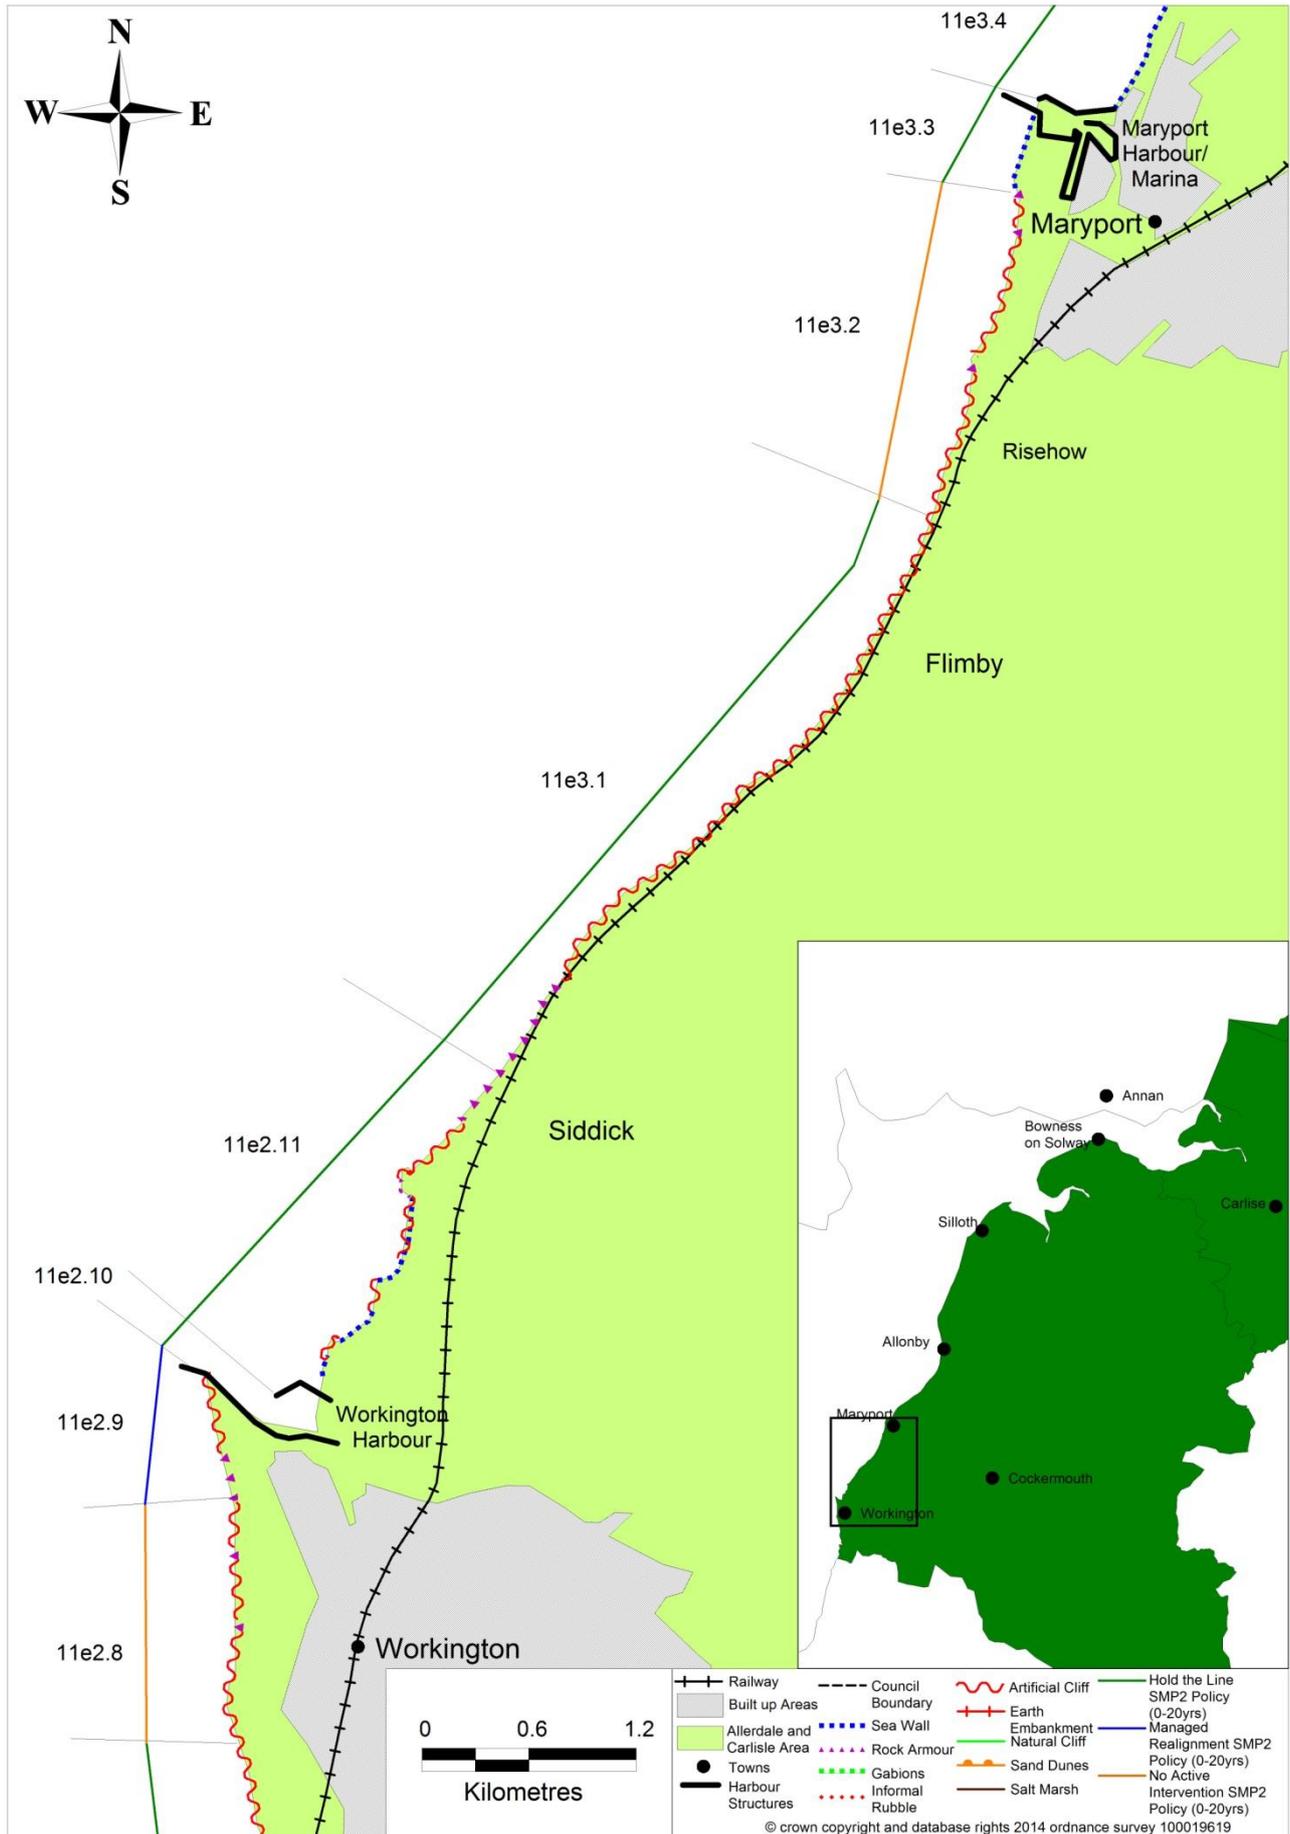
Approximately a third of this frontage is currently undefended with the majority of these sections comprising artificial tipped deposits e.g. slag waste and colliery spoil. Intermittent concrete defences have been constructed between Workington and Siddick. At Seaton, the original railway defences from the 19th century have been reinforced with rock armour in the past 20 years. Between Seaton and Flimby the railway is fronted by a mixture of tipped waste deposits from industrial workings and natural material that is heavily vegetated. A low boundary wall demarcates the seaward side of the railway here. At Flimby the original revetment protecting the railway is largely buried behind shingle and dune deposits. The remainder of the frontage consists of artificial slag banks intermittently defended by rock armour, apart from at the northern end of this frontage, where the shoreline and Maryport marina is defended by a large masonry faced embankment, constructed in 1860.

The seawall to the north of Workington harbour is fair condition. Some of the precast slabs on the defences north of Workington harbour have broken away. At Seaton the cliffs have eroded behind the gabion defences, leaving the gabions separated and unsupported causing them to collapse. At Siddick Ponds the defences are in fair condition, with damage to the southern end.

- **Workington Harbour:** Hold the Line in the short term (0-20yrs), medium term (20-50yrs) and long term (50-100yrs);
- **Workington Harbour to Siddick:** Hold the Line in the short term (0-20yrs), Managed Realignment in medium term (20-50yrs) and long term (50-100yrs);
- **Siddick to Risehow:** Hold the Line in the short term (0-20yrs), medium term (20-50yrs) and long term (50-100yrs);
- **Risehow to Maryport Marina:** No Active Intervention (0-20yrs), medium term (20-50yrs) and long term (50-100yrs); and
- **Maryport Harbour/Marina:** Hold the Line in the short term (0-20yrs), medium term (20-50yrs) and long term (50-100yrs).

The plan overleaf summaries the above information graphically:

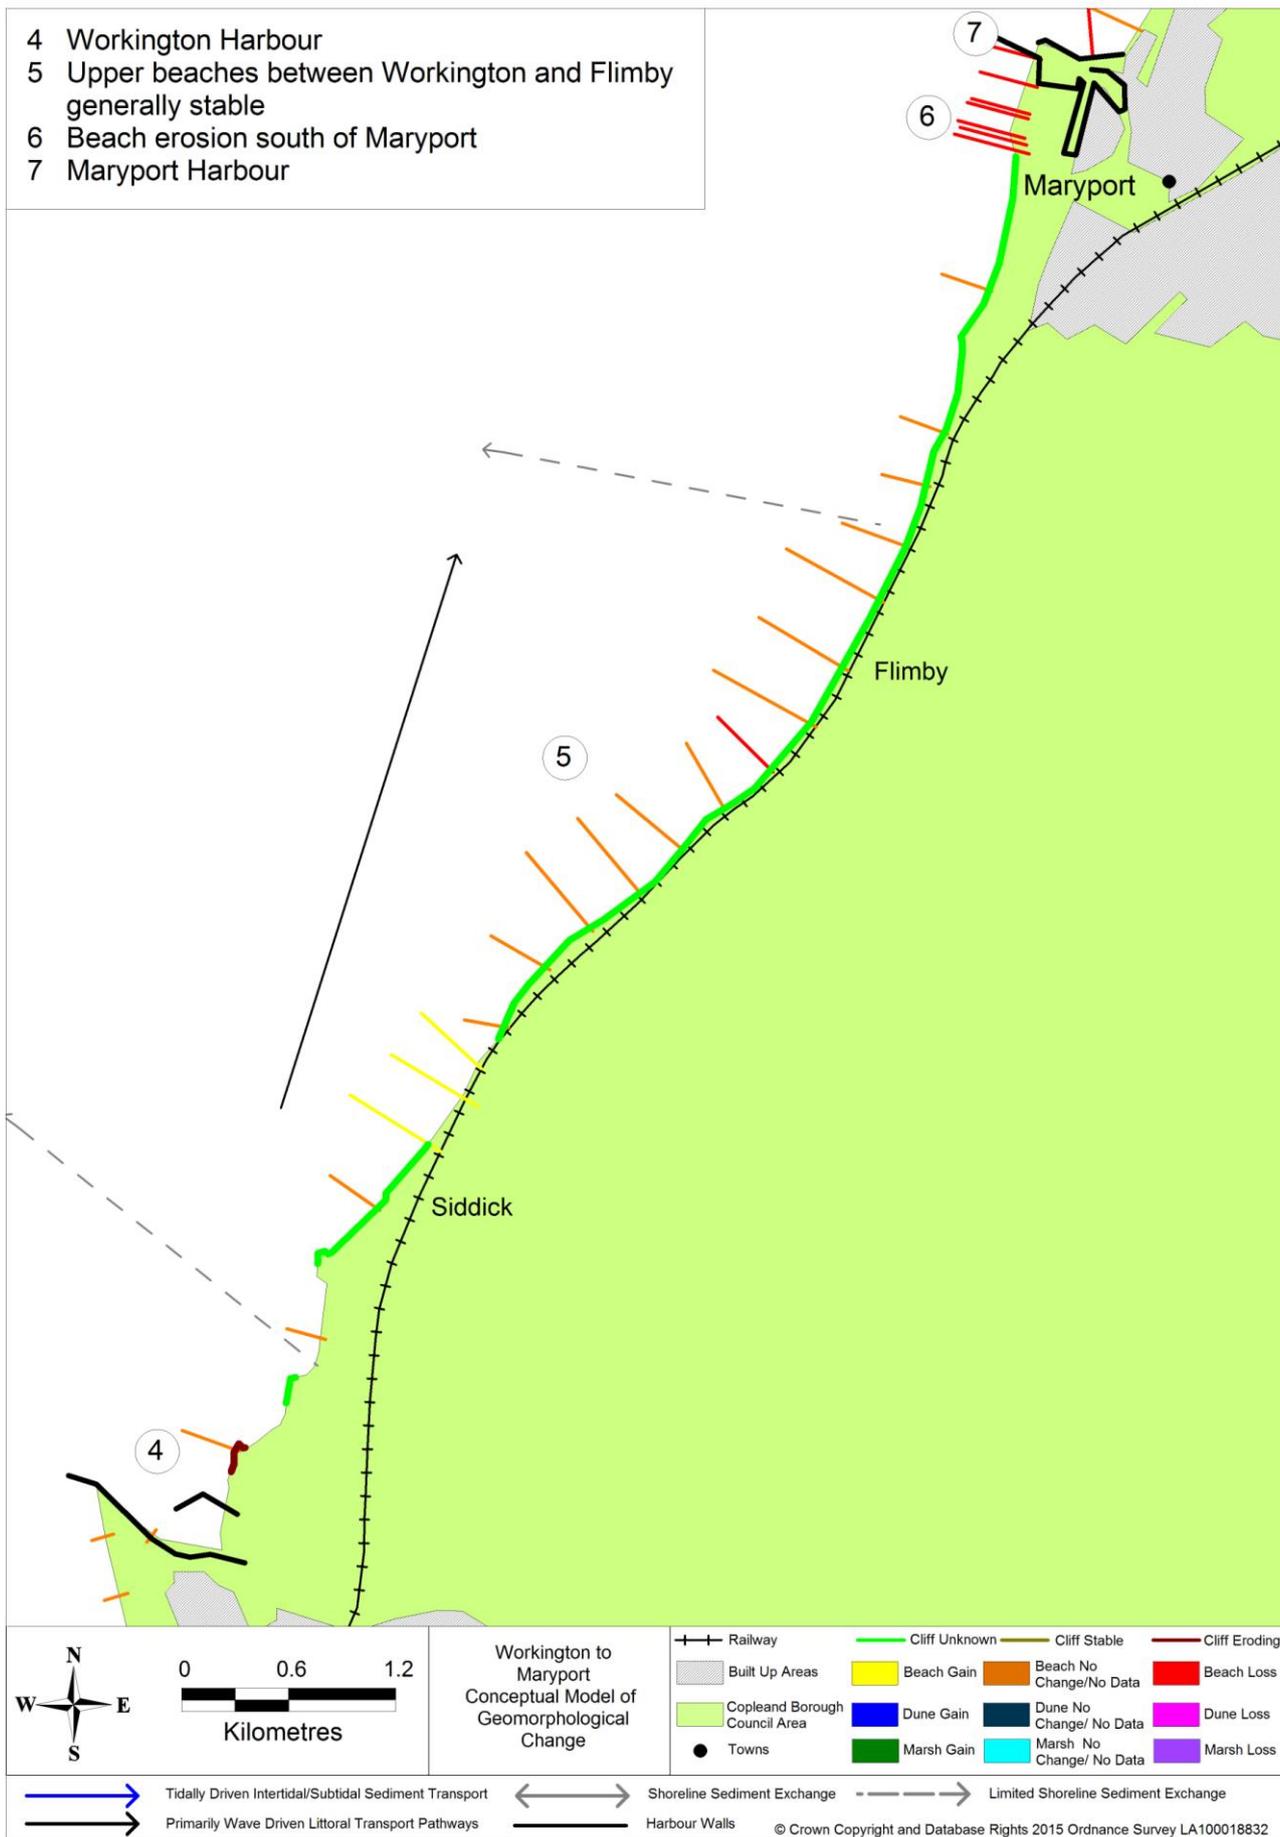
- Beach stable between Workington and Flimby. Profile change: 27% – accretion, 9% – erosion, 64% – no change; and
- Beach generally stable south of Maryport. Profile change: 0% – accretion, 100% – erosion, 0% – no change.

This behaviour is illustrated graphically on the plan overleaf.

Note: Where profile change is shown for individual profiles on the pictorial summaries, beach gain or loss is identified, where the magnitude of change in cross sectional area is greater than 2%. Where the magnitude of change is less than or equal to 2% this is denoted as no change.

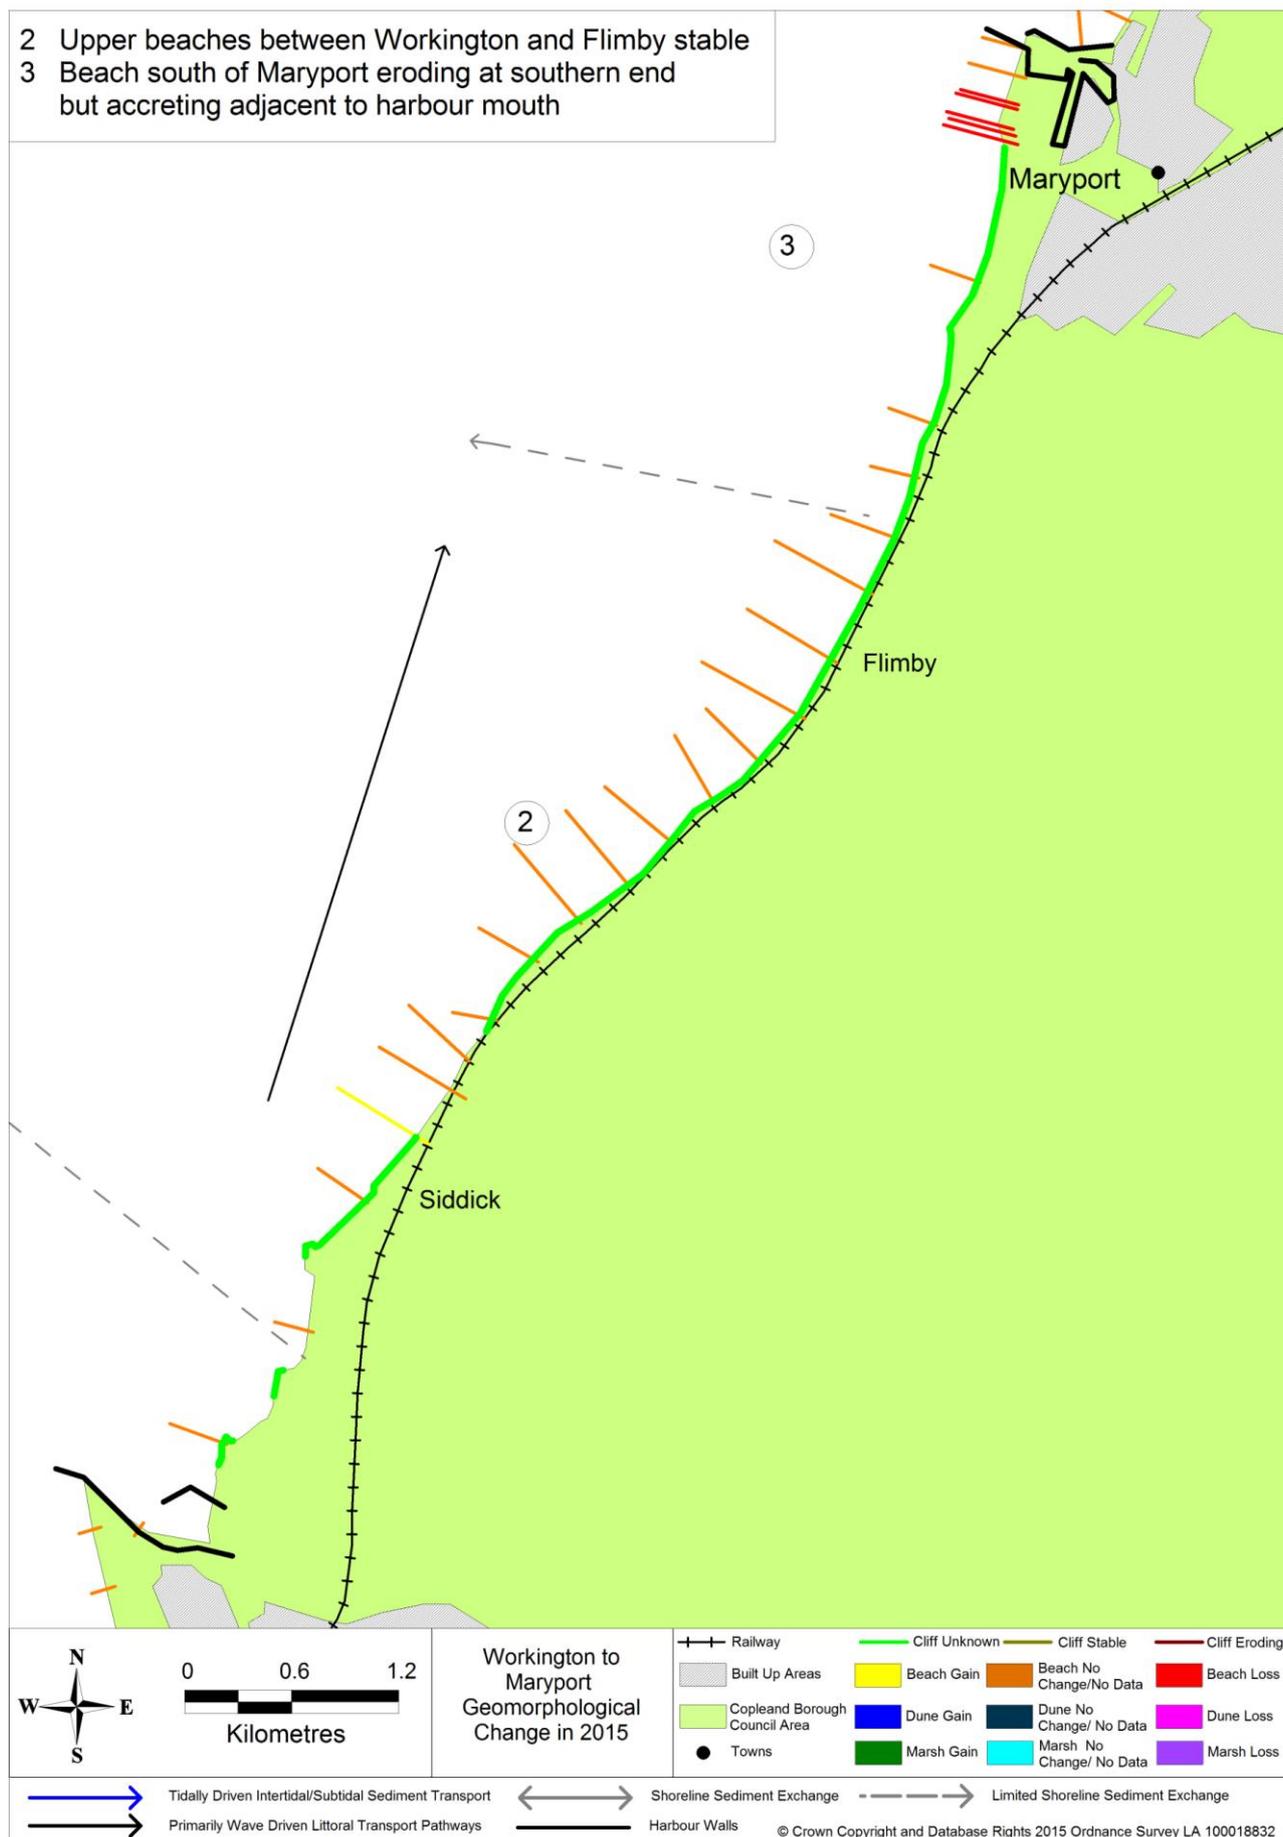
- Only 13 out of 28 profiles available for comparison;
- Profile change at Seaton and Flimby: 16% – accretion, 0% – erosion, 84% – no change;
- Profile change at Maryport: 0% – accretion, 66% – erosion, 33% – no change; and
- No comparison data elsewhere.

Note: Where profile change is shown for individual profiles on the pictorial summaries, beach gain or loss is identified, where the magnitude of change in cross sectional area is greater than 2%. Where the magnitude of change is less than or equal to 2% this is denoted as no change.

The plot overleaf summarises the results from the monitoring data analysis for this section in 2015.
