BEACH MANAGEMENT PLAN REPORT

Sandgate and Folkestone

BMP186

Document Title: **Beach Management Plan Site Report 2013**

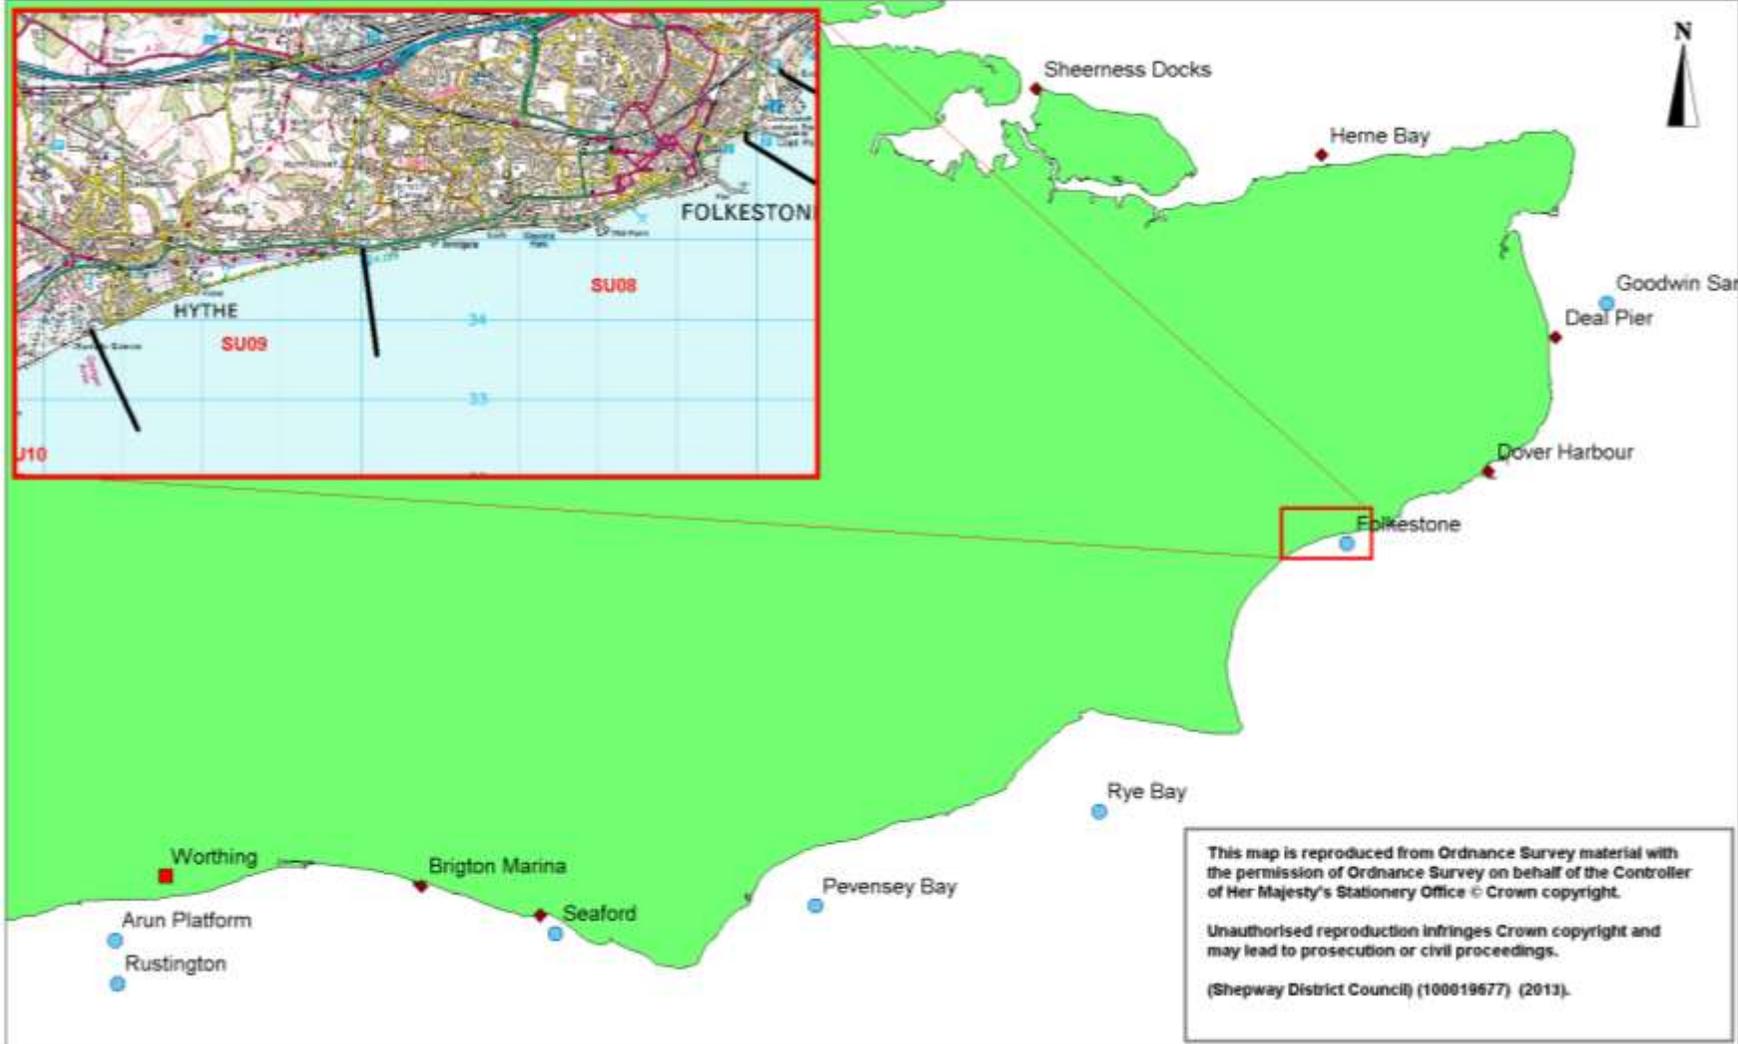
Figure 1: Site Location and Wave/Tide Gauges

The location of the frontage is shown on Figure 1 illustrating the division between the two Survey Units and the position of the nearest wave recorder in the Hythe Bay.

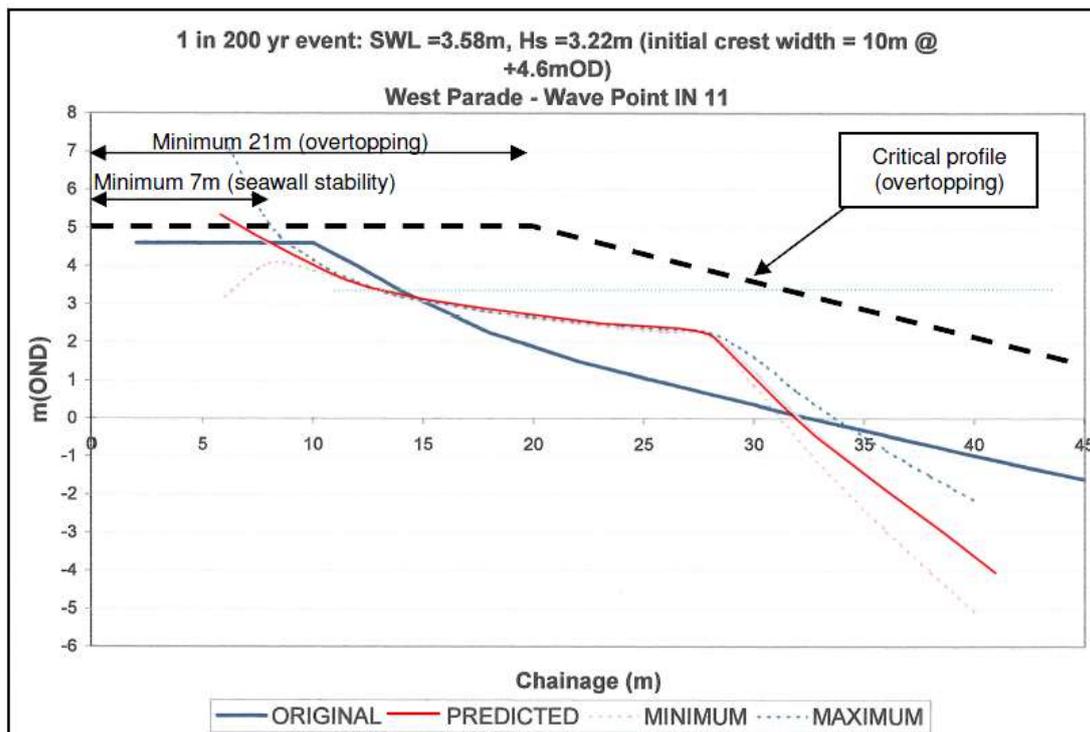
Figure 2: Example SHINGLE model output beach reporting section 1, for a 1:200 year event, annotated with the critical beach profile.

An example of a SHINGLE model output is provided in Figure 2 and illustrates the initial profile (original), the post storm profile (predicted) and annotated with the critical minimum profile crest width for overtopping standard of protection and seawall stability. The profile response includes retreat of the beach crest by approximately 2.5m and erosion of the submerged beach profile, leading to the formation of a lower beach berm.

Based on the SHINGLE modelling, a series of critical beach profiles were established to achieve the 1 in 200 year standard of protection along the frontage. These profiles were then rationalised during the design stage, depending on the defence type, the elevation of the ground behind the defences and the potential depletion of material through longshore transport processes between recycling events. A final design profile in relation to the critical profile was developed for each Survey unit to ensure that prior to a storm event the beach profile is equal to or in excess of the critical

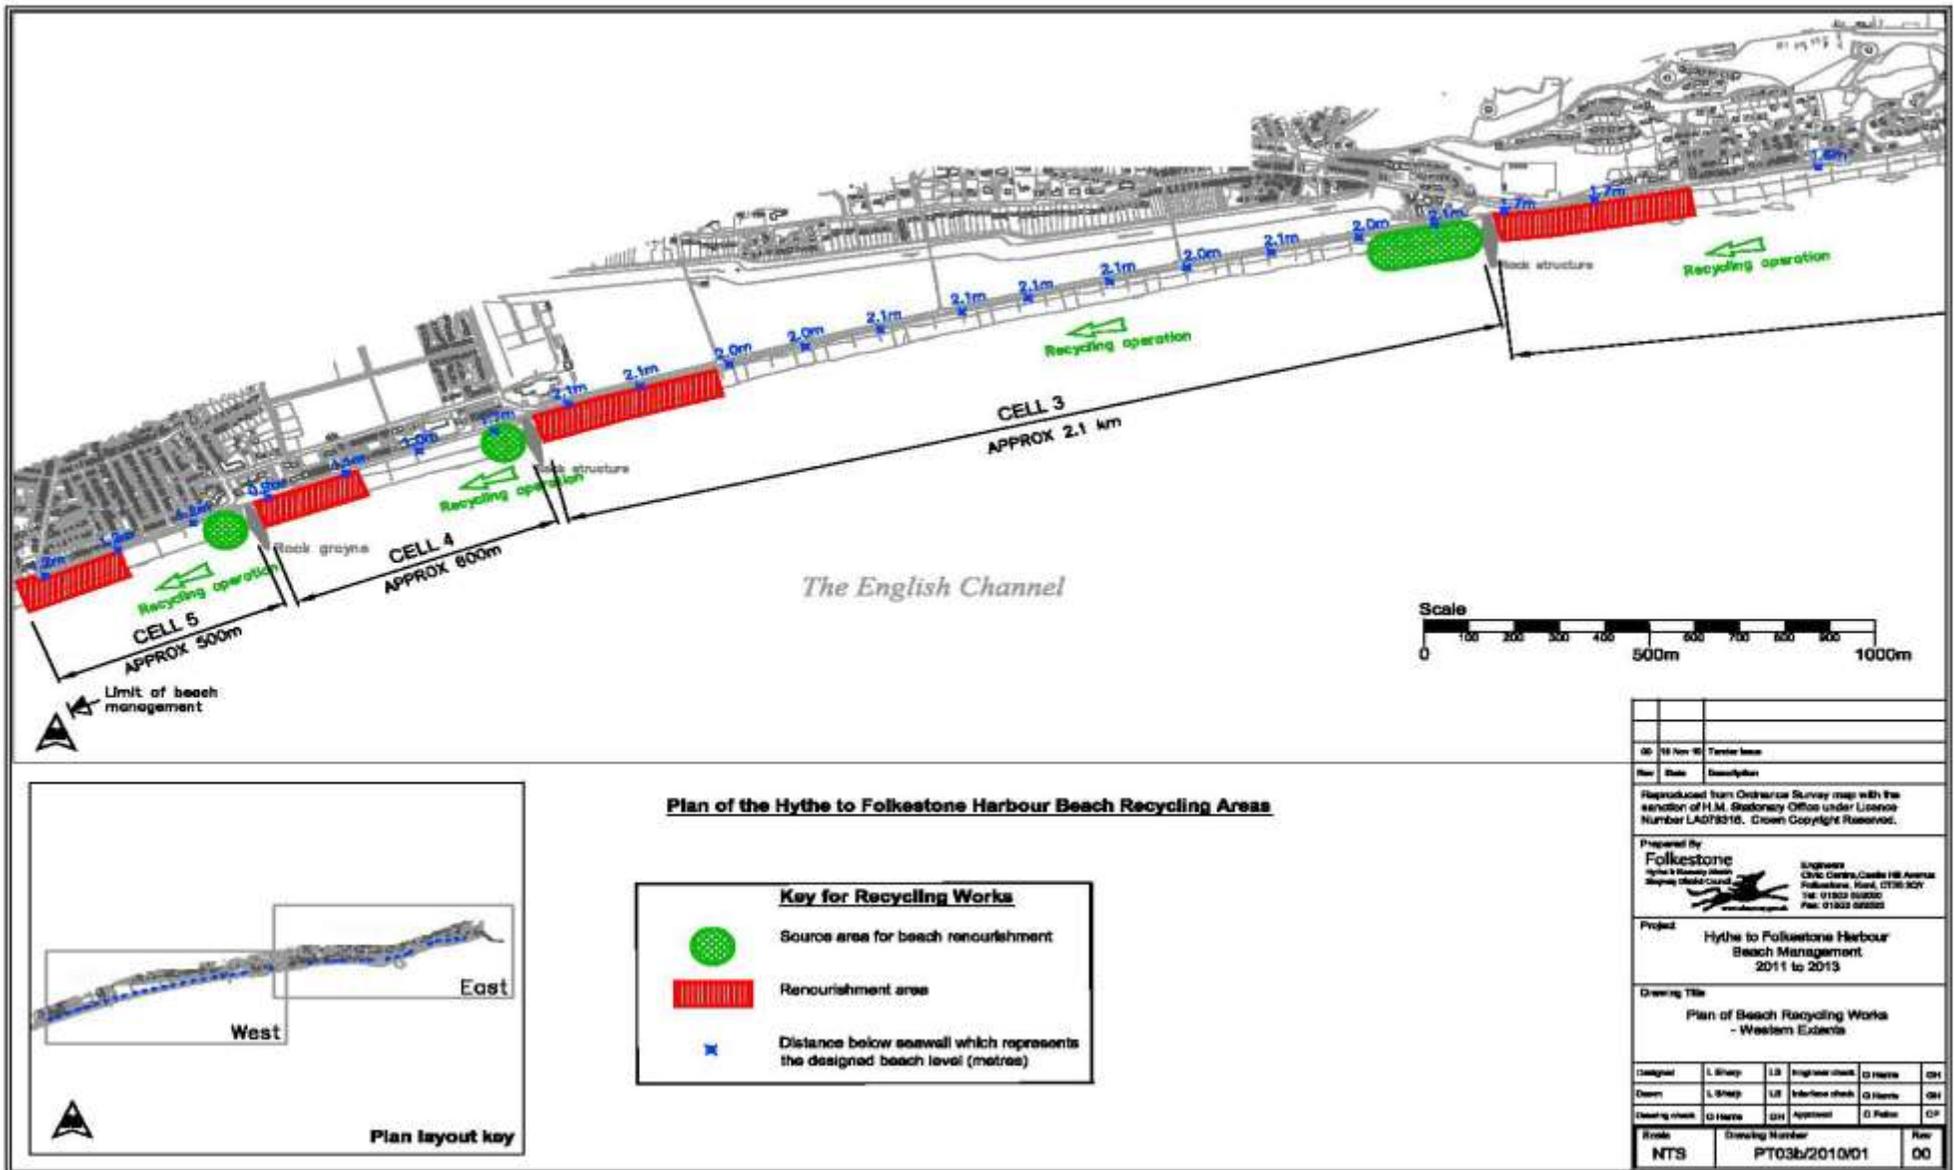
Figure 3: Beach Recycling Areas- Western Extents

Beach Management operations are currently undertaken bi-annually in the Spring and Autumn. The operations are weighted to account for the increased storm activity in the winter period and consequently larger volumes are recycled in the autumn to prepare the beach for successive storm events. The spring operations aim to readdress the losses incurred over the winter months and to regrade the beach to a more amenable profile. These operations currently utilise the annual monitoring data to accurately target areas along the frontage where excessive erosion has occurred. Figures 3 and 4 overleaf illustrate the recycling operations across the entire frontage and the proposed areas for extraction and deposition.

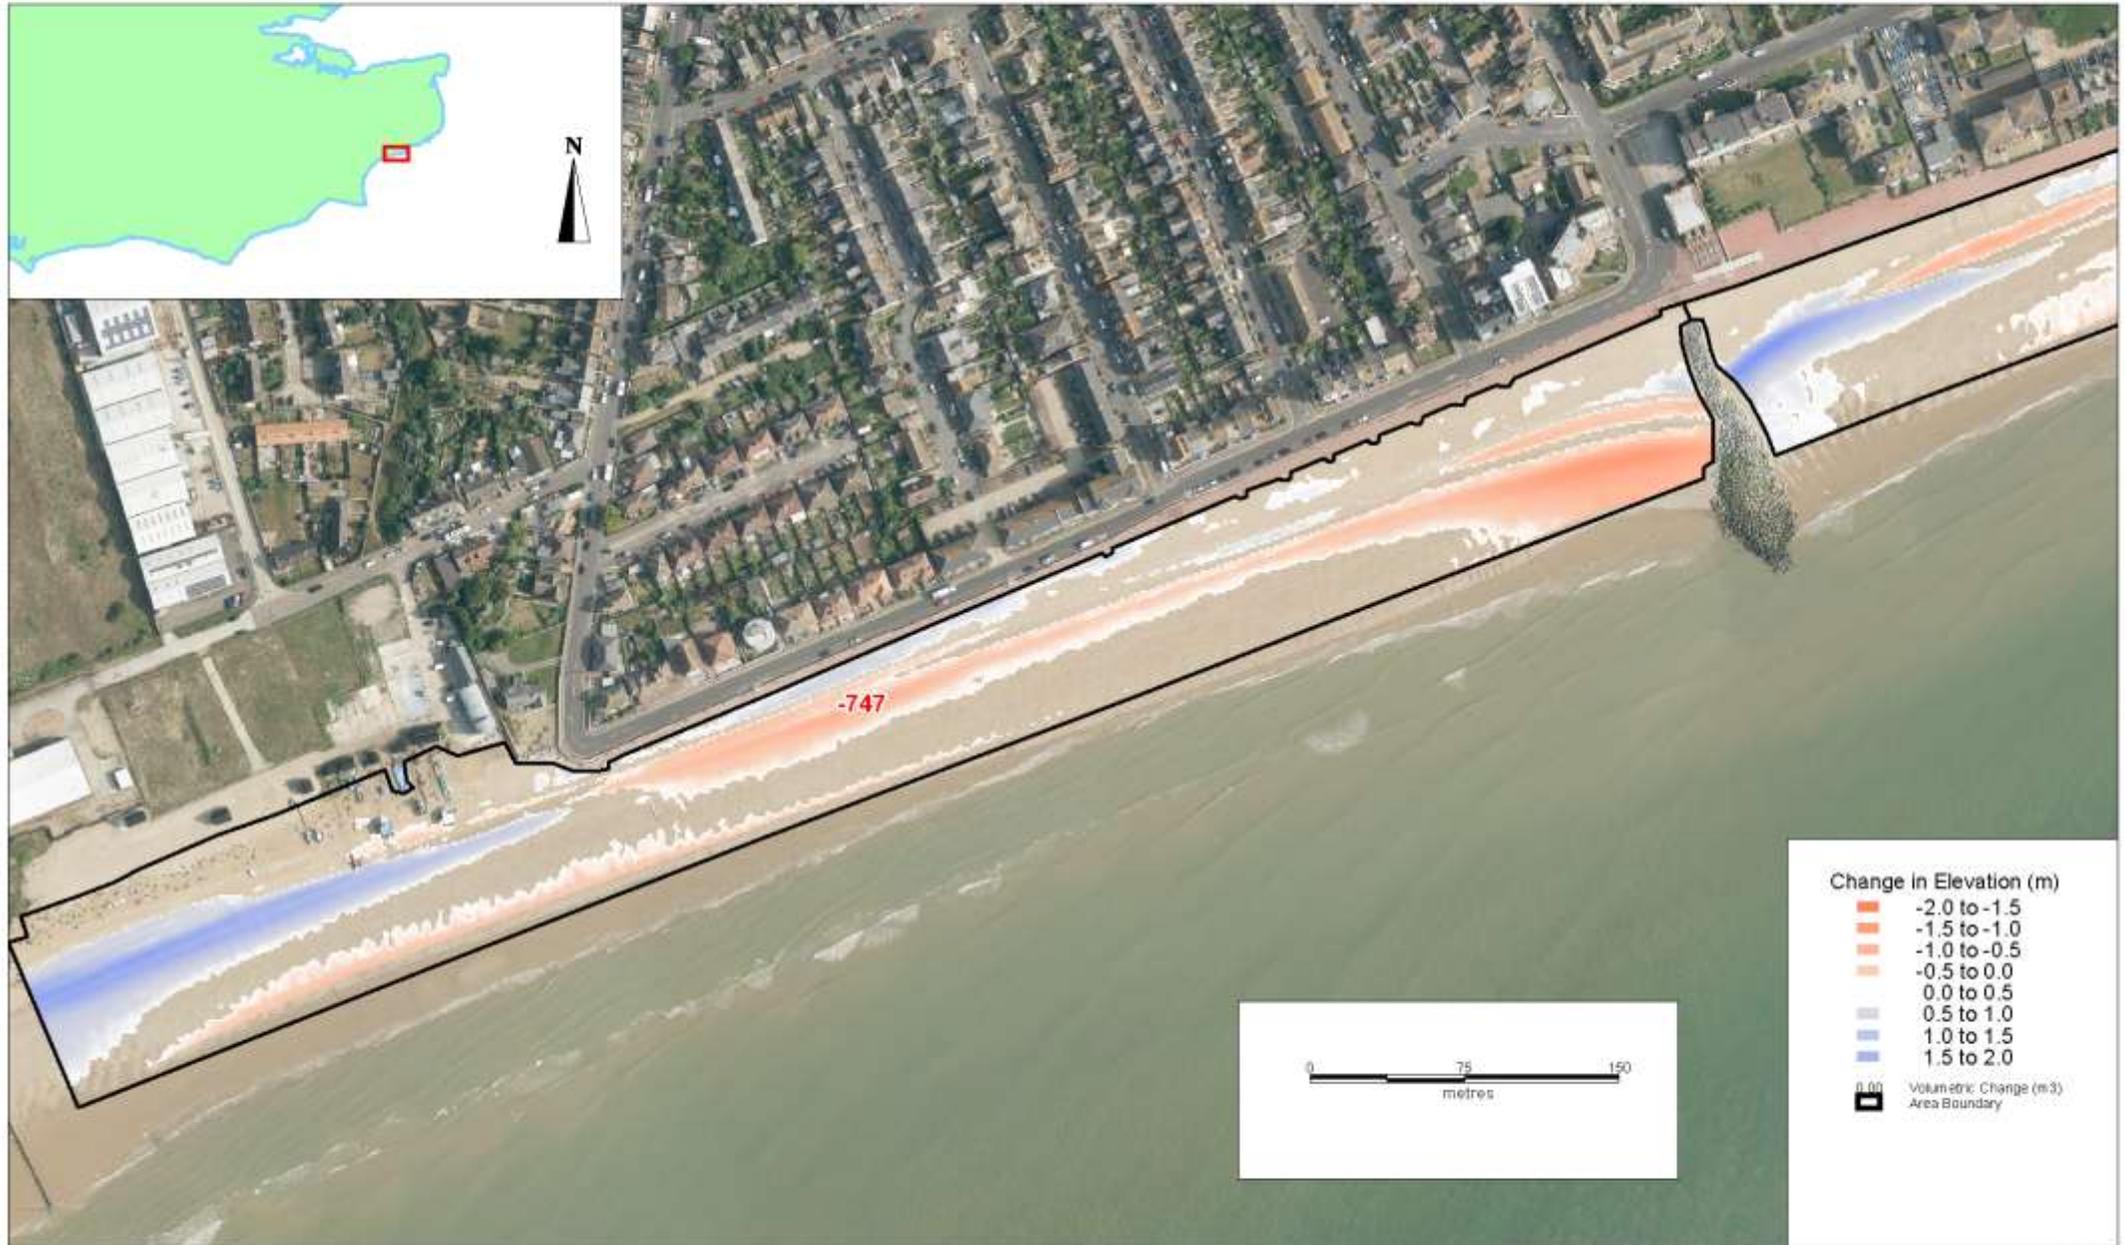
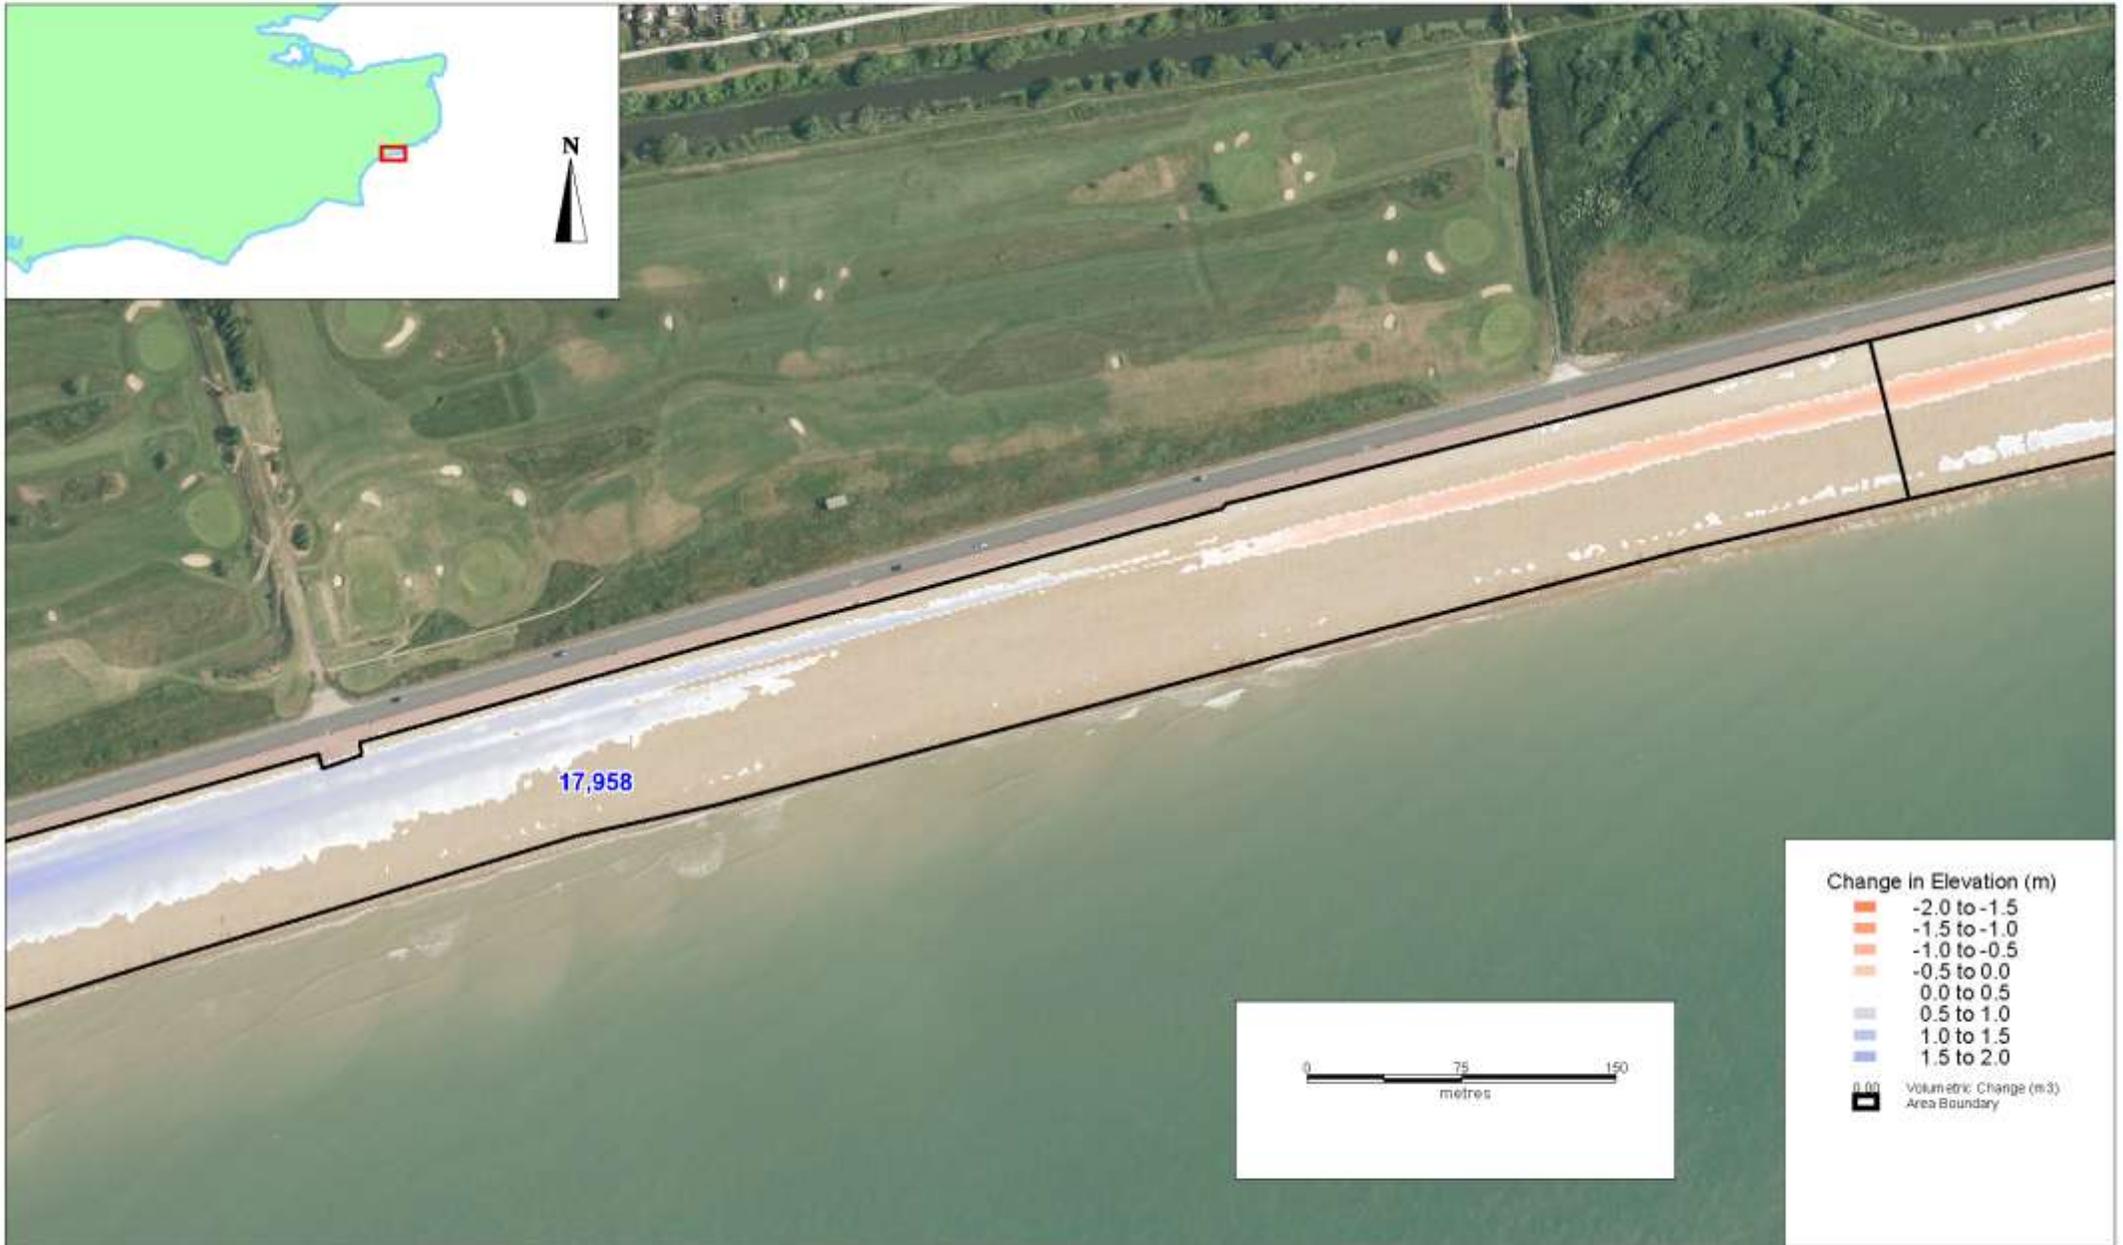
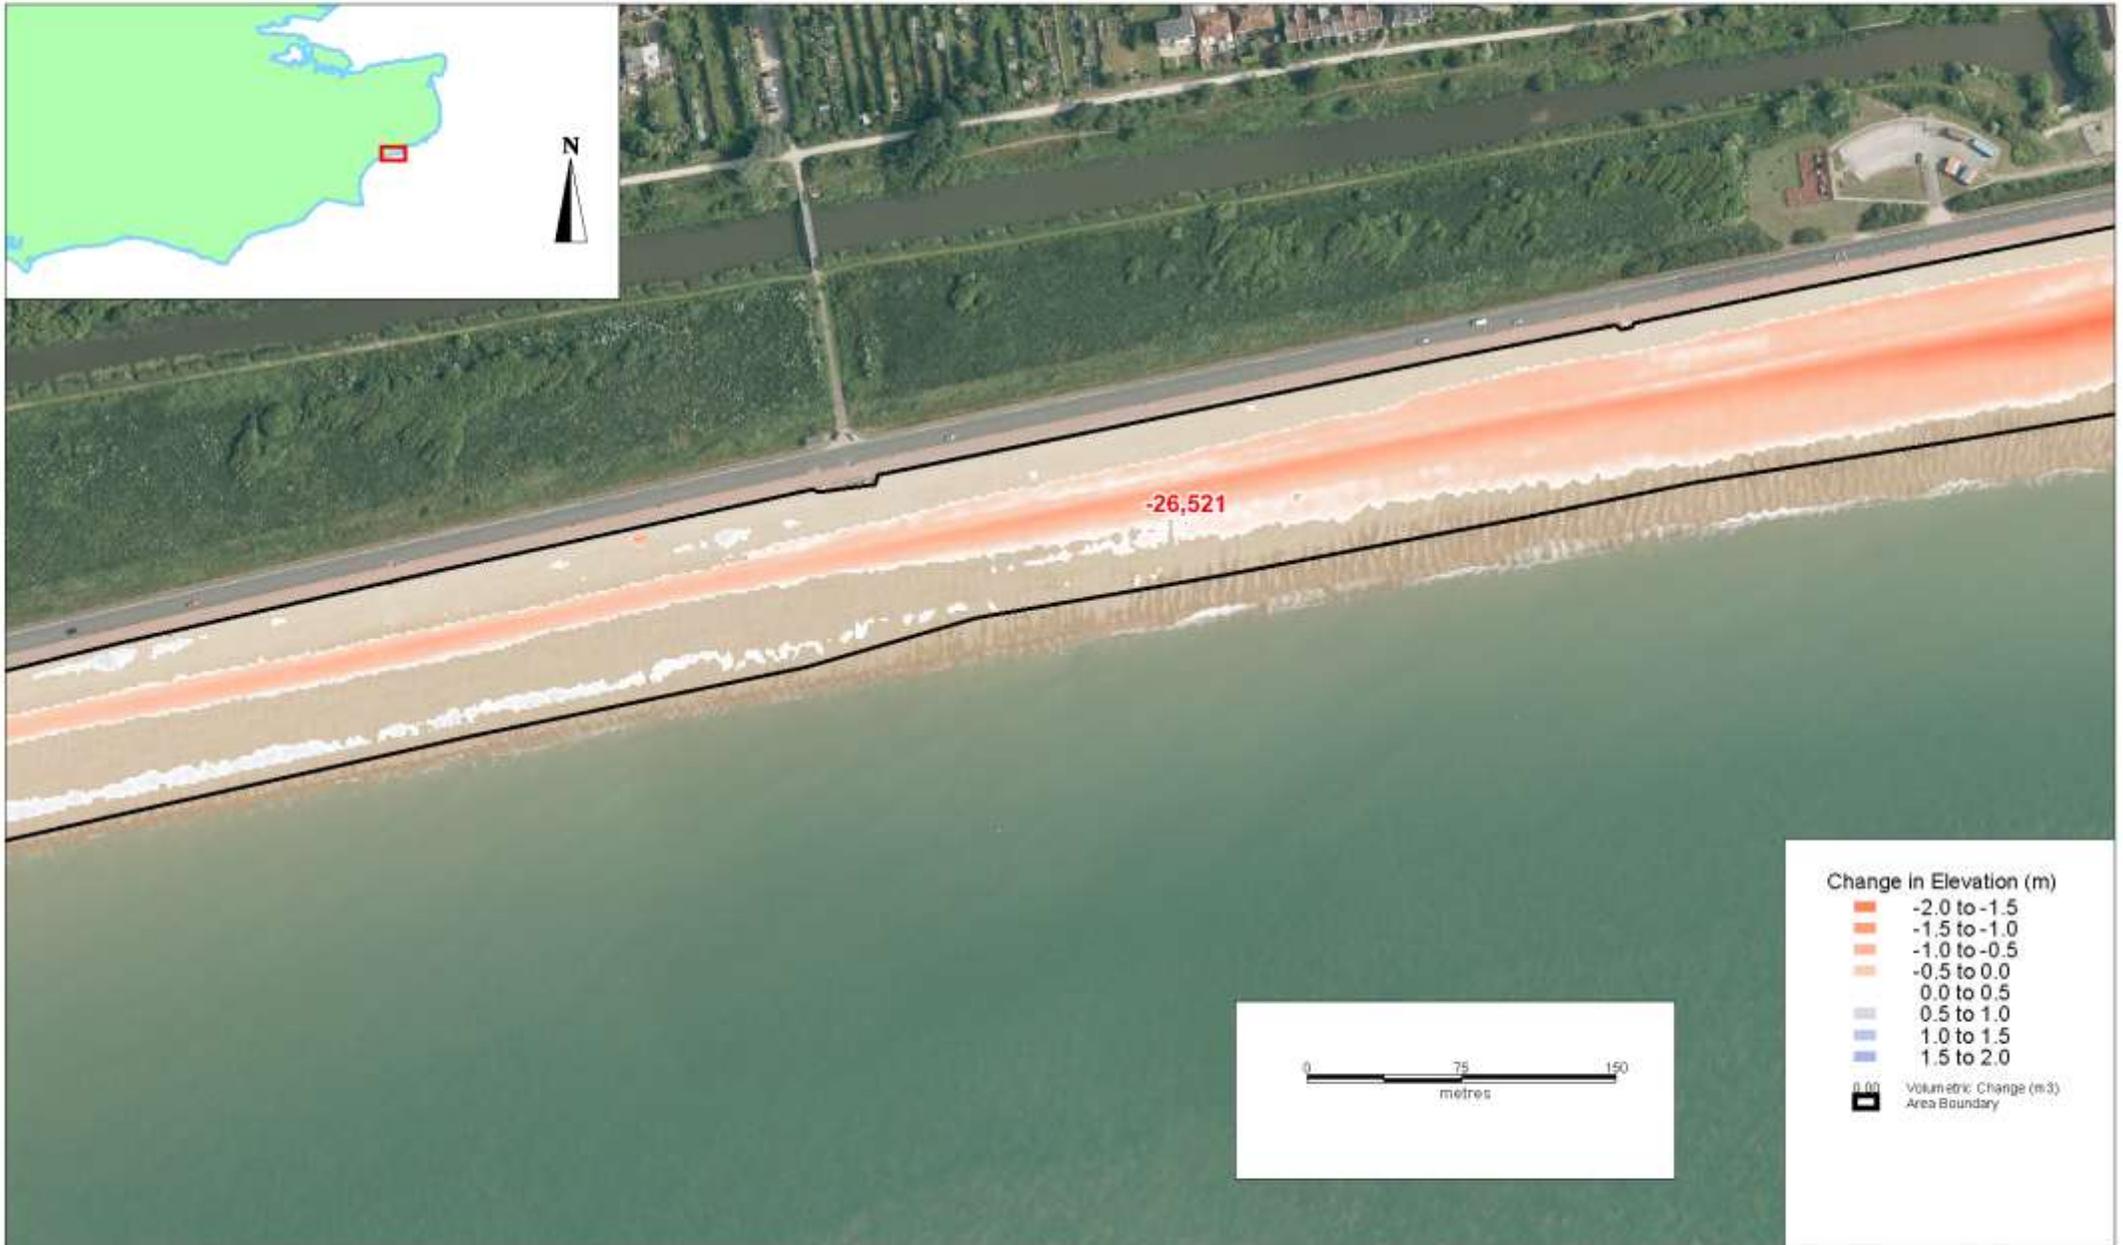
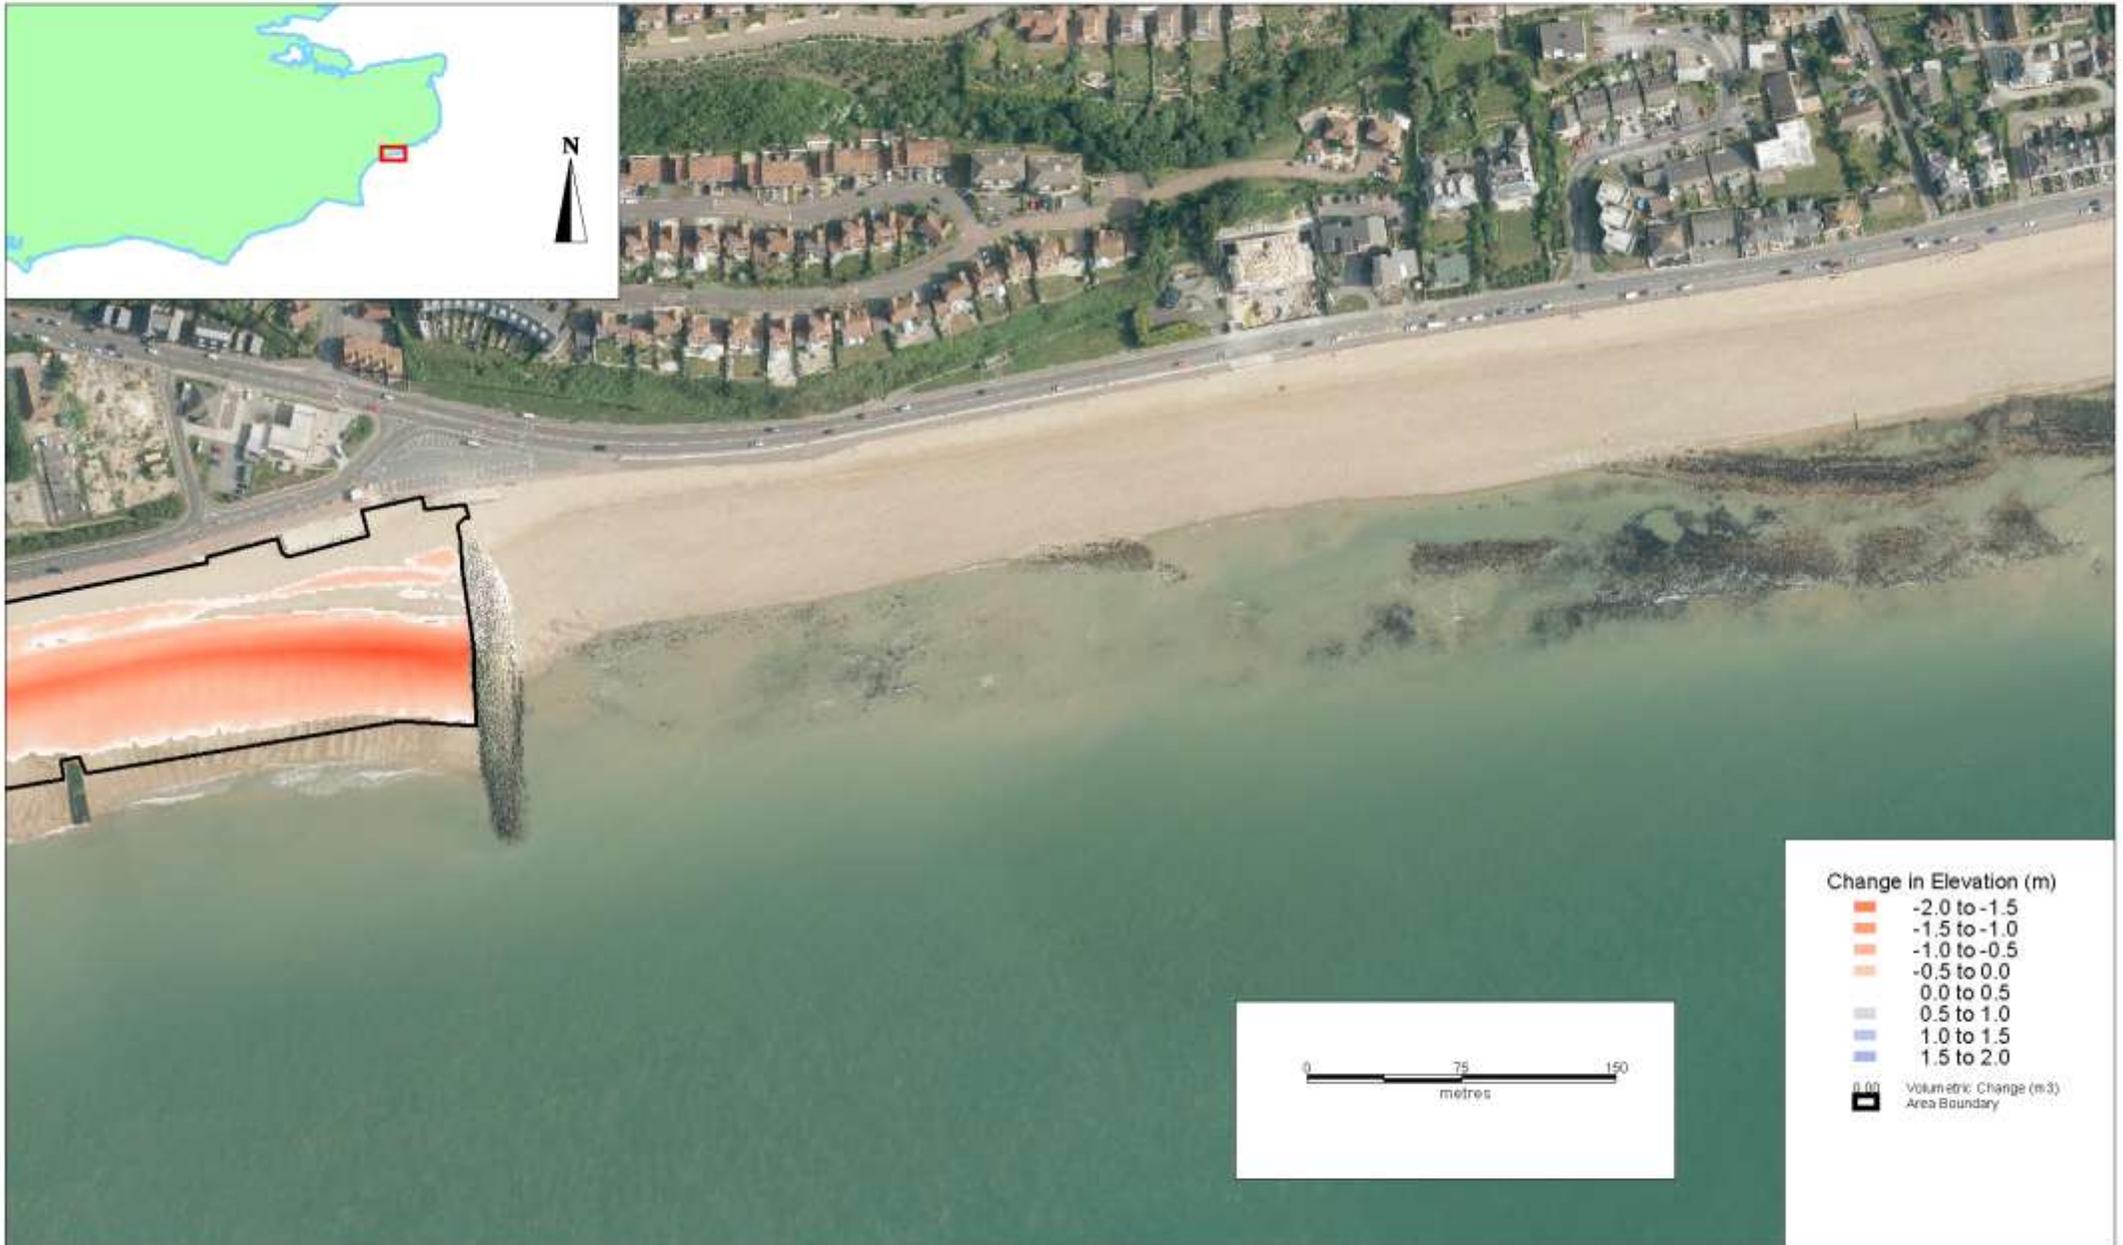
To aid purposeful analysis the survey unit has been split into four sections as depicted in the diagram overleaf. These reflect changes in beach configuration and/or the presence of terminal structures. In the context of this report, beach change will be described in these four sections; these being labelled one to four, passing from west to east.
