BEACH MANAGEMENT PLAN REPORT

Sandgate and Folkestone

BMP186

Document Title: **Beach Management Plan Site Report 2013**

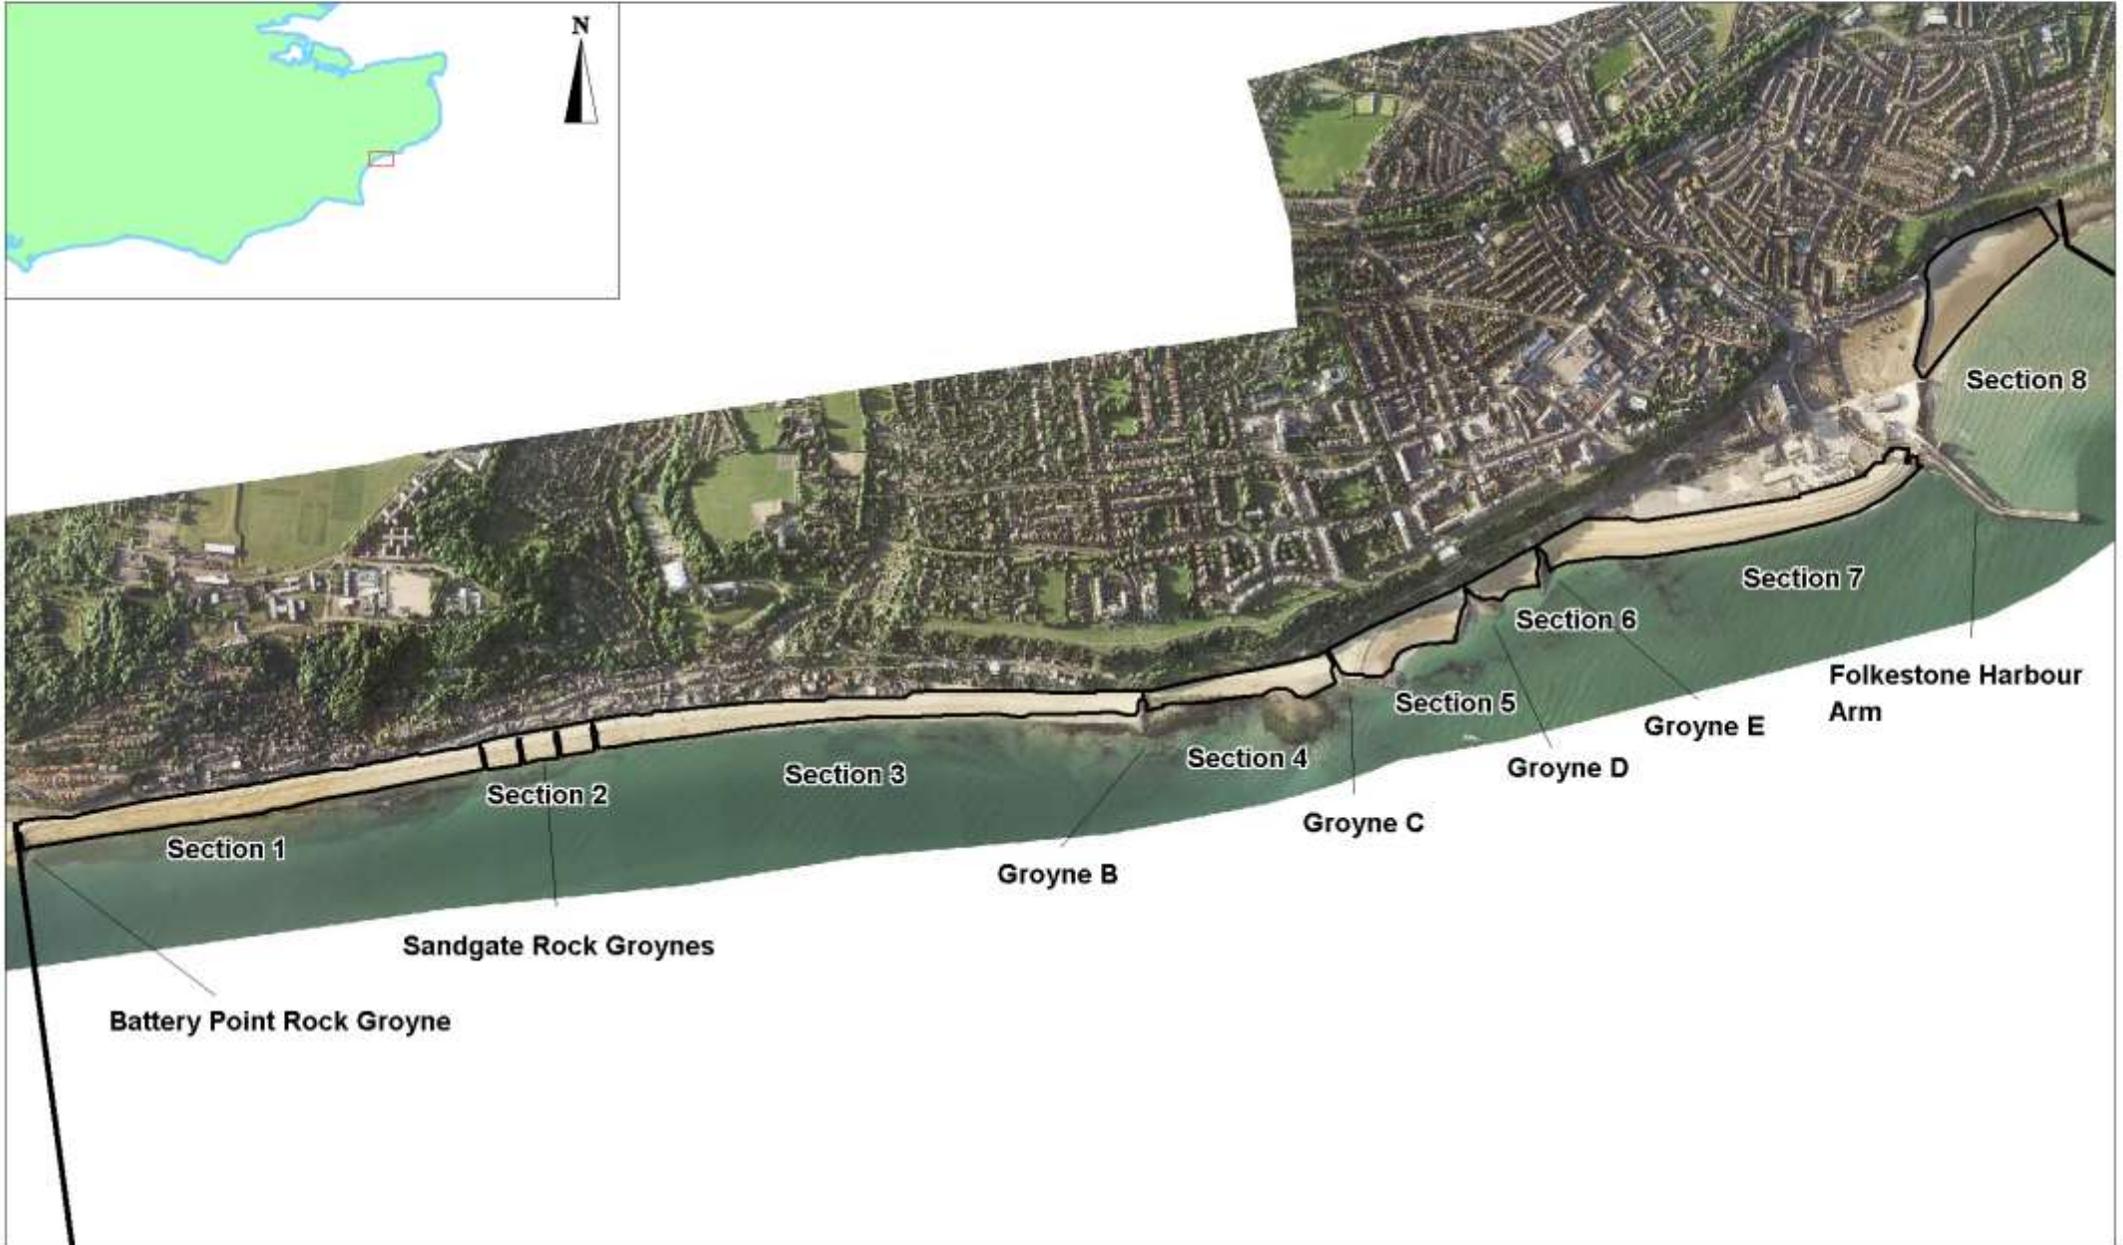
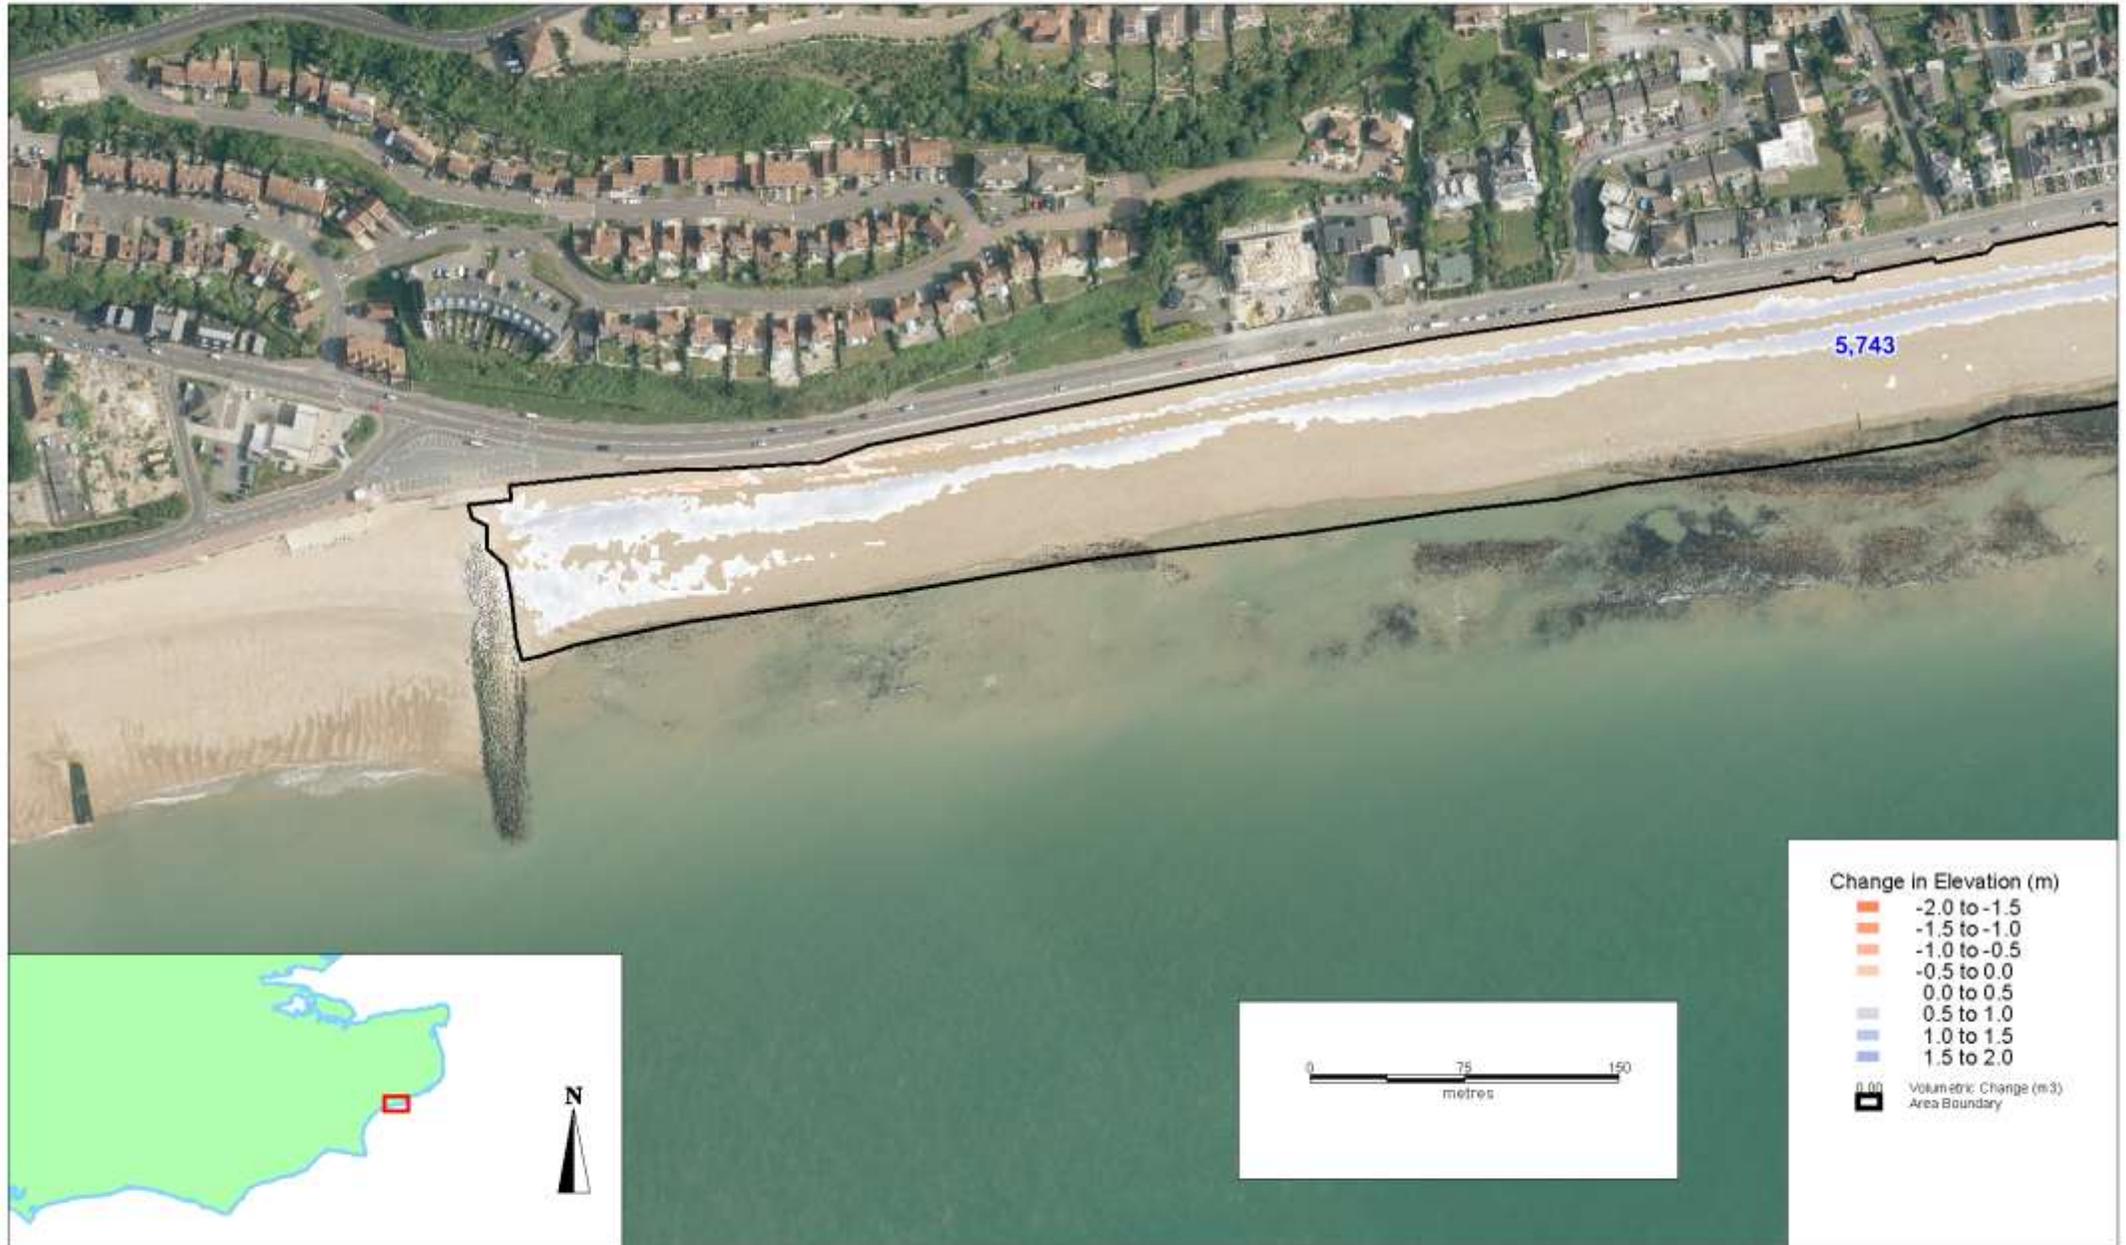
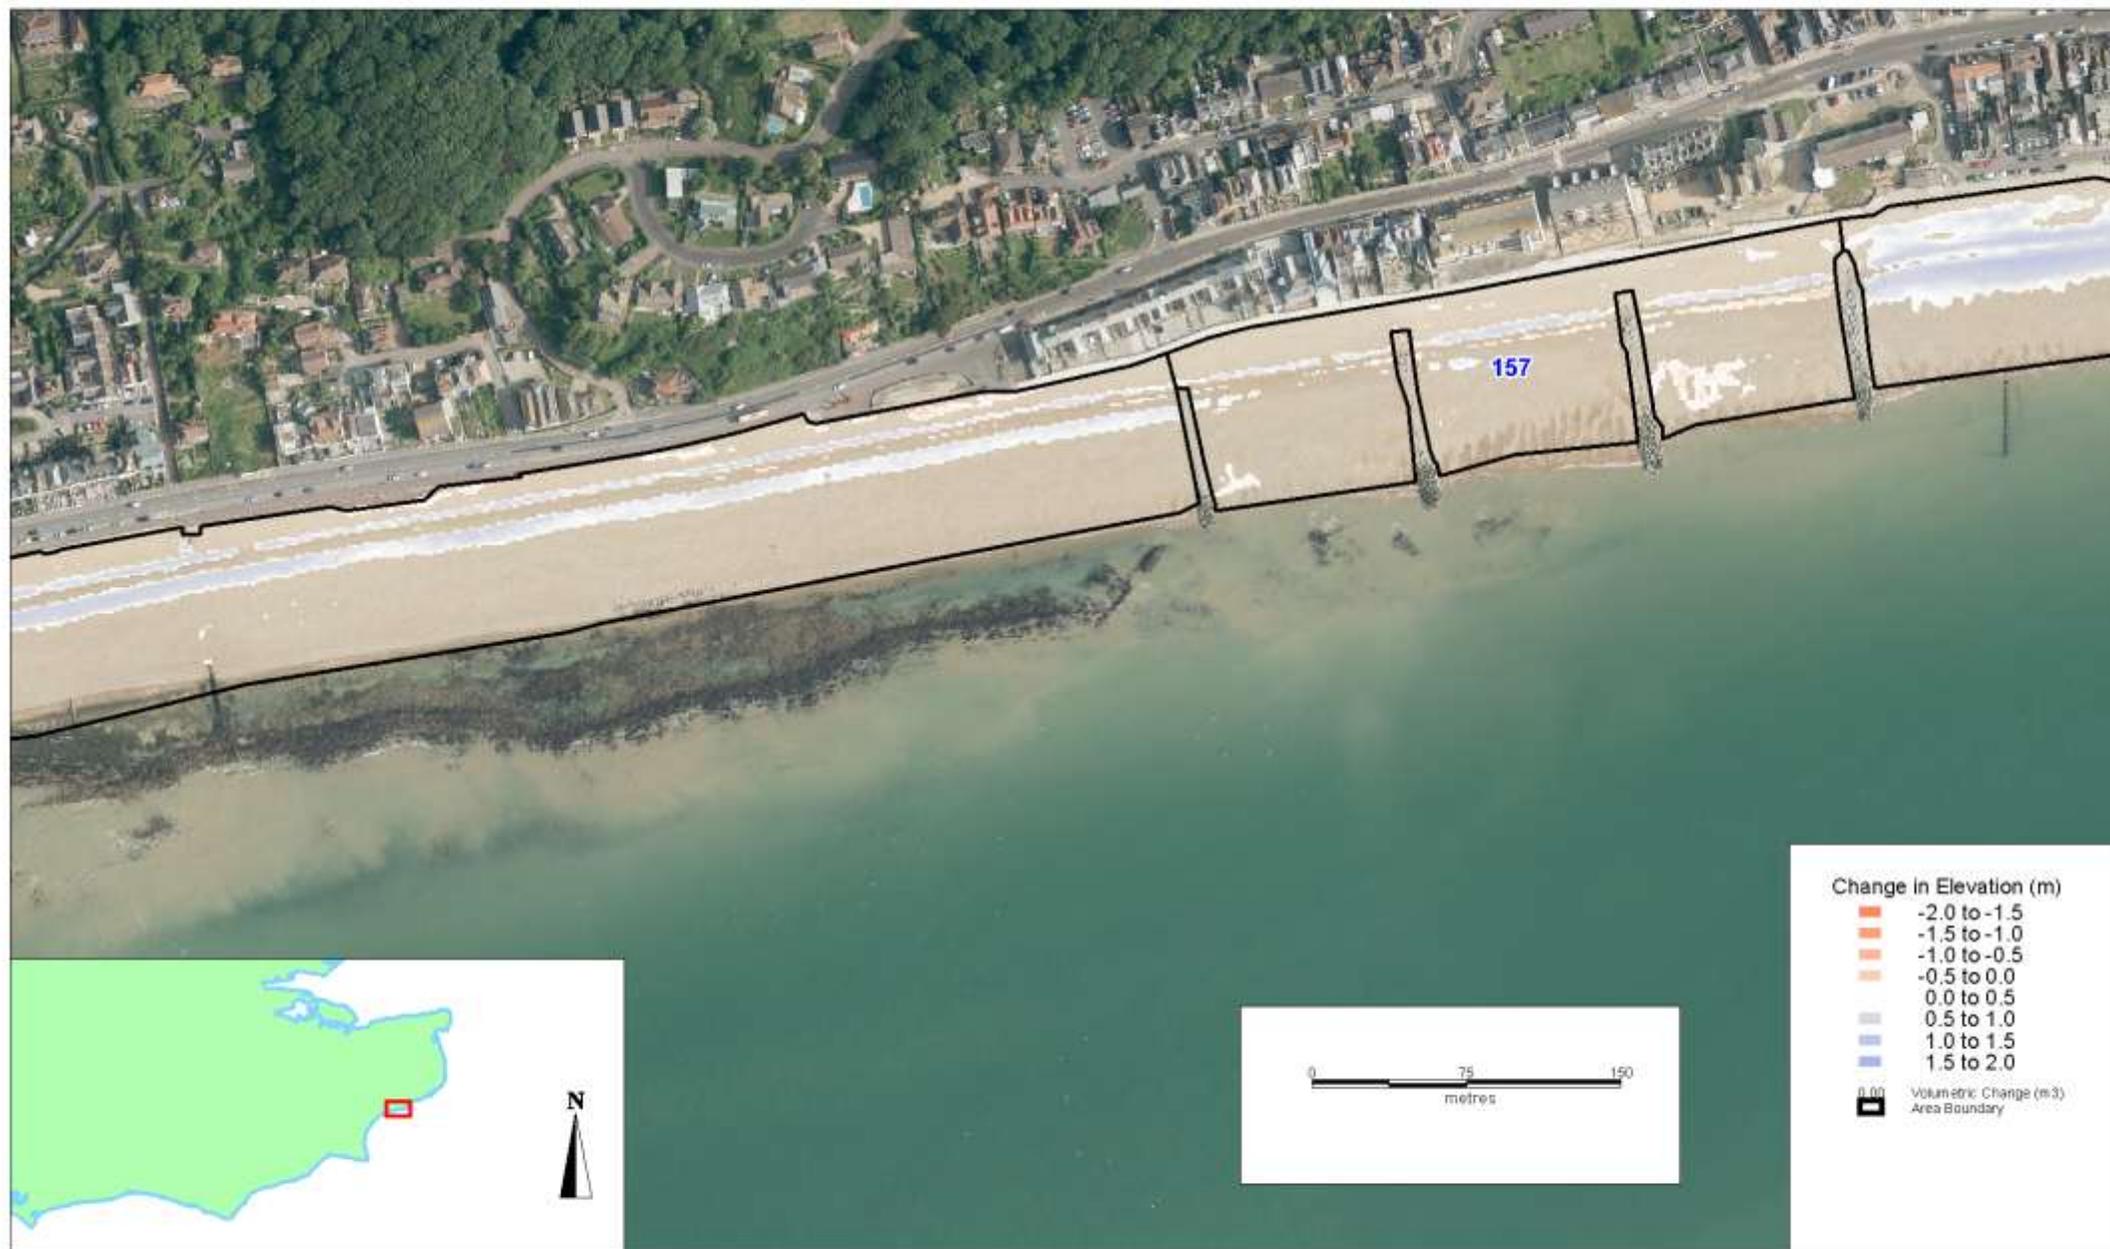
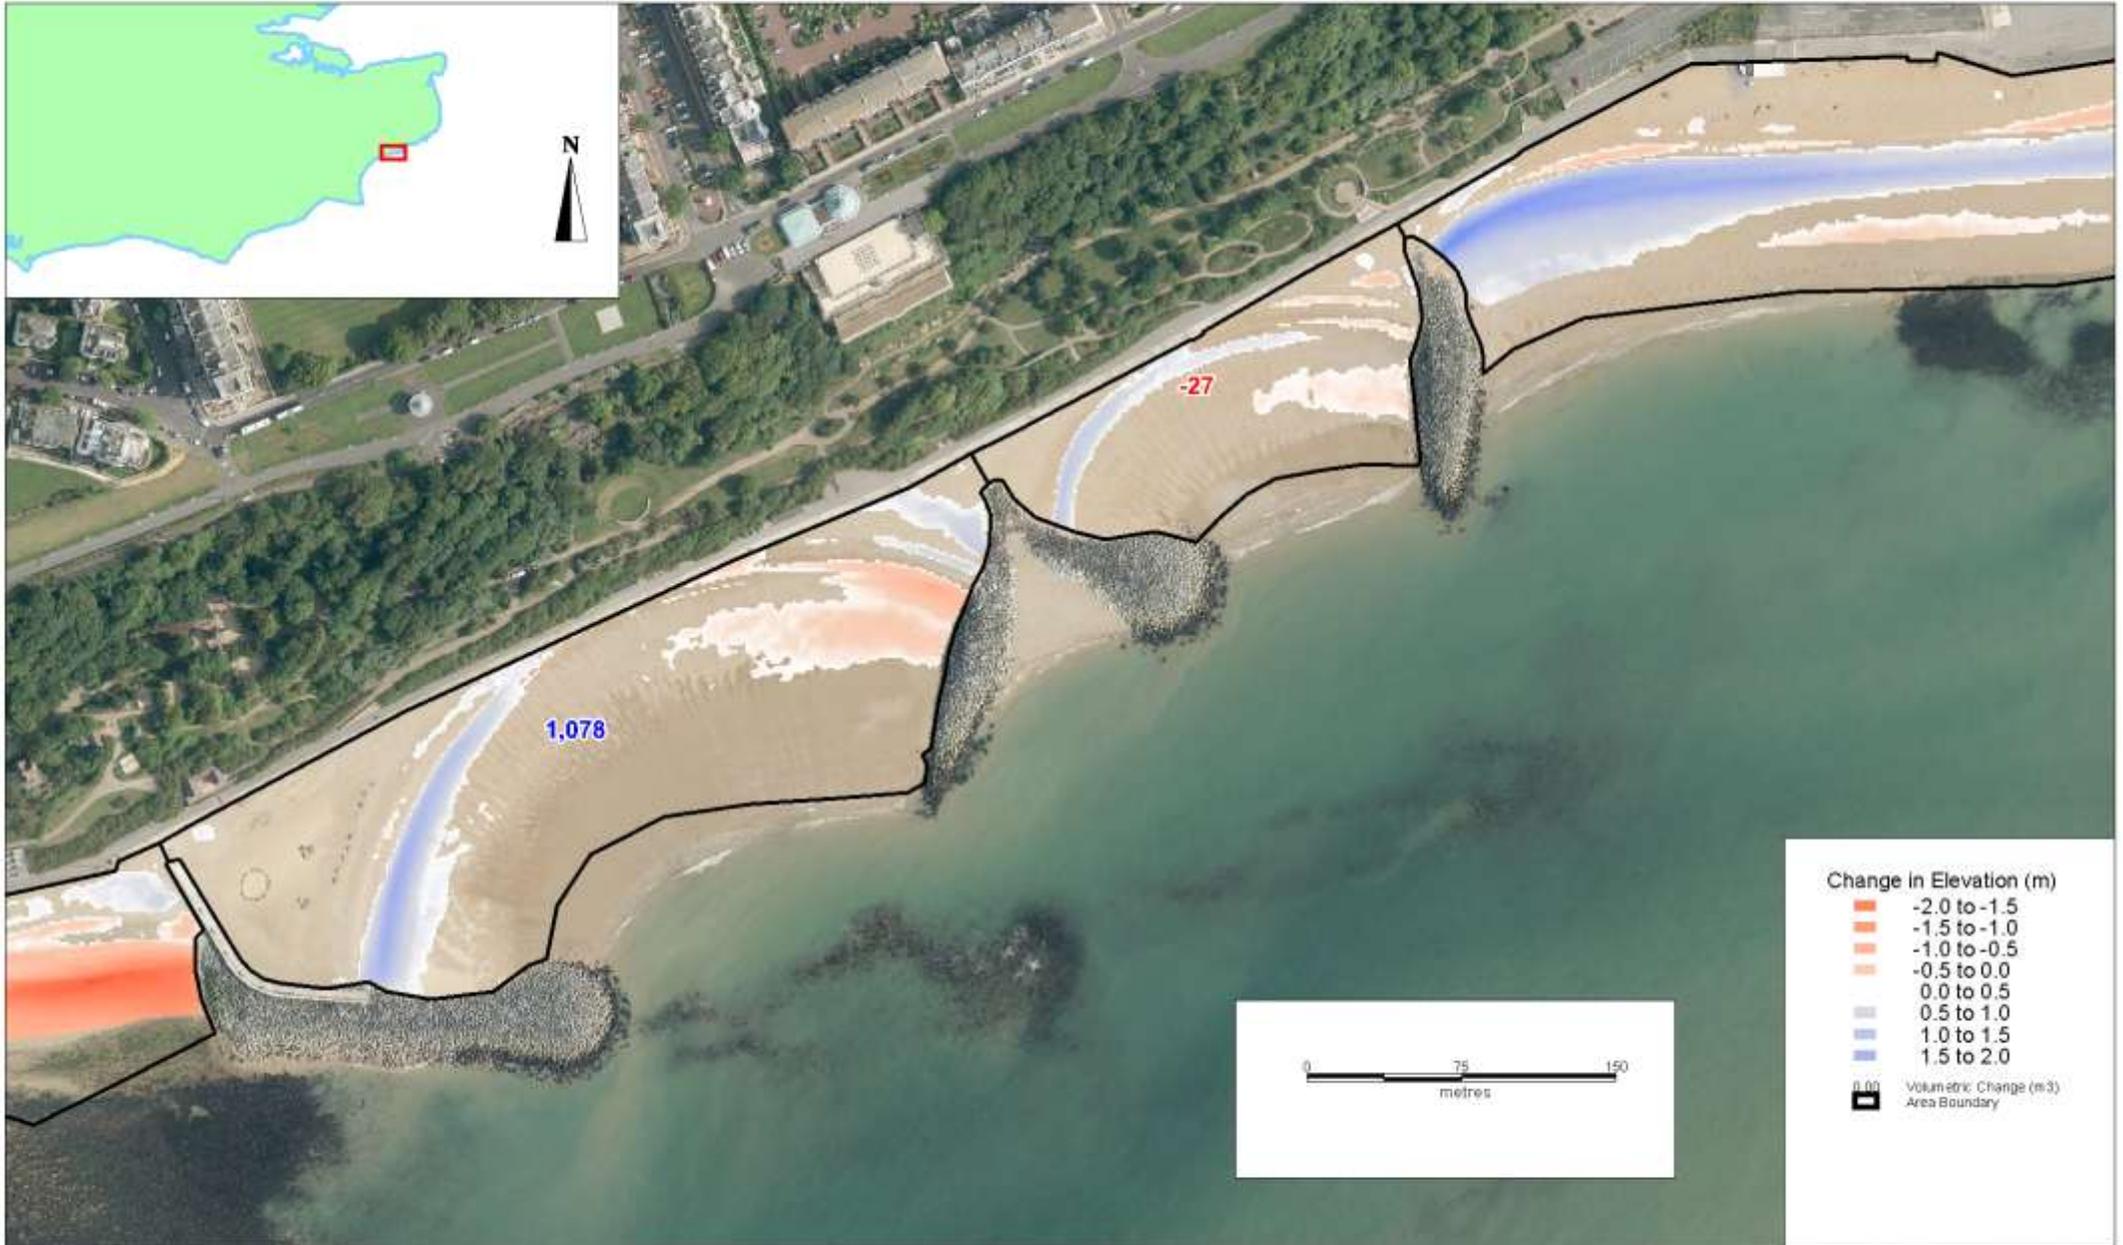
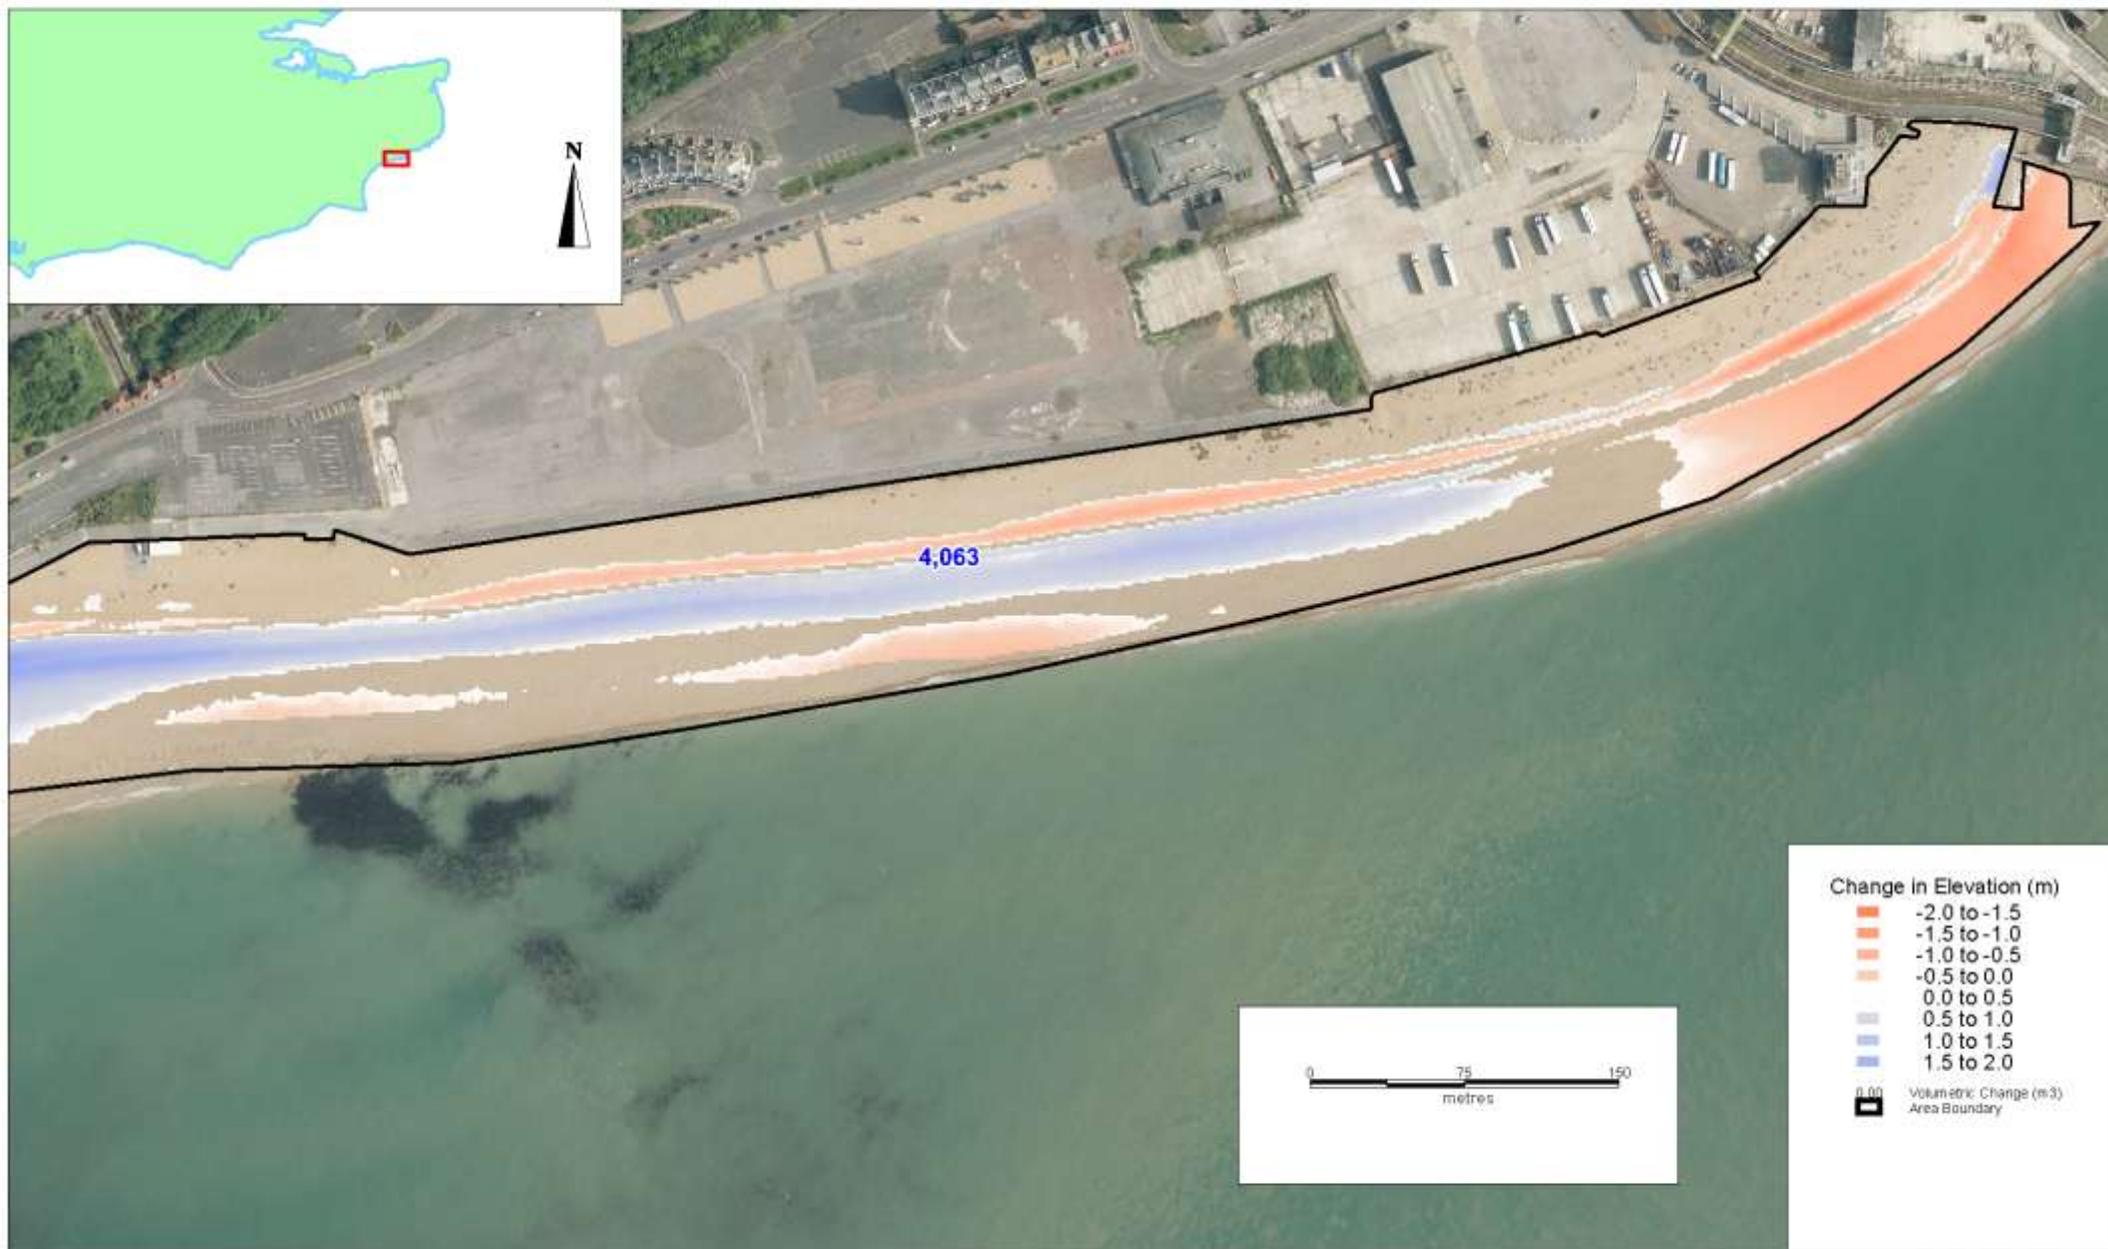
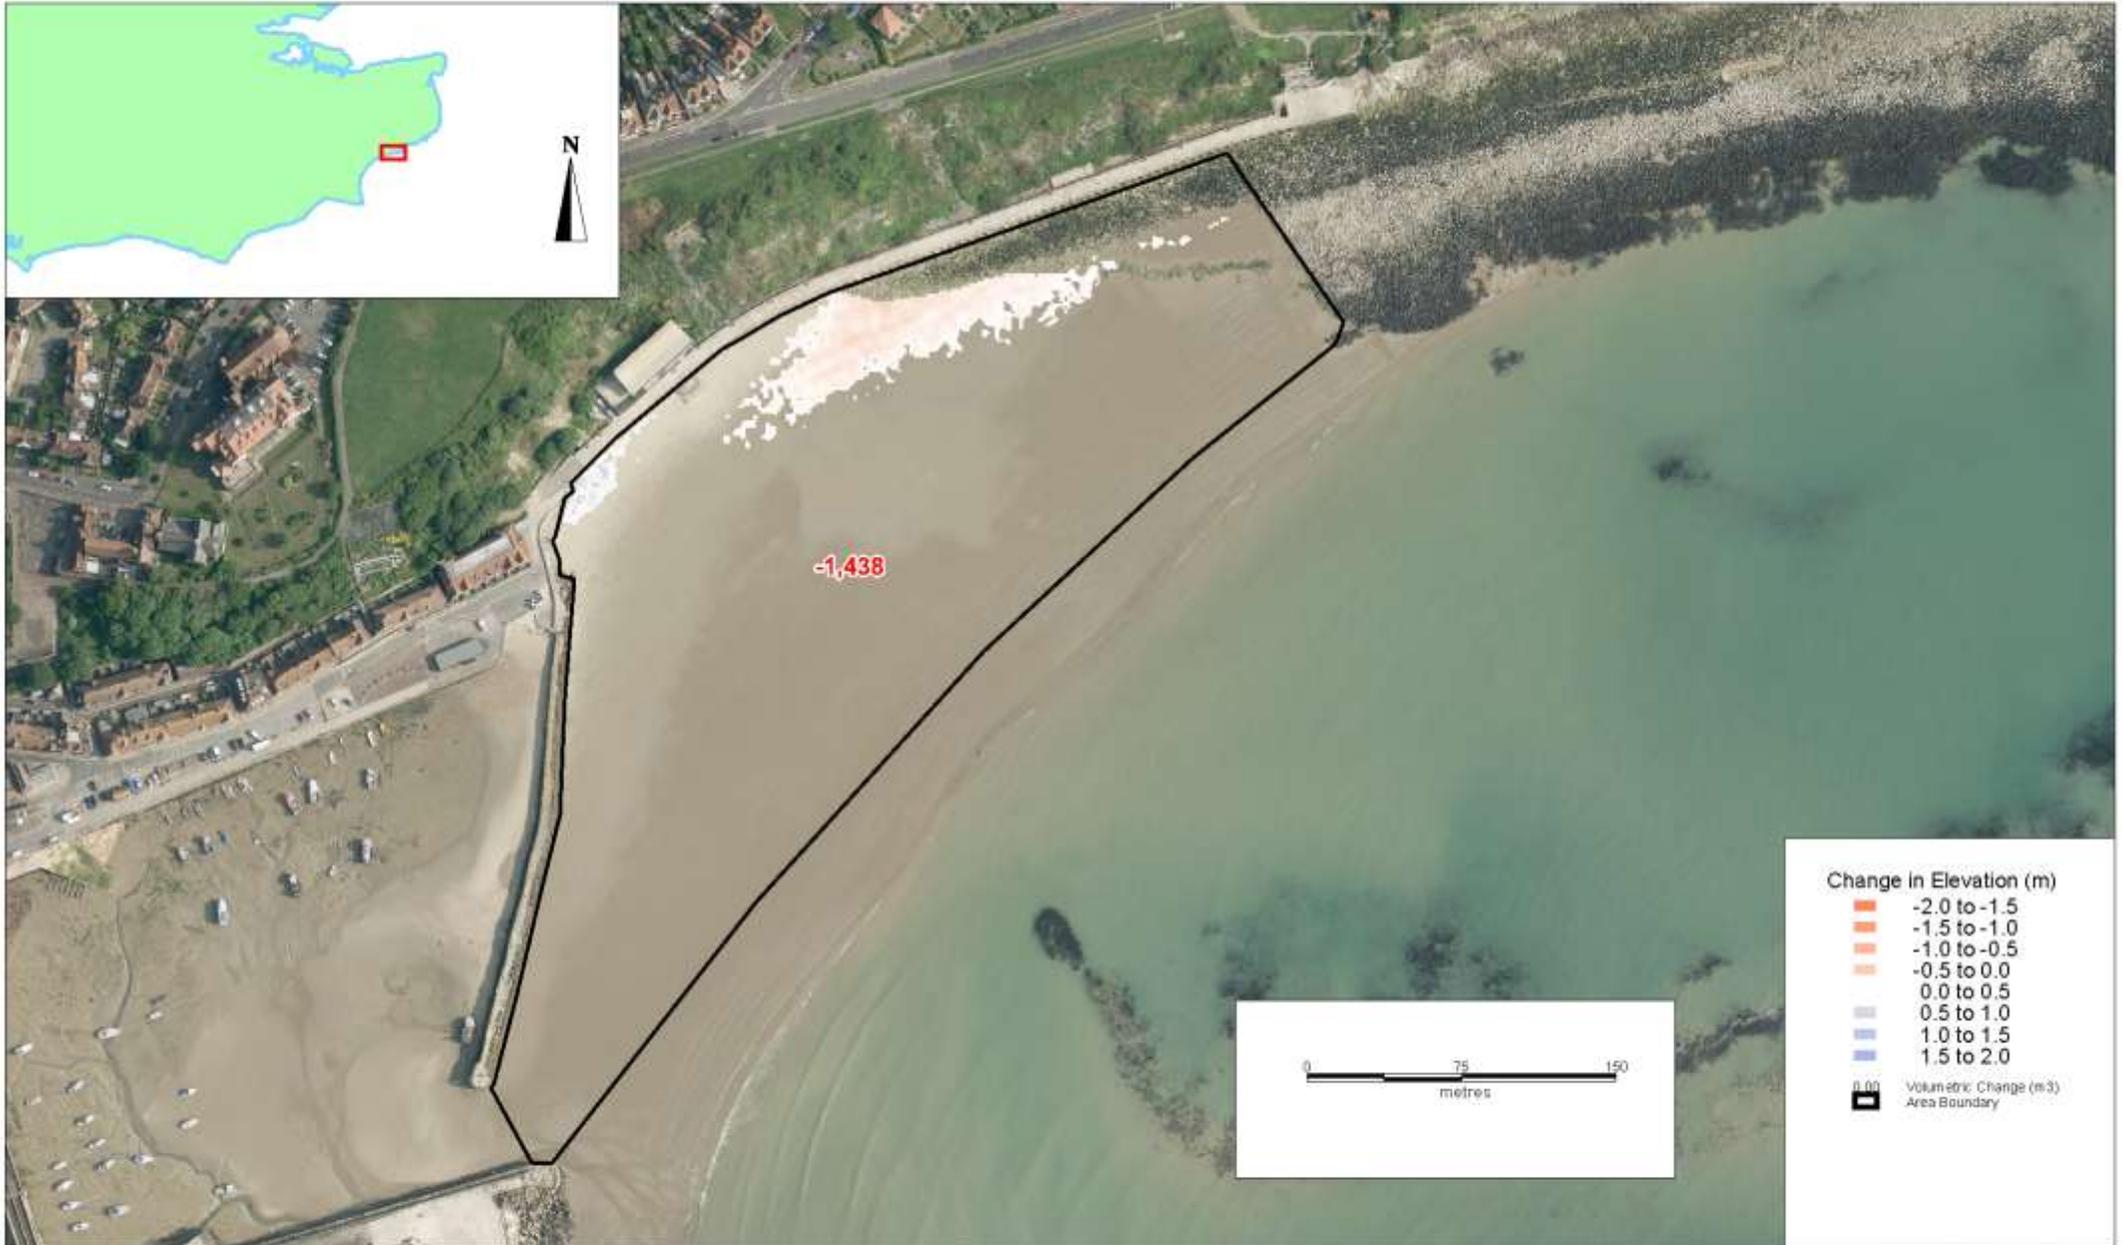
To aid purposeful analysis the unit has been split into eight sections as depicted in the diagram overleaf. These reflect changes in beach configuration and/or the presence of terminal structures.

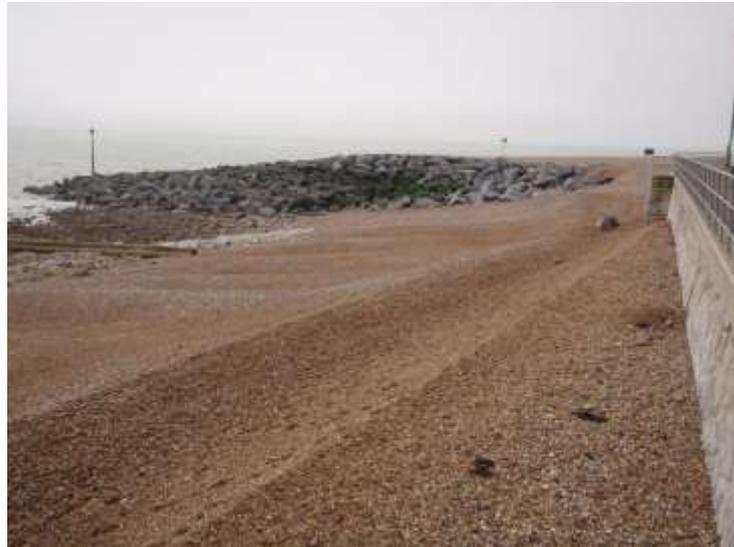
Figure 5: Photograph of beach draw down in lea of groyne B.

Section 4 extends between Groyne B and Groyne C. The leeward side of groyne B has been identified as an area where material rapidly depletes and consequently can lead to the exposure of the short length of rock revetment and foundations at the seawall toe. This is illustrated in figure 5 below.

In the current reporting period this section has experienced a moderate change with the gain of $2,418\text{m}^3$. The difference model shows the influence of the recycling operations has on this section, the eastern end shows significant accretion which opposes the longshore drift movement. During the Autumn of 2012 and Spring of 2013, approximately $19,500\text{m}^3$ of shingle had been recycled in this section. From this, it is apparent that these recycling works were able to maintain the overall sediment budget in this section. Future recycling volumes in this section will need to be maintained or increase to maintain an equilibrium sediment budget.

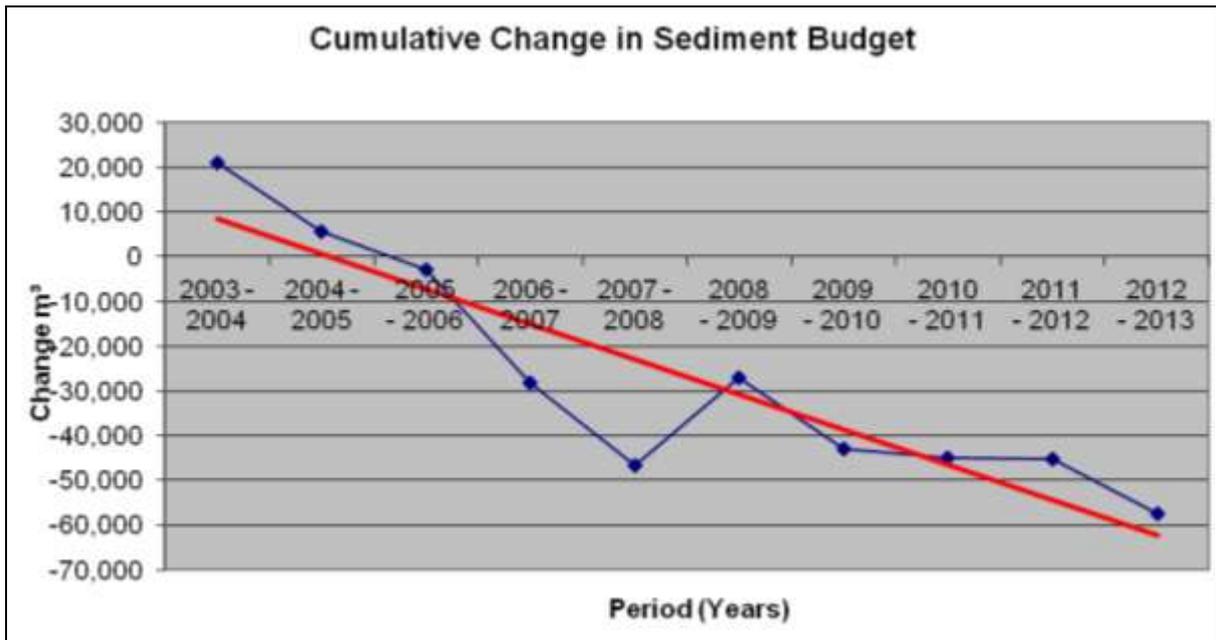
Figure 6: Cumulative change in the sediment budget for SU09.

When looking at the cumulative change in sediment budget as shown in figure 6 below, it is clear that this Survey Unit continues to loose material at a relatively constant rate. Trends indicate a continuation of erosional processes in the immediate future which will cause the standard of protection to fall. It is imperative that monitoring continues and that design volumes are established to identify when critical thresholds are met and thus initiate when any emergency works are required.

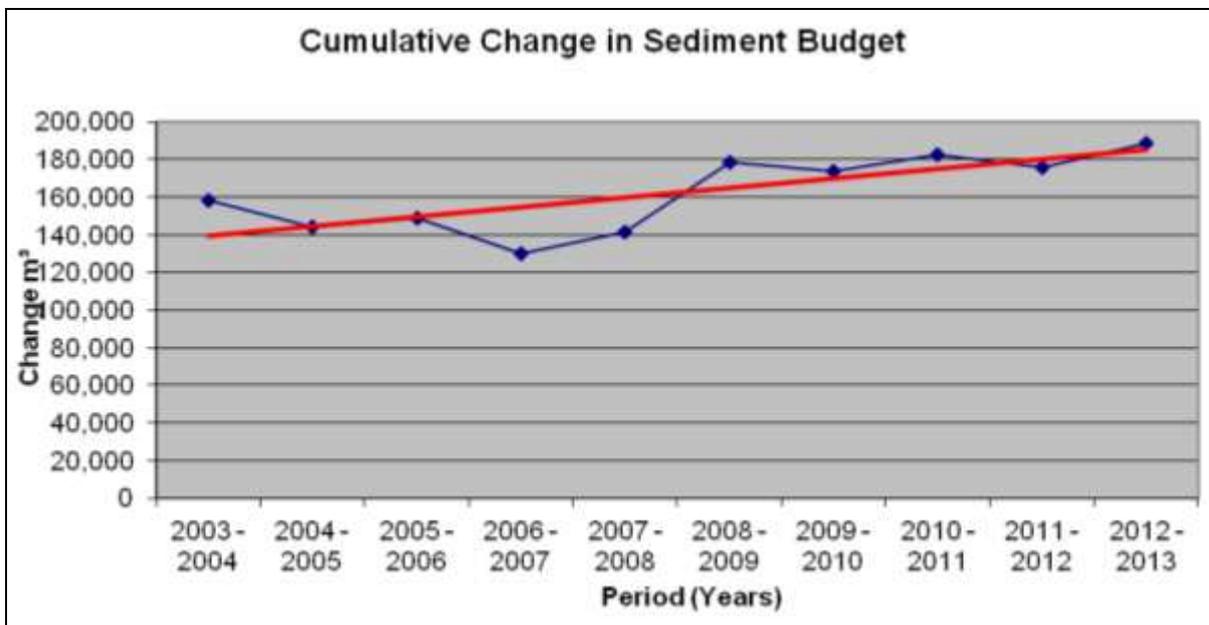
Figure 7: Cumulative change in the sediment budget for SU08.

It is apparent that there has been a net gain in survey unit of approximately 13,200m³. This can be considered relatively negligible when taking into account the size of this Unit. Figure 7 below charts the cumulative changes in sediment budget for SU08 and illustrates a gradual accumulation of material across the frontage.

It is important to recognise the recycling activities that took place across this Survey Unit during the current reporting period which have aided to reduce longshore loses. It therefore can be suggested that without the recycling works the overall change would have likely resulted in net loses.
