# BEACH MANAGEMENT PLAN REPORT

## Dungeness Power Station

Document Title: **Beach Management Plan Site Report 2013**

Reference: **BMP 183**

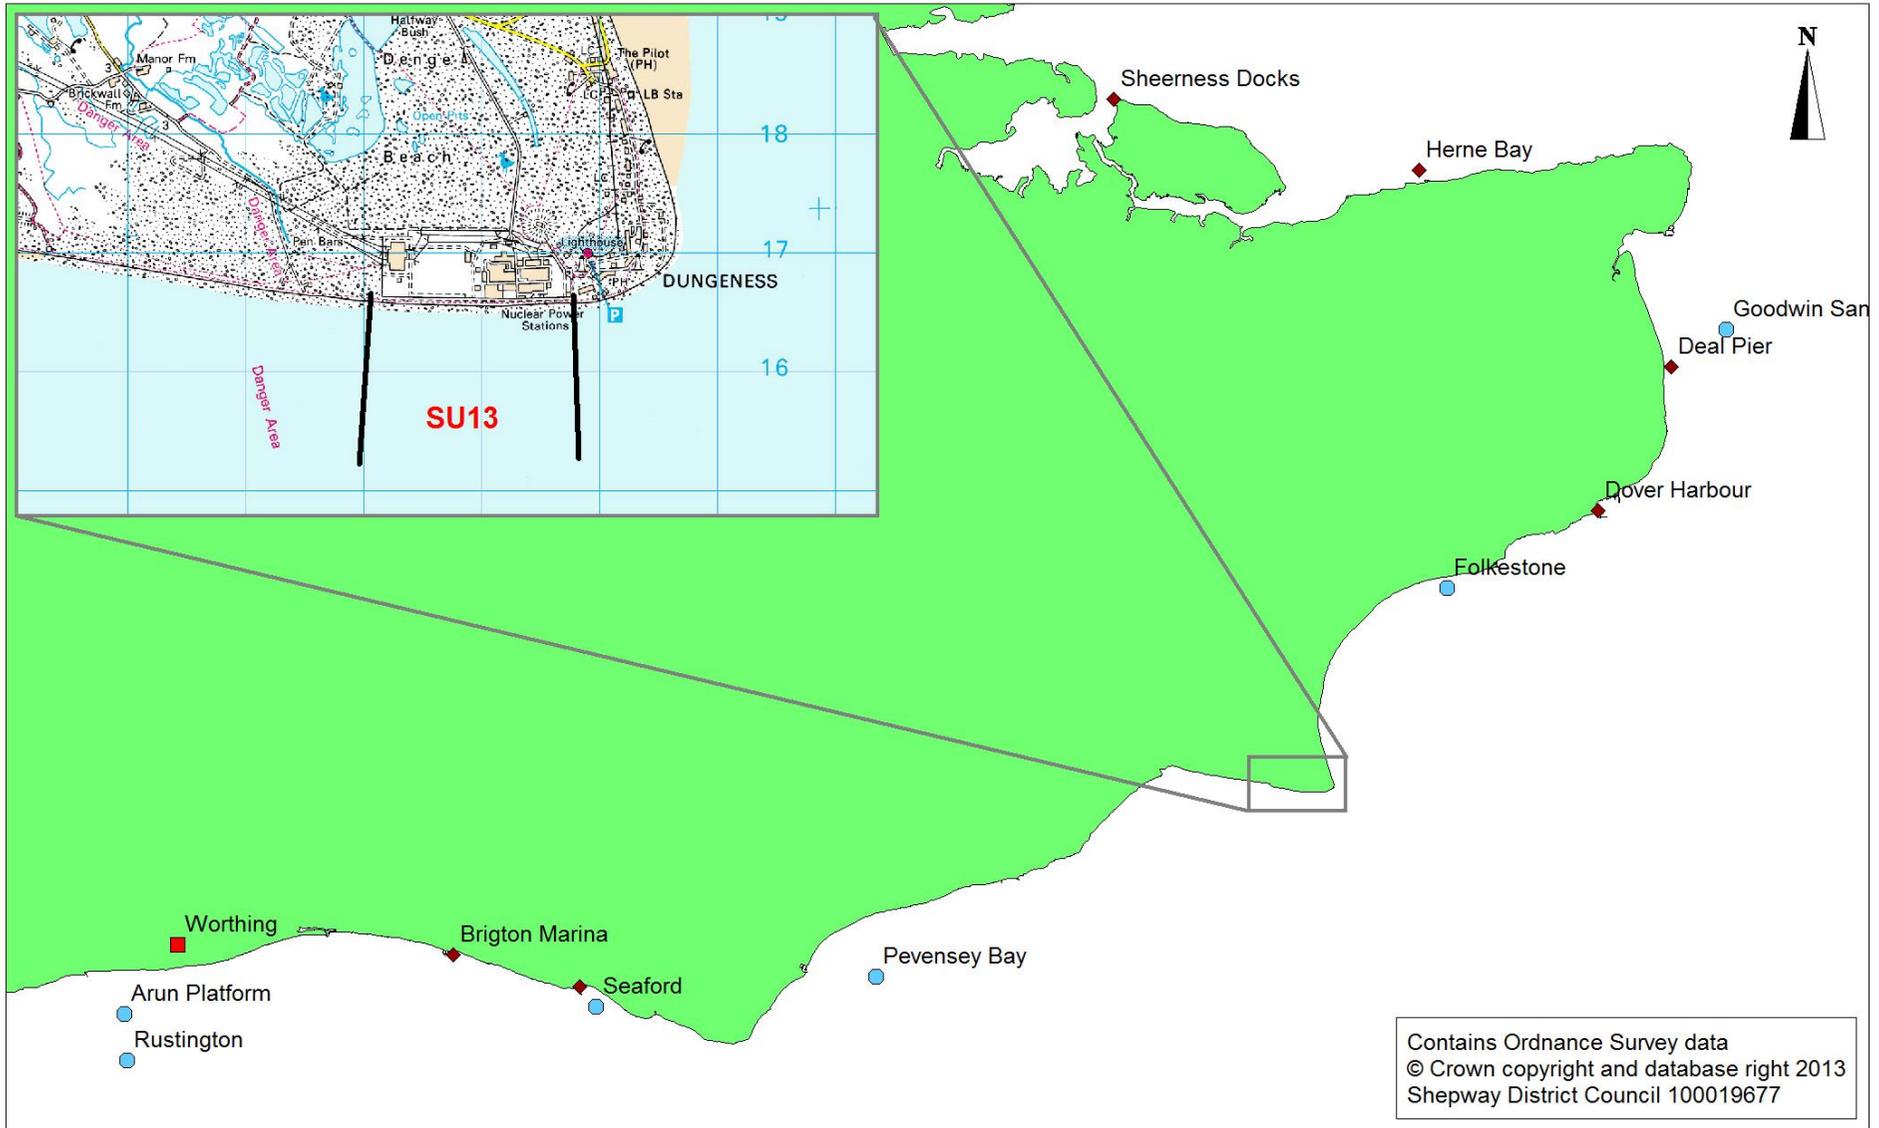
Figure 1: Site Location and Wave/Tide Gauge

The location of the frontage is shown in Figure 1 and also includes the nearest wave buoys and tide gauges.

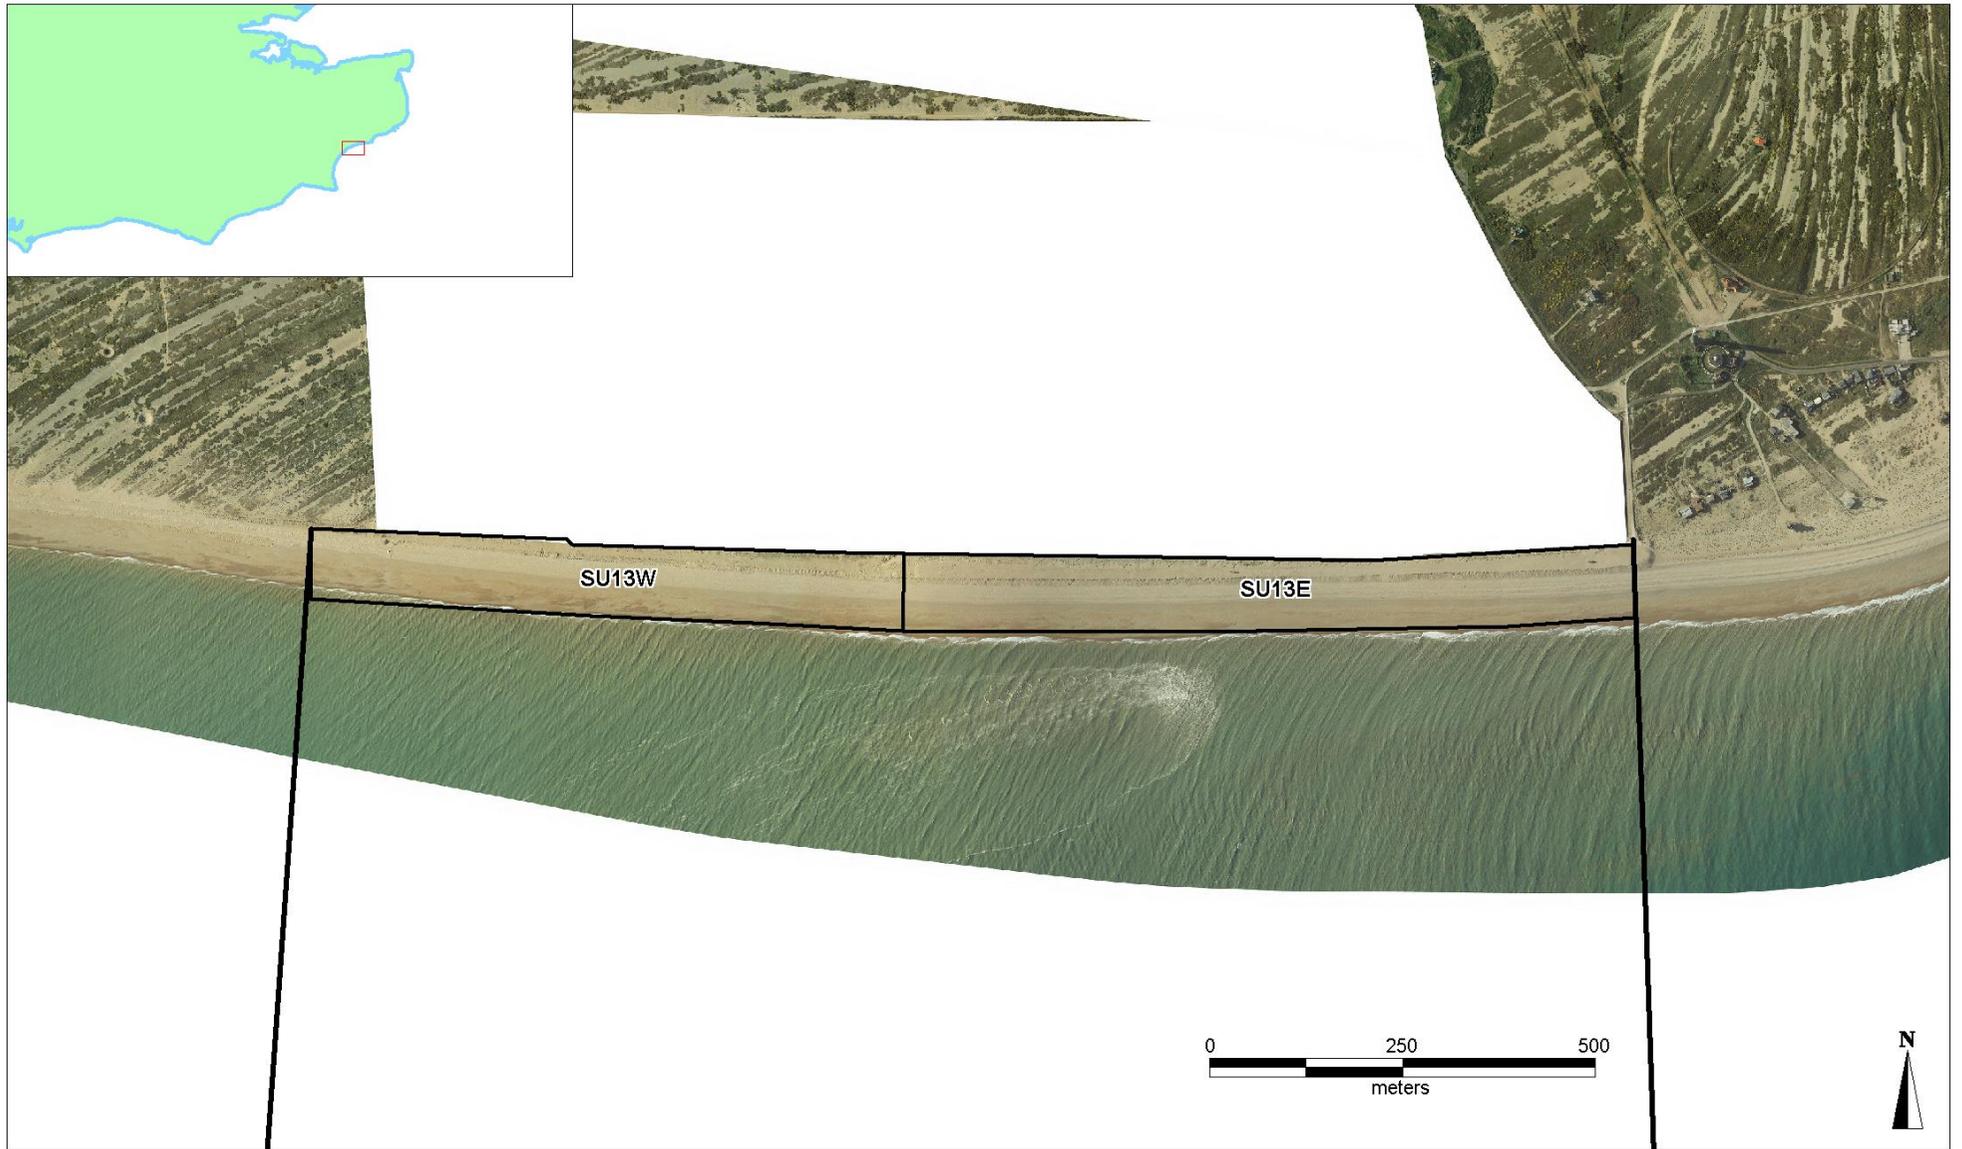
Figure 2: SU13 beach analysis sections

Unlike the majority of other coastal monitoring reports, this relatively short frontage is only divided into two individual sections for analysis. The boundary between SU13W and SU13E is derived from recycling data submitted by Halcrow (the boundary is located at profile 4c00787).

Beach Management Plan Site - Reporting Sections

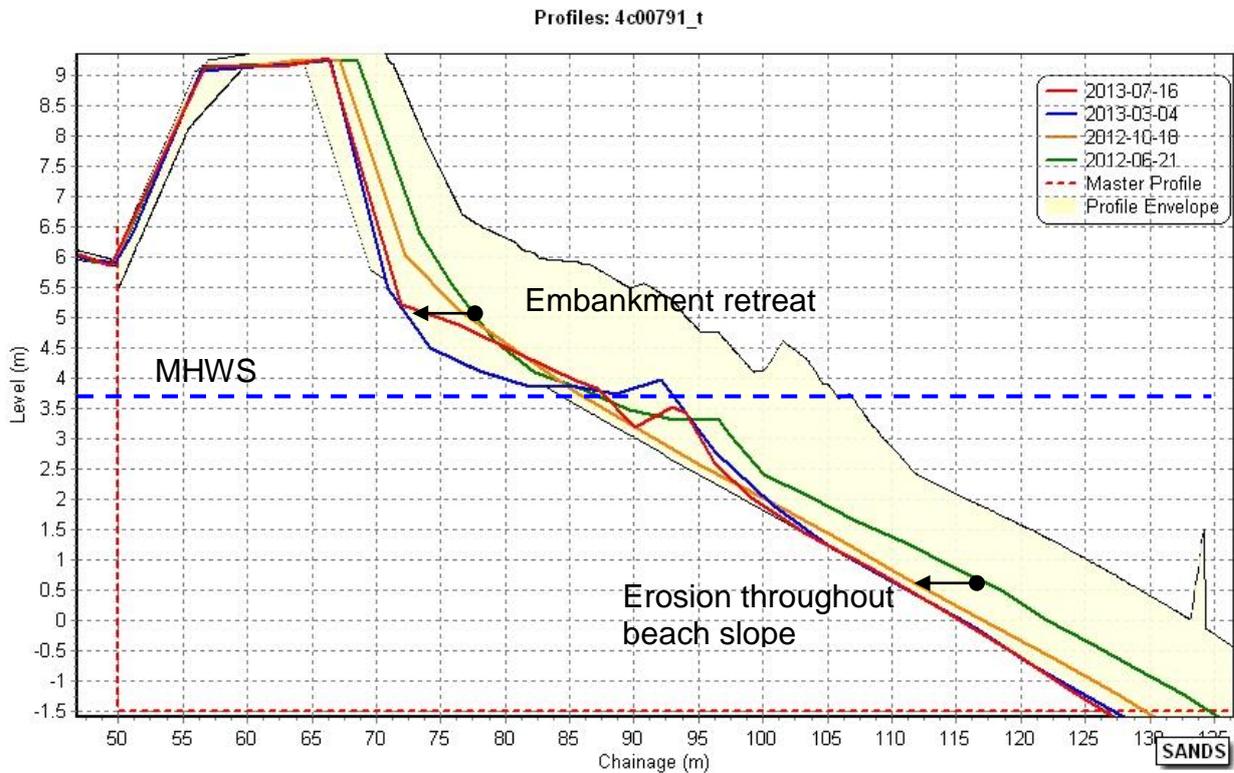
Figure 3: Cross sectional changes at profile 4c00794

During the 2012-2013 reporting period this section has seen a seventh consecutive year of net erosion with the loss of approximately 16,500m<sup>3</sup>. The rate of erosion is in keeping with previous years and supports a relatively consistent rate of material loss. The loss of material has primarily occurred throughout the beach slope although the embankment has also incurred some losses as shown in figure 3 below.

From Profile 4c00791 it can be seen that between June 2012 and July 2013 the slope of the embankment had retreated by approximately 5m. This loss is consistent throughout the entire height of the embankment indicating the natural angle of repose for the embankment.

The apex of the embankment has largely remained constant over the past few years with the profile envelope indicating the maximum and minimum elevation since monitoring begun. This again reiterates the stabilising effect the annual beach works have in maintaining the embankment height with a maximum deviation of 0.4m across 9 years for data for this profile.

The main area for concern, and main contributor to the net losses indicated in the difference models is the continued loss of material at the crest of the beach in front of the embankment. The profile clearly indicates a further reduction in crest width by approximately 5m. By considering the profile envelope it is also possible to identify that the current position of the beach profile demarks the most landward limit of all profiles since 2003. This therefore indicates that the mobile beach in front of the embankment has the lowest cross sectional area since records began and reflects the degree of erosion that has occurred over the past seven years.

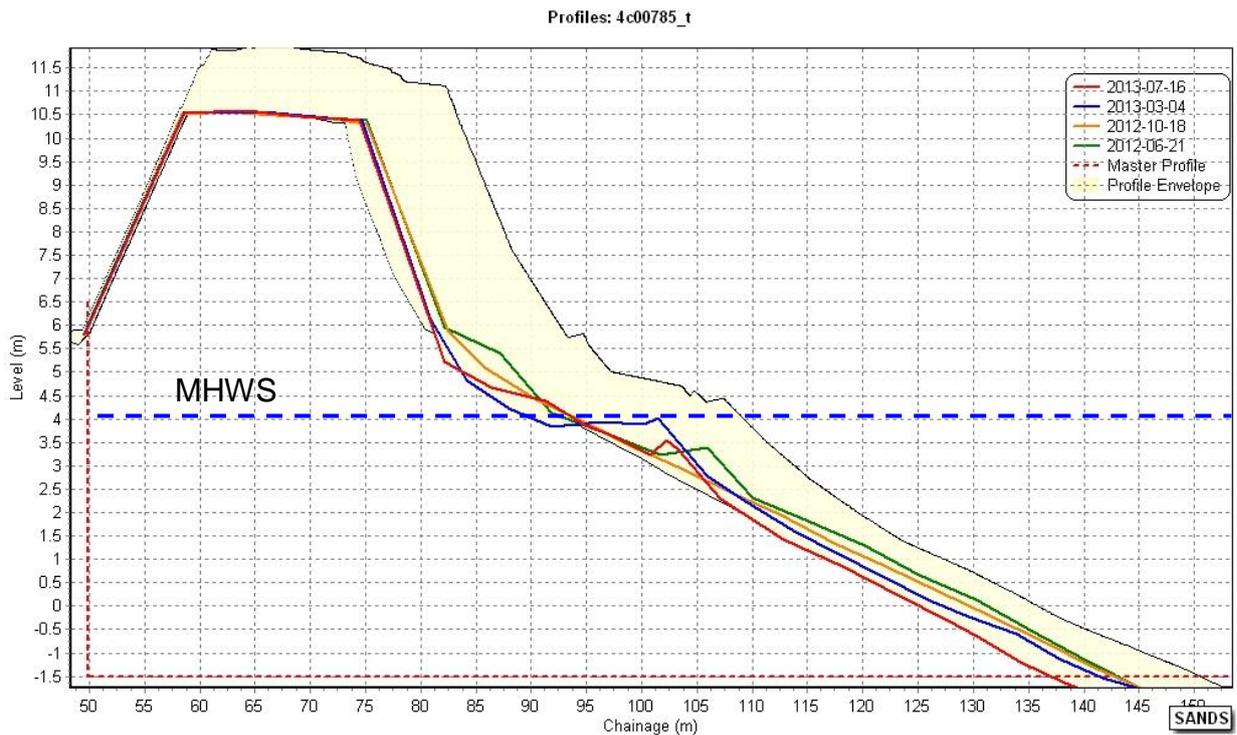
Figure 4: Cross sectional losses at profile 4c00785.

During the current reporting period section 2 has again shown a continuation of erosive processes at a similar rate to neighbouring section 1. Between 2012 and 2013 this section has lost approximately 16,000m<sup>3</sup> of material. From the difference models it can be seen that the majority of these losses have occurred linearly across the beach slope in a shore parallel bands, although there has also been some localised losses along the top of the embankment. Figure 4 below illustrates how these losses have affected the beach cross section for profile 4c00785 which is located in the centre of this section.

From Figure 4 it can be seen that the losses over the past year have been most notable at the base of the embankment and the lower beach slope. The toe of the embankment has reduced in height by 0.5m and maintains the lowest elevation surveyed since records began. The beach slope in front of the embankment has rolled back to a slightly steeper profile and represents one of the lowest cross sectional areas since records began.

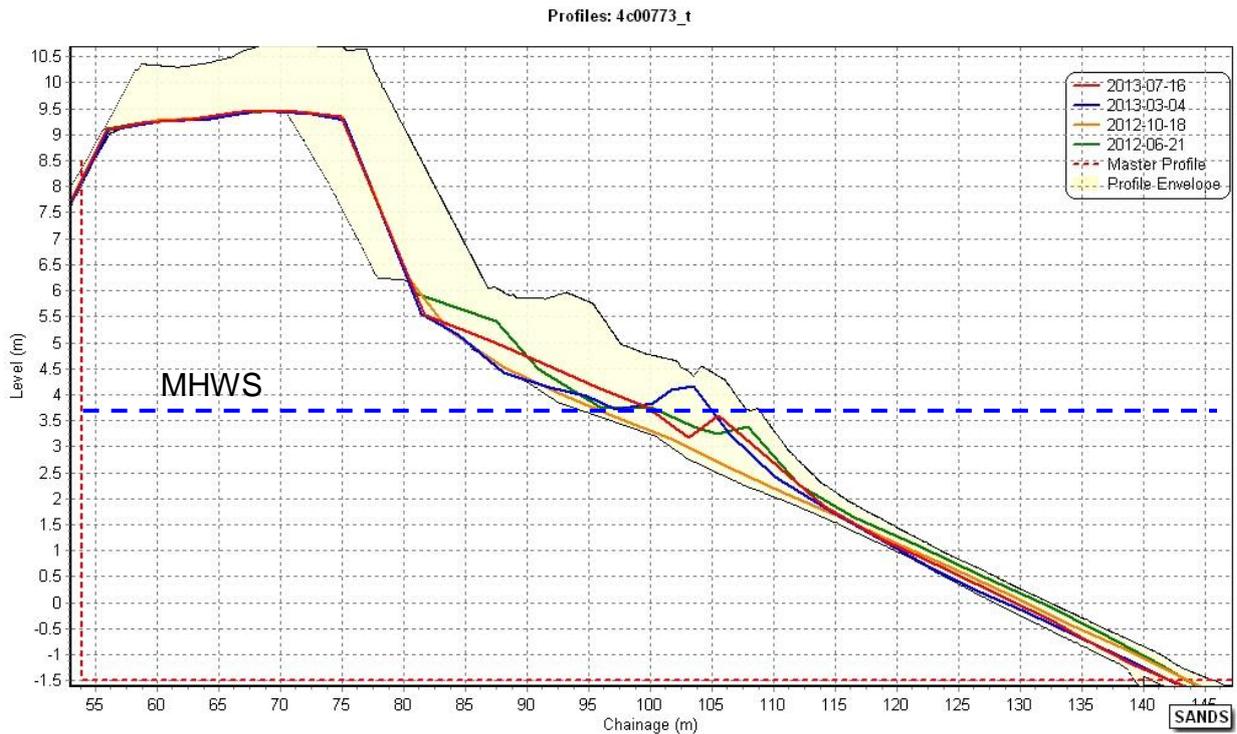
Figure 5: Profile 4c00773 showing a stable embankment formation

Figure 5 below shows the beach cross section for Profile 4c00773 which is located near the eastern boundary of section 2. This profile presents a more stable view in contrast to the changes shown in Figure 4 and clearly shows a stable embankment height and width over the past year.

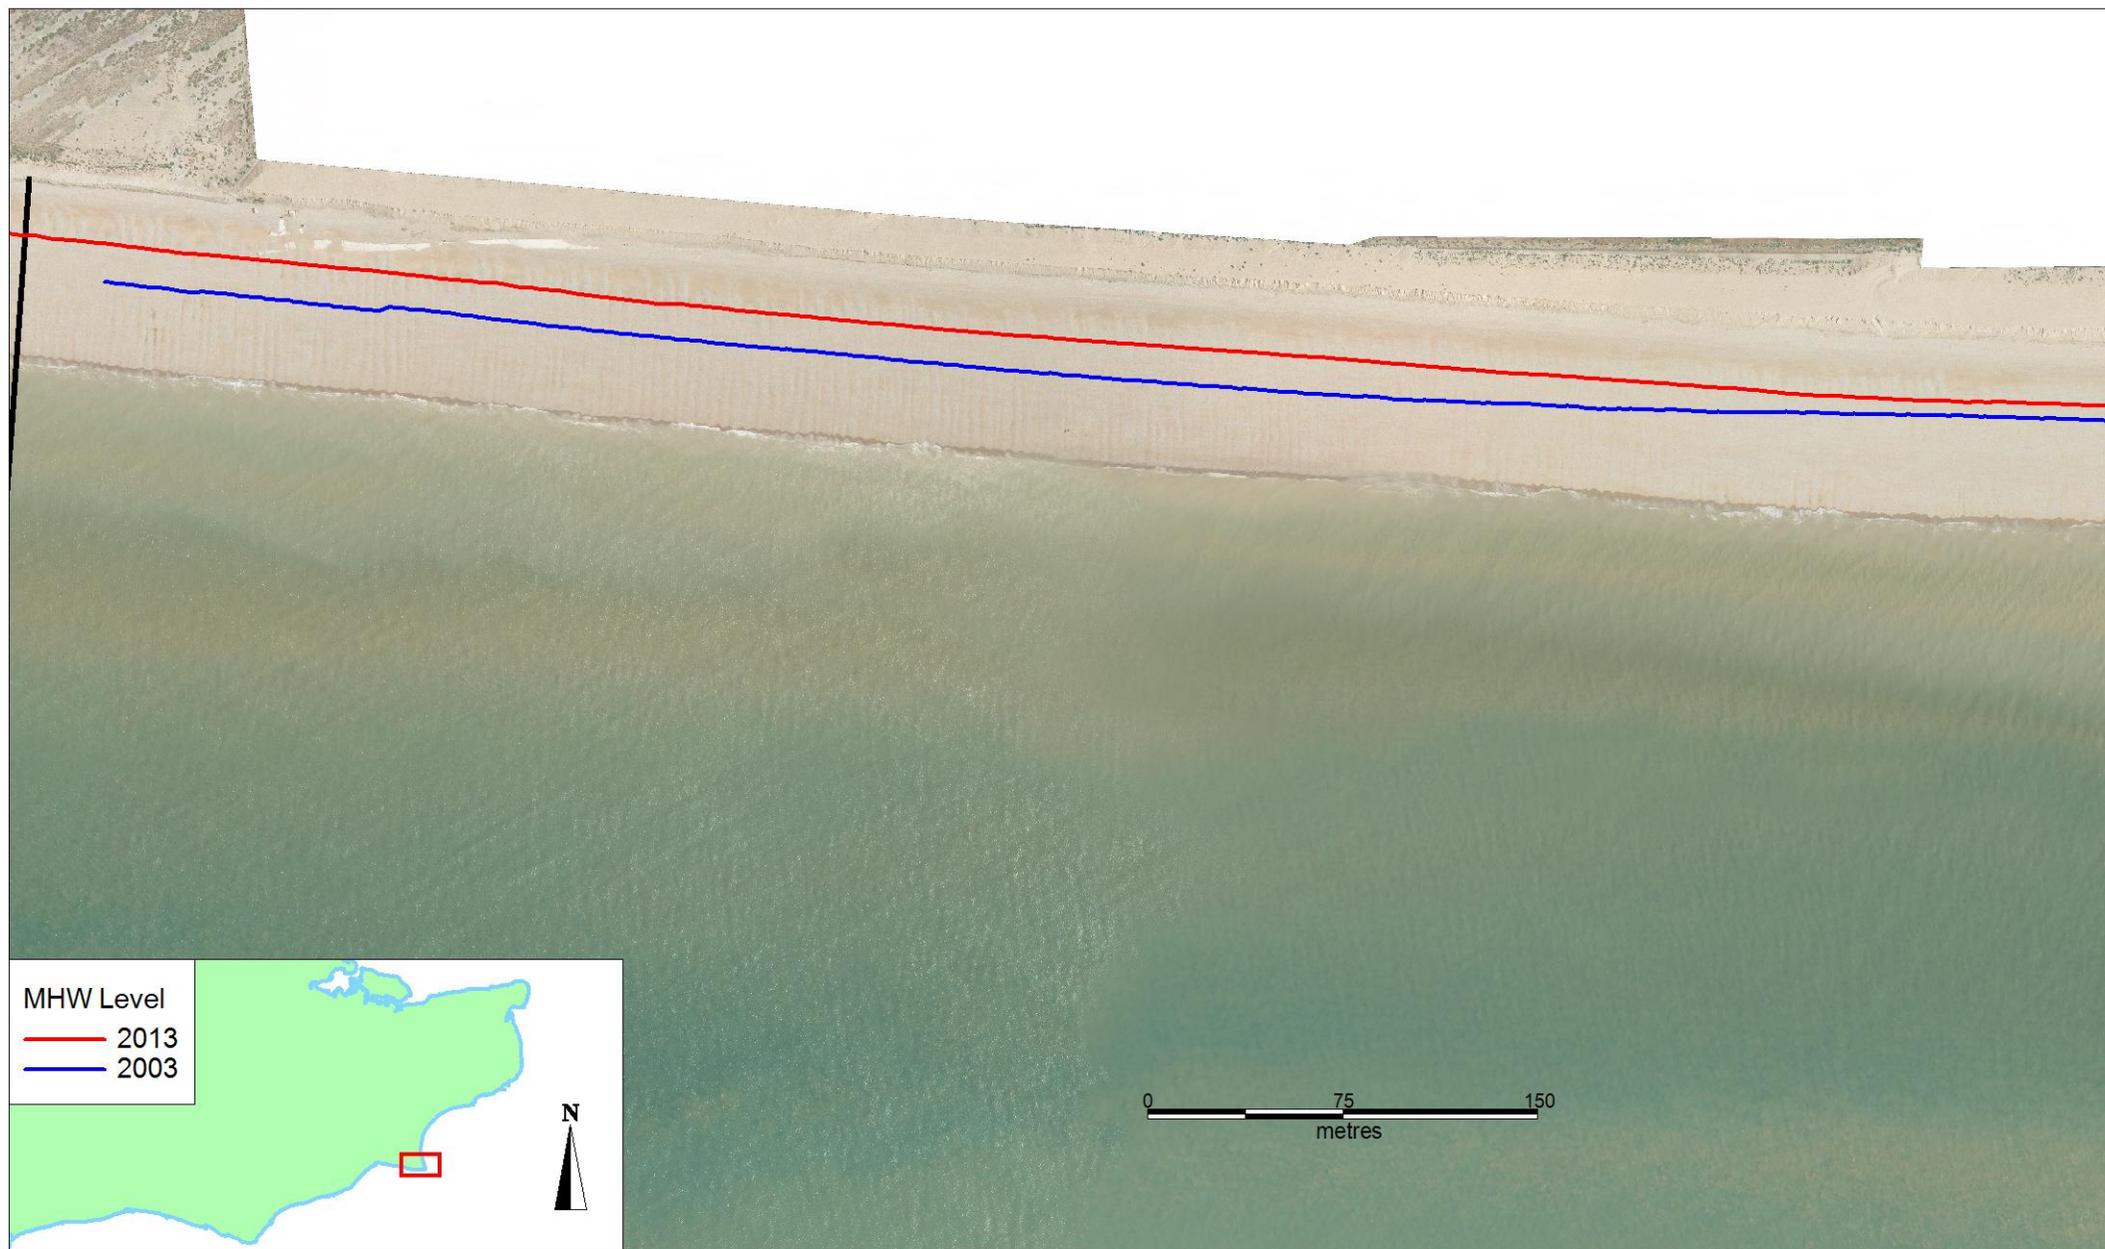
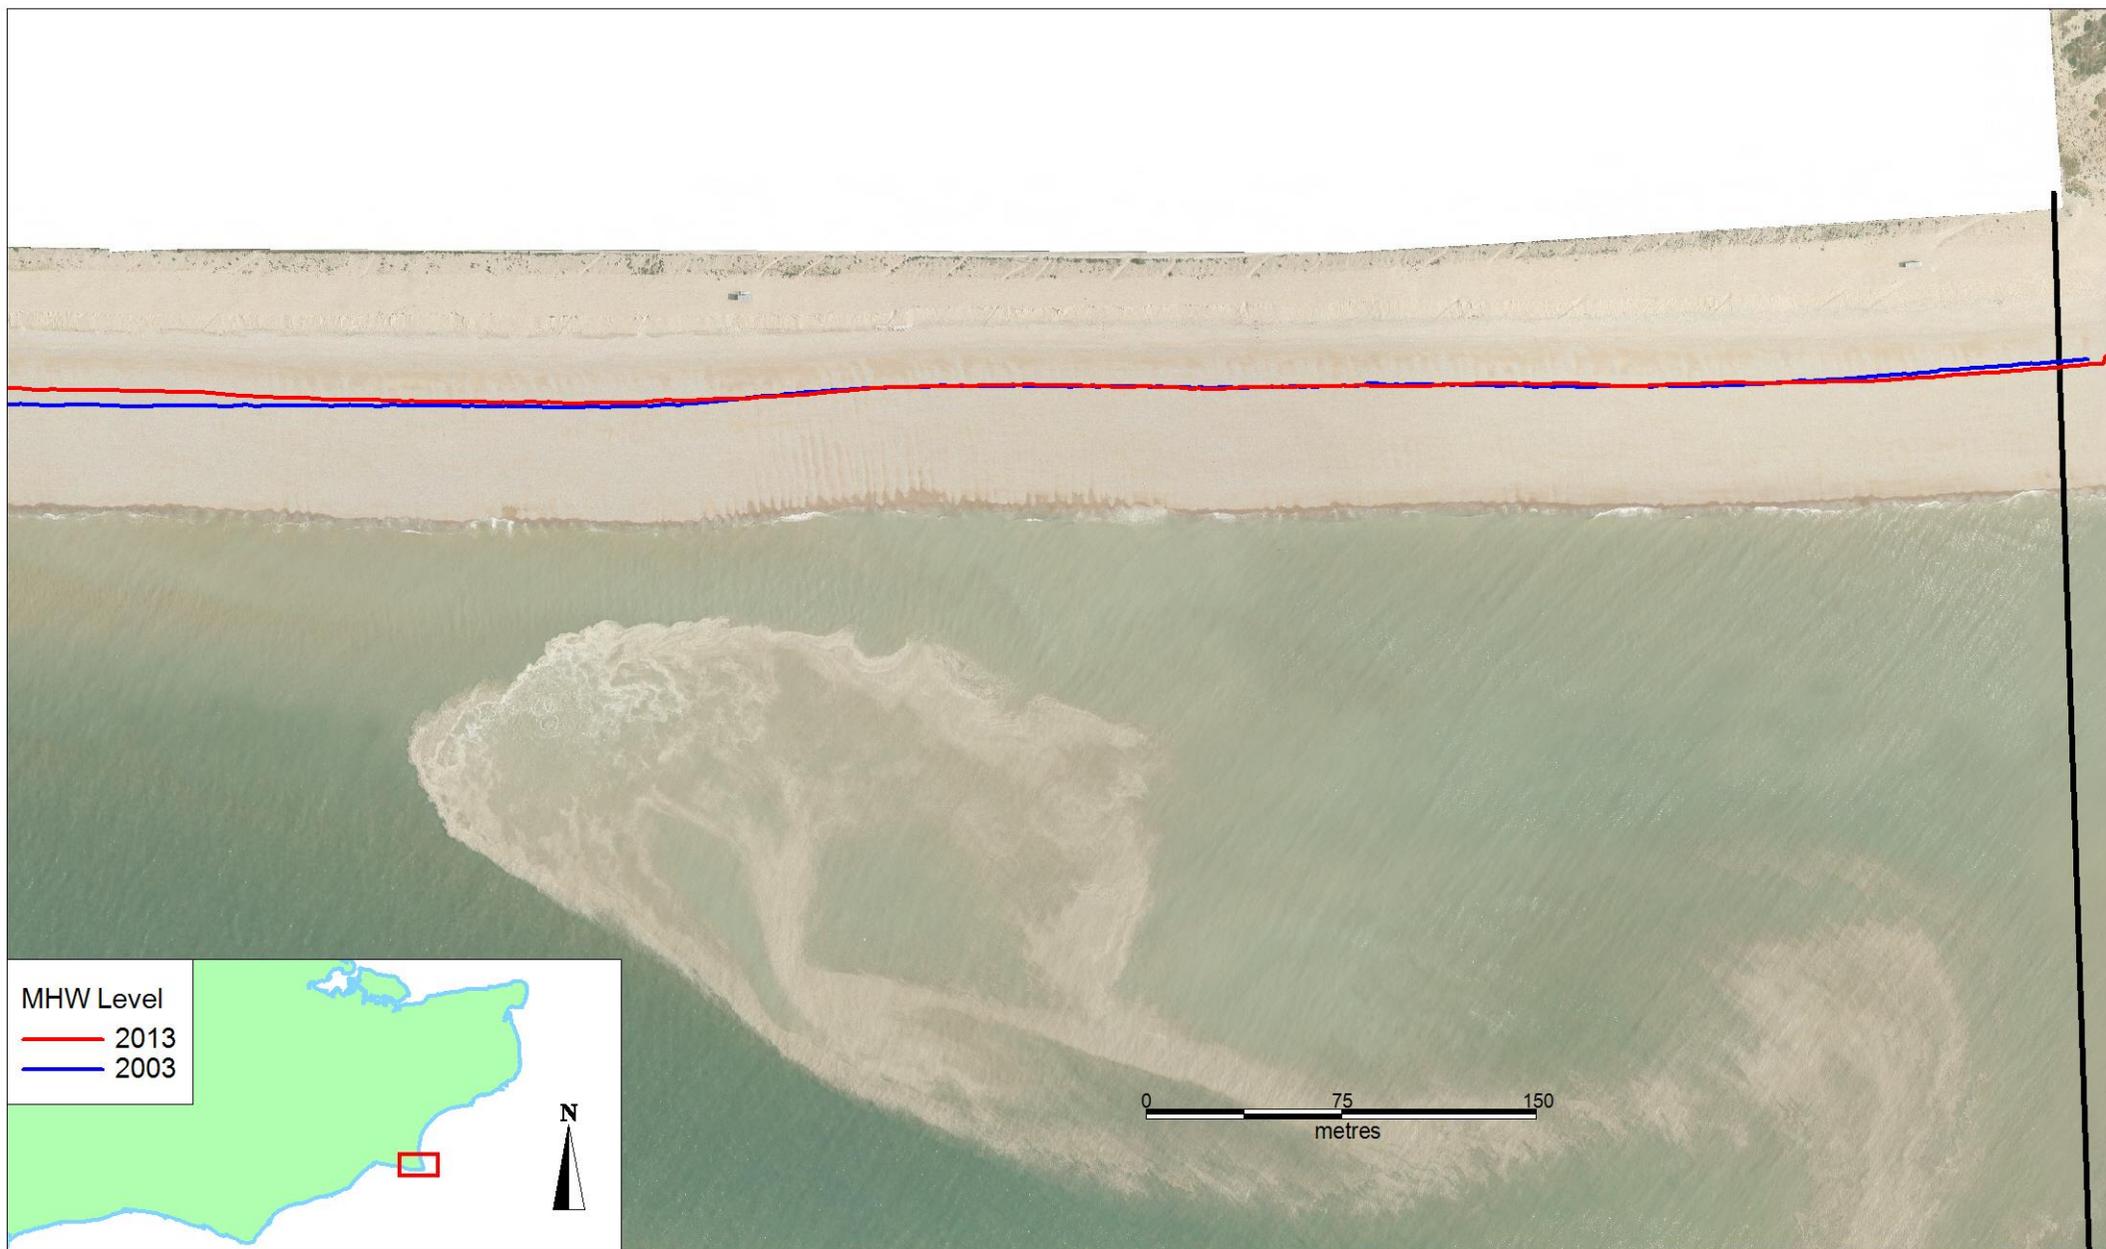
The Mean High Water mark at Dungeness is +2.75m OD. The MHW contour has been cut out of the Digital Ground Models for 2003 (the first dataset) and 2013 (the current dataset) and compared in Plate 3; shown below. In general, the 2013 MHW mark has retreated in the west and maintained position in the east. This trend clearly reflects the management regime which has allowed the shingle embankment to roll back in areas where the flood risk is reduced.

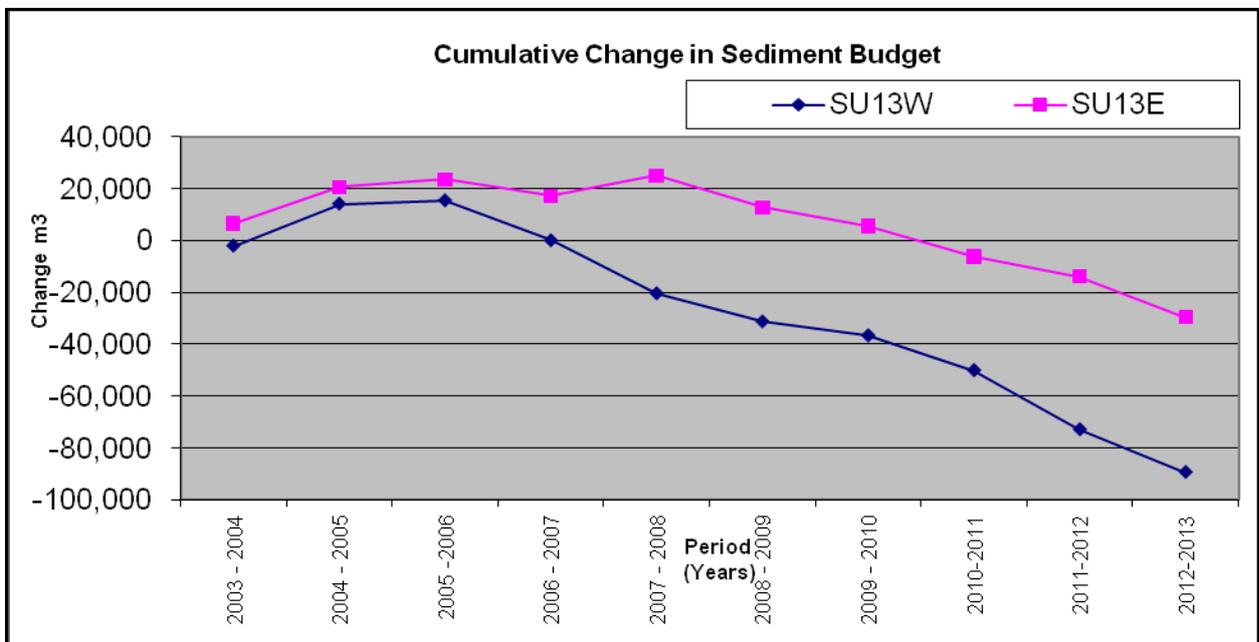
**Figure 6: The cumulative change in sediment budget for Survey Unit 13.**

Figure 6 above clearly shows the negative trend for this frontage and projects a continued rate of sediment loss. The graph also indicates the disparity between the

western and eastern sections and the magnitude of losses that have occurred in the west.
