Introduction

This report presents the change in elevation recorded by three LiDAR surveys of Bawdsey Beach within Hollesley Bay on the Suffolk coast. The extent of the area assessed runs from just north of East Lane Bawdsey to the beach fronting Bawdsey Manor.

This report is produced as part of the Anglian Coastal Monitoring (ACM) project. The ACM project is a partnership programme of coastal surveys providing long term data for coastal monitoring and analysis. More information about the project can be found at: <http://www.coastalmonitoring.org/anglia/> and at the East Anglia Coastal Group: http://www.eacg.org.uk/default_monitoring.asp.

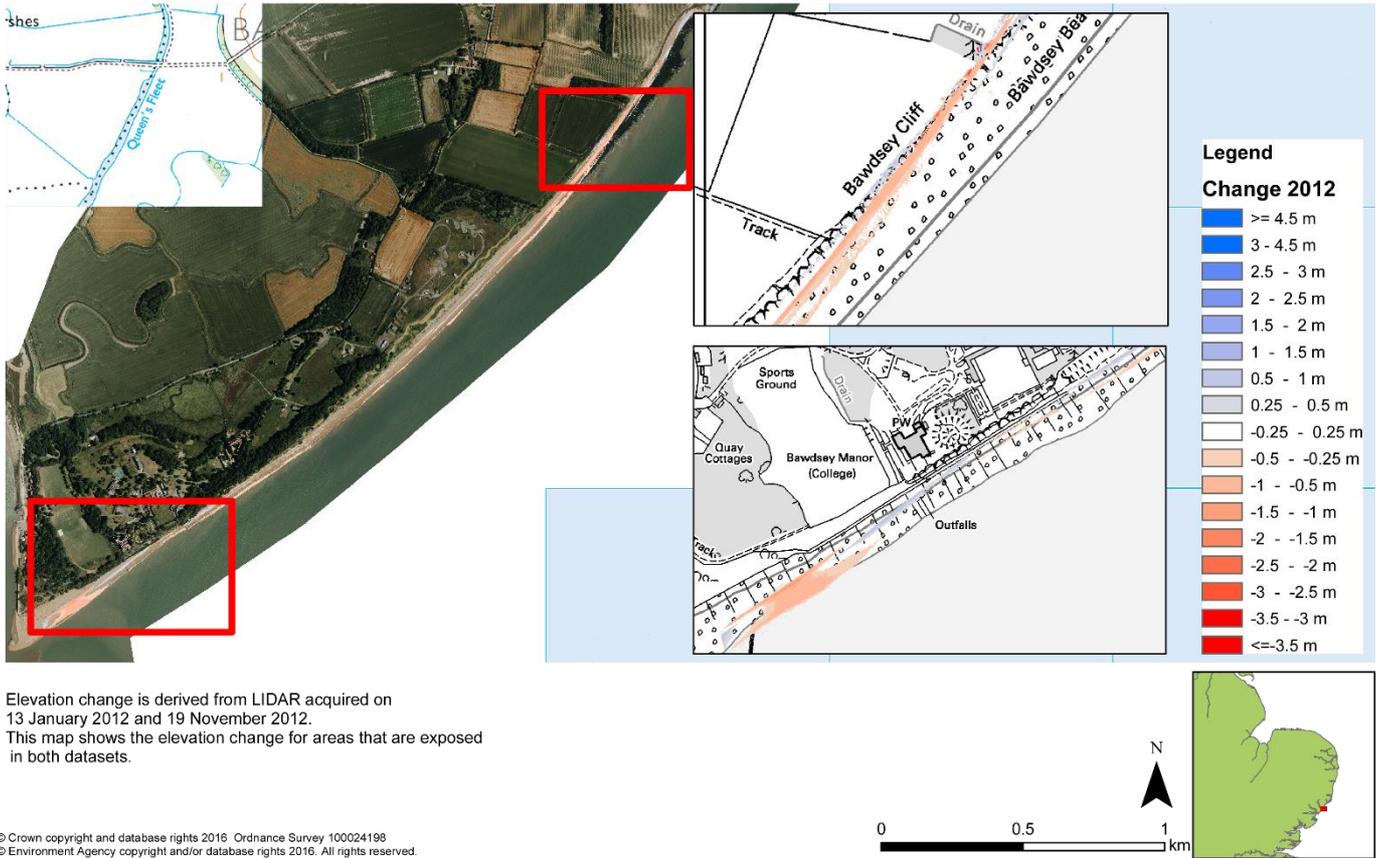
Figure 1: LiDAR difference model showing elevation change between January 2012 and November 2012.

In the following plots increased elevation, such as the result of deposition and accumulation of sediment on the beach is shown in a graded scale of blue. Areas of erosion or lowering elevation are coloured red. When there is no significant change (\pm 25 cm) the data is not included in the difference model.

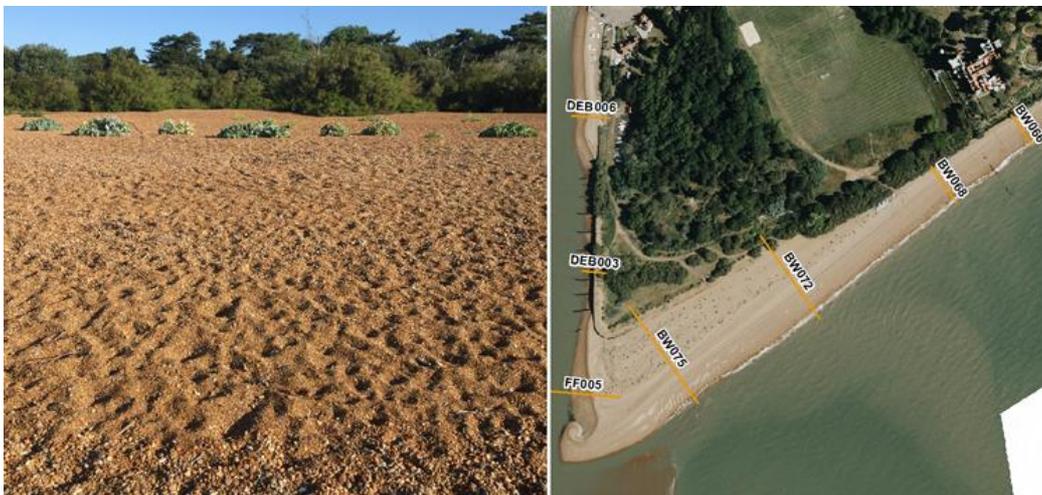
Figure 2: Land survey (2015) and aerial photograph (2014) of the beach at the location of transect BW072

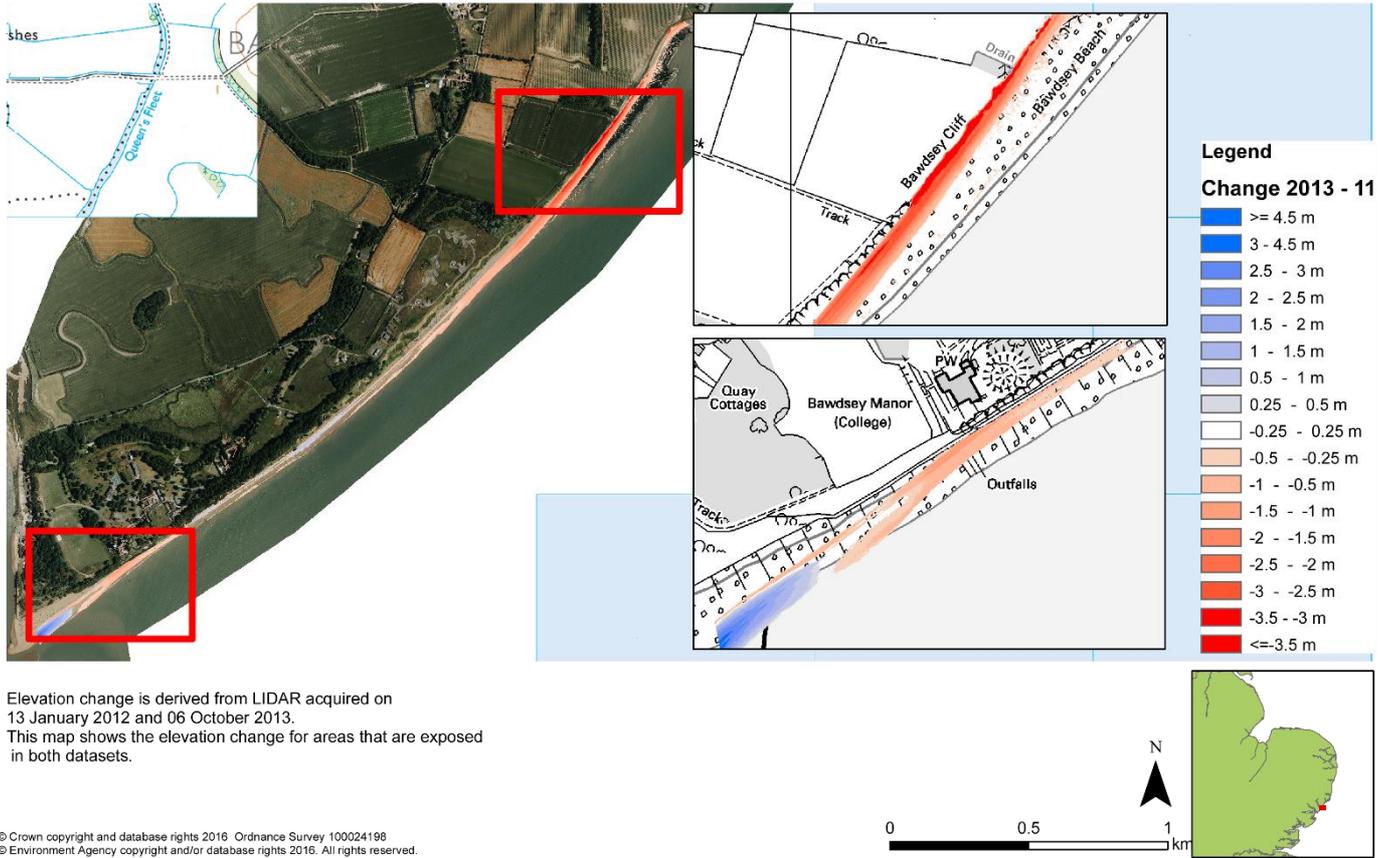
Figure 3: LiDAR difference model showing elevation change between January 2012 and October 2013.

There is a noticeable area of erosion south of Bawdsey Manor, however over the year sediment can be seen to have accumulated at the point to feed on to The Knolls in the River Deben. This accumulation on the lower beach can be seen in the profiles at transect BW072 (Figure 4).

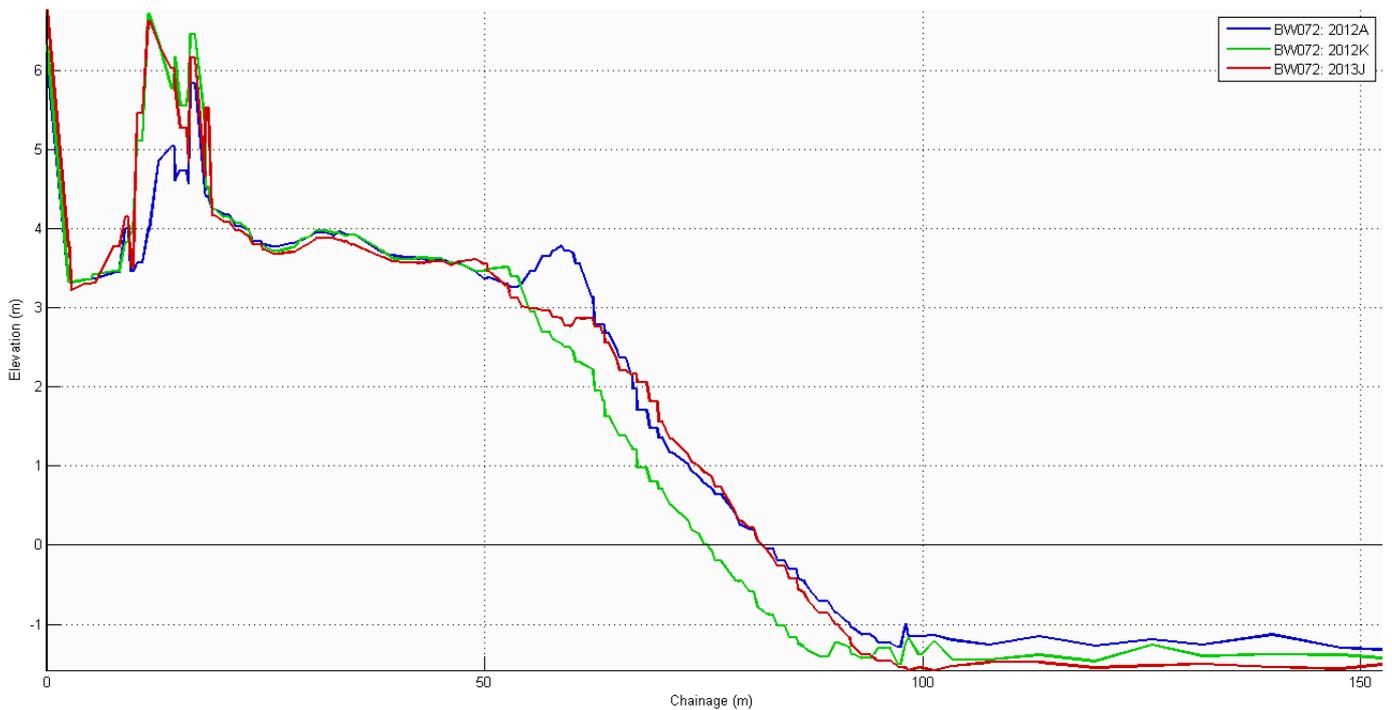
Figure 4: Beach profiles extracted from the three LiDAR surveys along transect BW072 at the southern end of Bawdsey Beach.

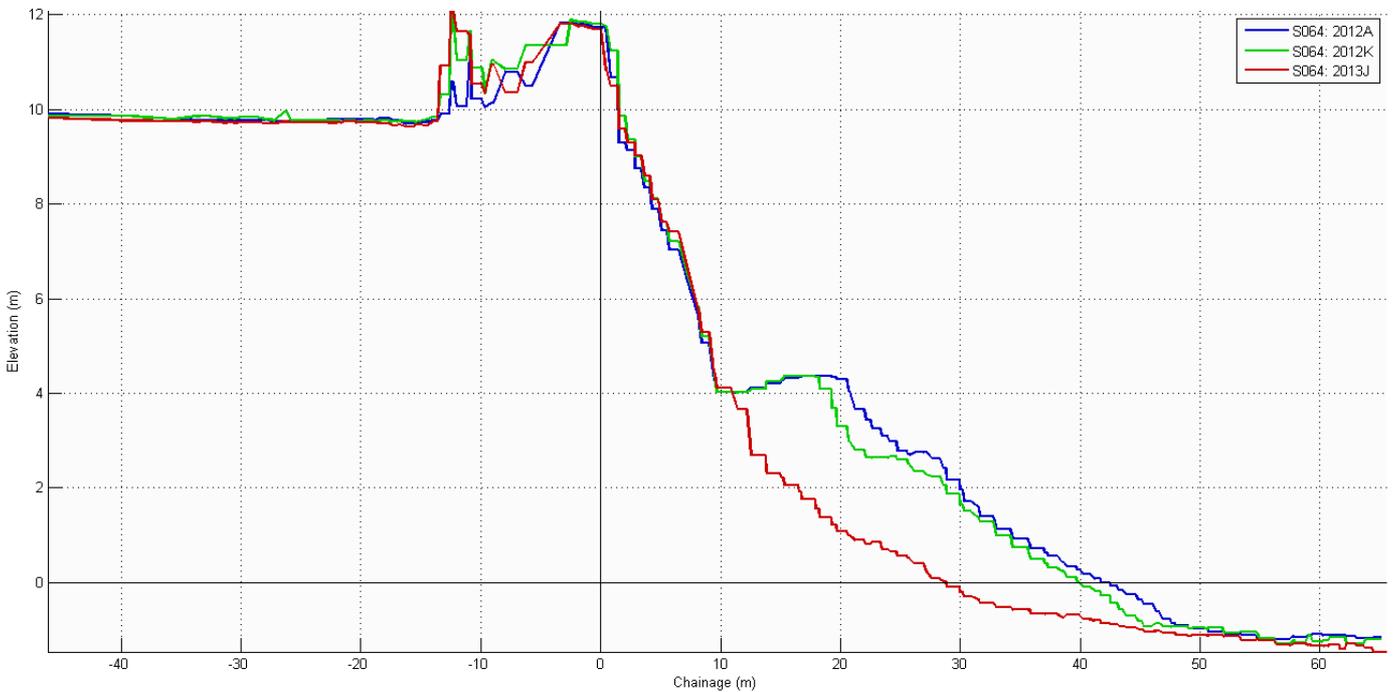
Figure 5: Beach profiles extracted from the three LiDAR surveys along transect S064 at Bawdsey cliffs.

There is erosion on the upper beach section fronting Bawdsey Cliffs. The soft cliffs here are fronted with a shingle beach. Whereas the lower beach is exposed clay and relatively stable. The profiles extracted from the LiDAR seen in Figure 5 show that the erosion is the movement of the shingle beach that runs from the toe of the cliff. This is not a redistribution of the sediment across the beach profile and the longer topographic surveys show the cliff toe is exposed when the shingle beach is not present, such as in October 2013. However at transect BW016, just south of the Martello Tower at East Lane Bawdsey the most significant cliff erosion recorded occurred between 2009 and 2011, where the cliff face moved back 20 m. At this time the shingle beach was removed, and although the beach is now at a much lower elevation the cliff erosion has slowed significantly. The beach, a mix of shingle and fallen material, has built up around the toe of the cliff, the photograph in 2015 also shows vegetation growth.

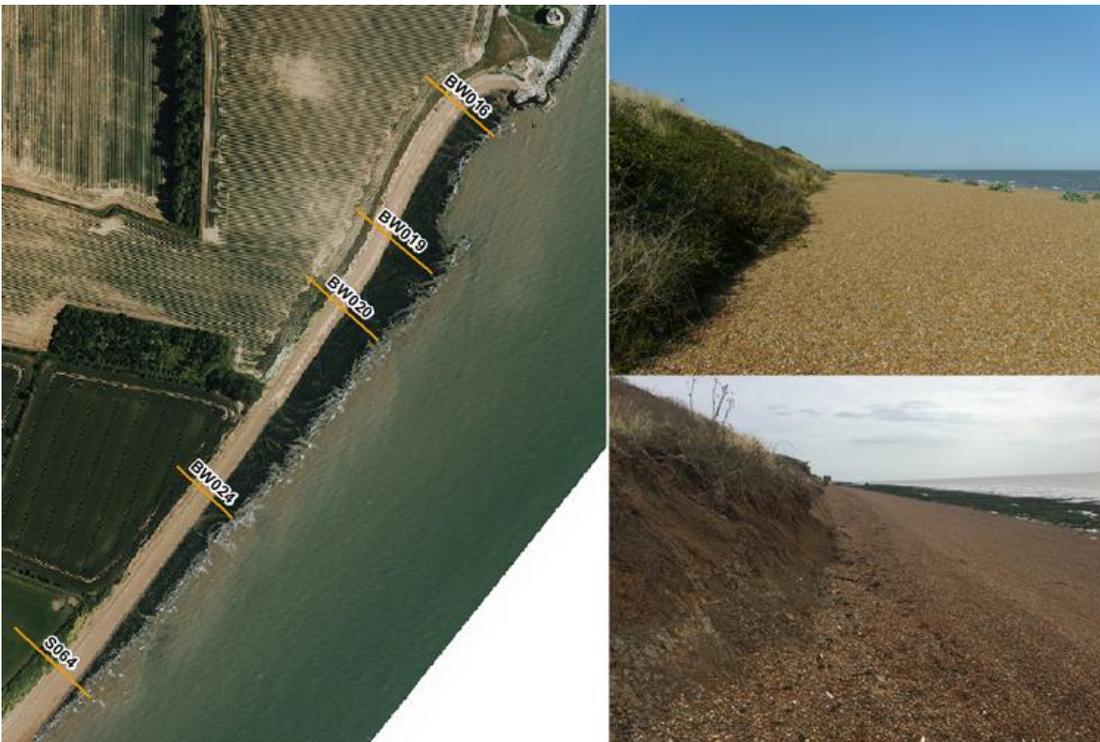
Figure 6: Left: aerial photograph (2014) of the beach south of East Lane. Top right: the beach at transect S064 in August 2009. Bottom right: the lowered shingle beach in August 2015.

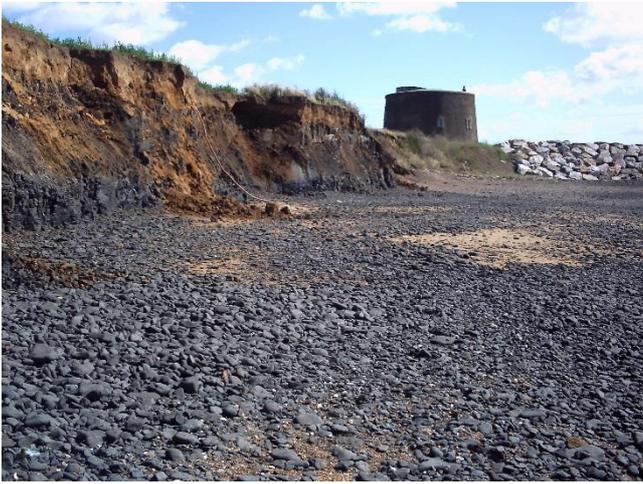
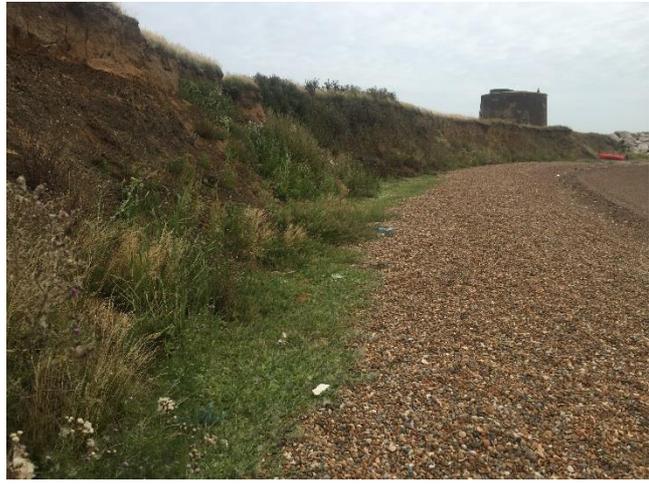
Figure 7: Left: The beach at transect BW016 striped of shingle in July 2010. Right: In 2015 a lower profile shingle beach than previously existed is now present and currently stable.

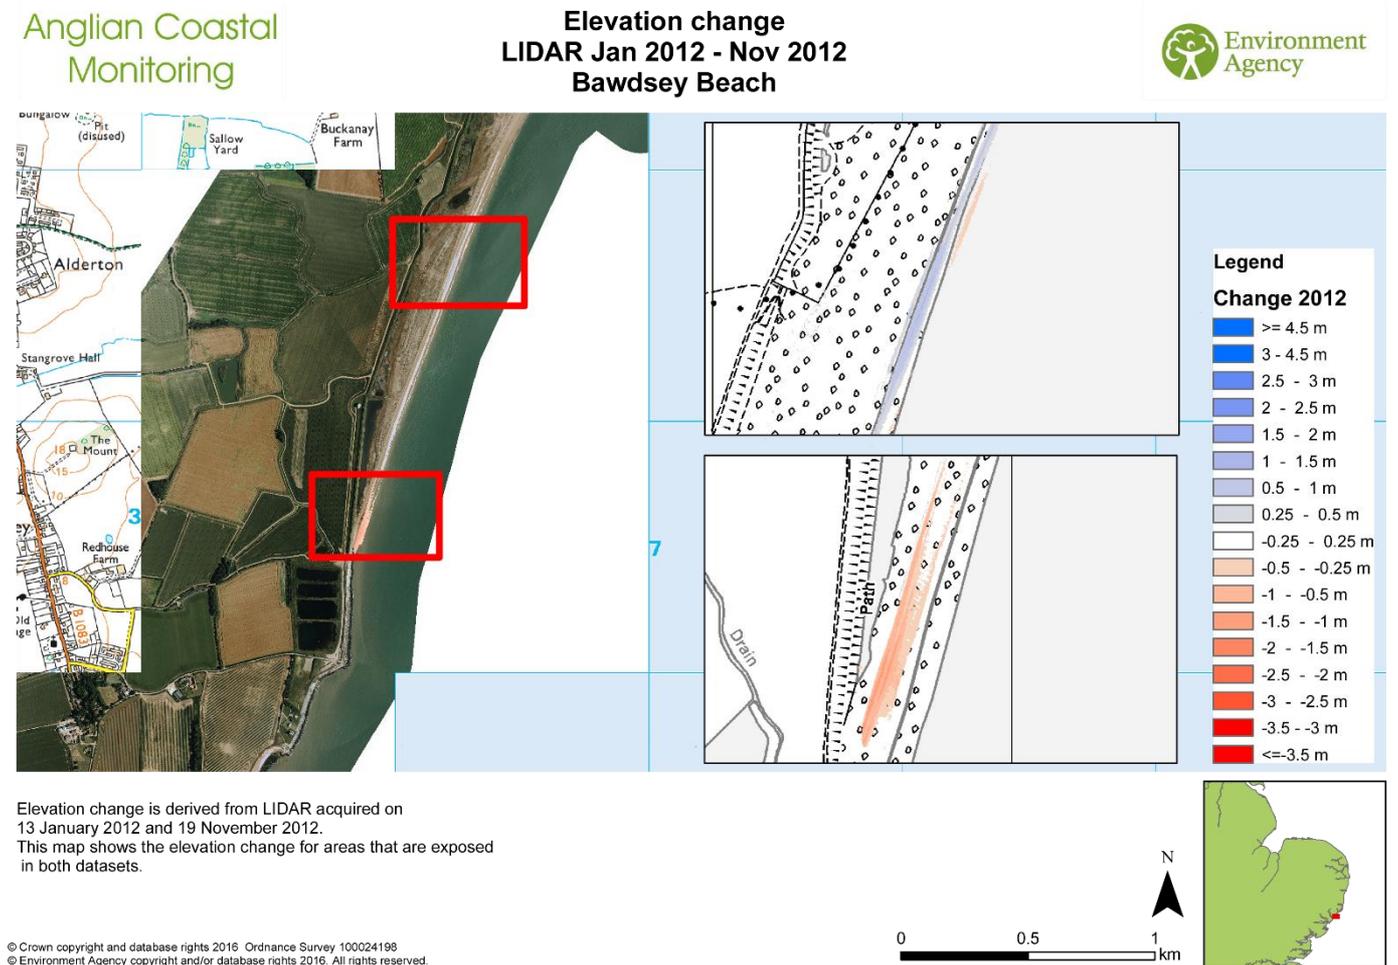
Figure 8: LiDAR difference model showing elevation change between January 2012 and November 2012.

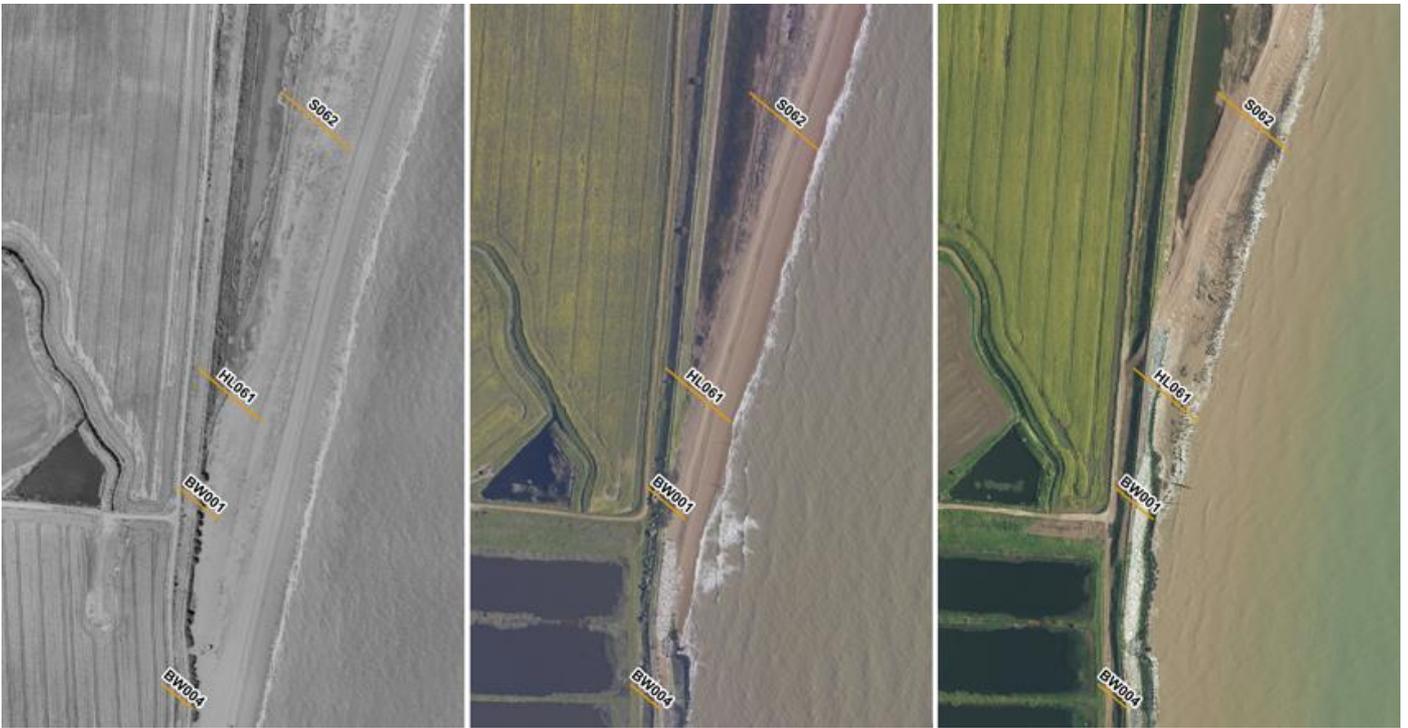
Figure 9: Aerial photography in 1992, 2012 and 2015 of the beach and lagoon north of East Lane.

North of East Lane Bawdsey, the beach fronting the lagoon has been steadily eroding (Figure 9). The difference model shows over a metre fall in elevation over the year as the beach slope lowers. There is however a build-up of sediment alongside the rock defence and terminal groyne. To the north, at the north end of the lagoon where the Martello Tower is located, the beach is observed to be accumulating sediment. Further north from the location of transect HL048 the beach is considered to be relatively stable (Figure 11). There is an observed balance in sediment movement, elevation differences likely reflecting changes in the beach berms.

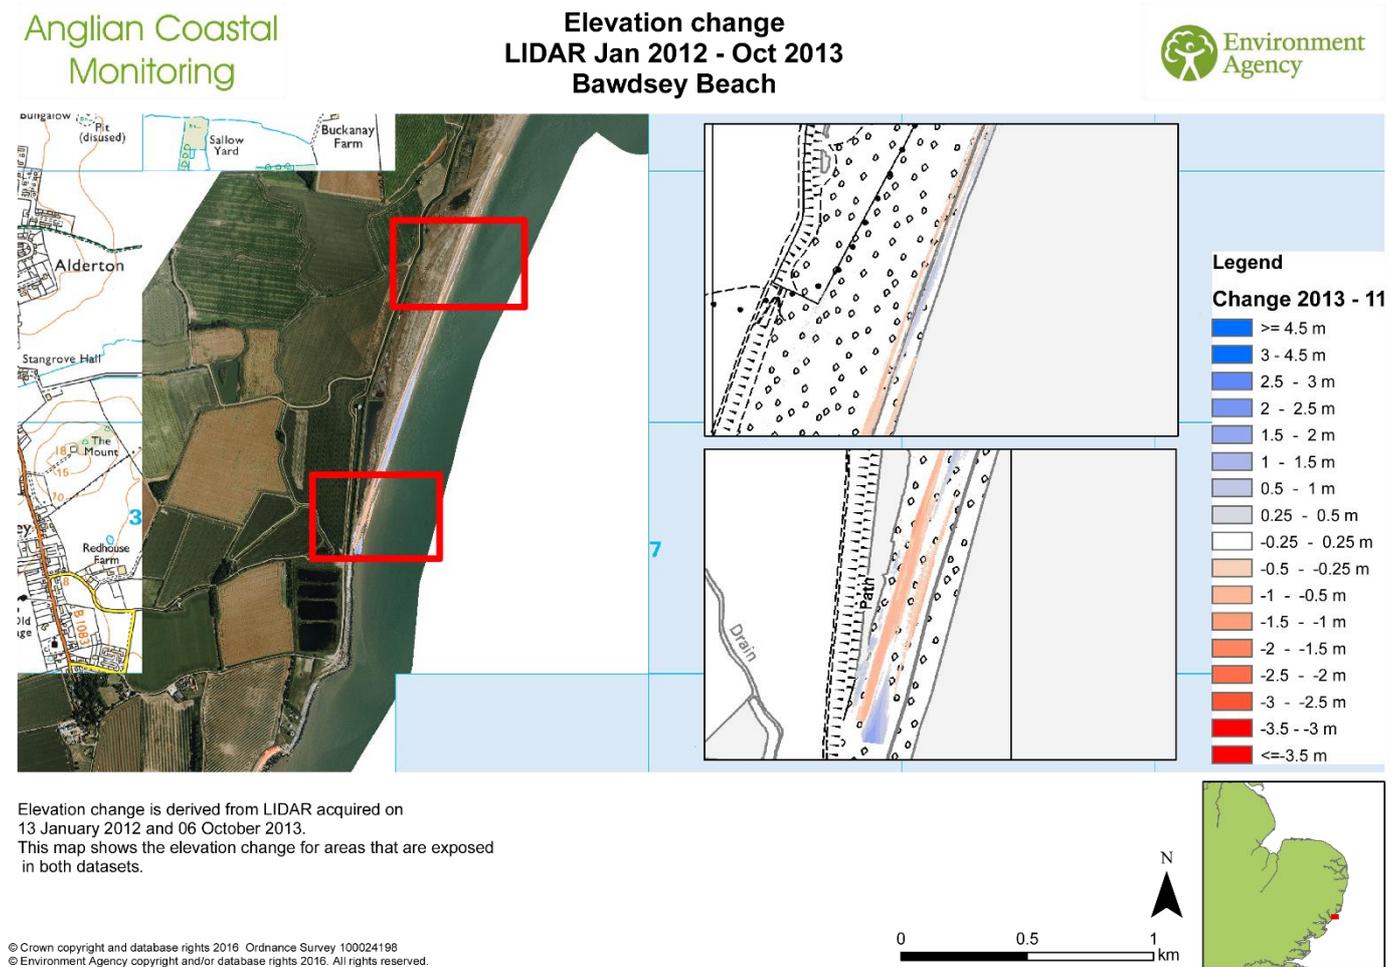
Figure 10: LiDAR difference model showing elevation change between January 2012 and October 2013.

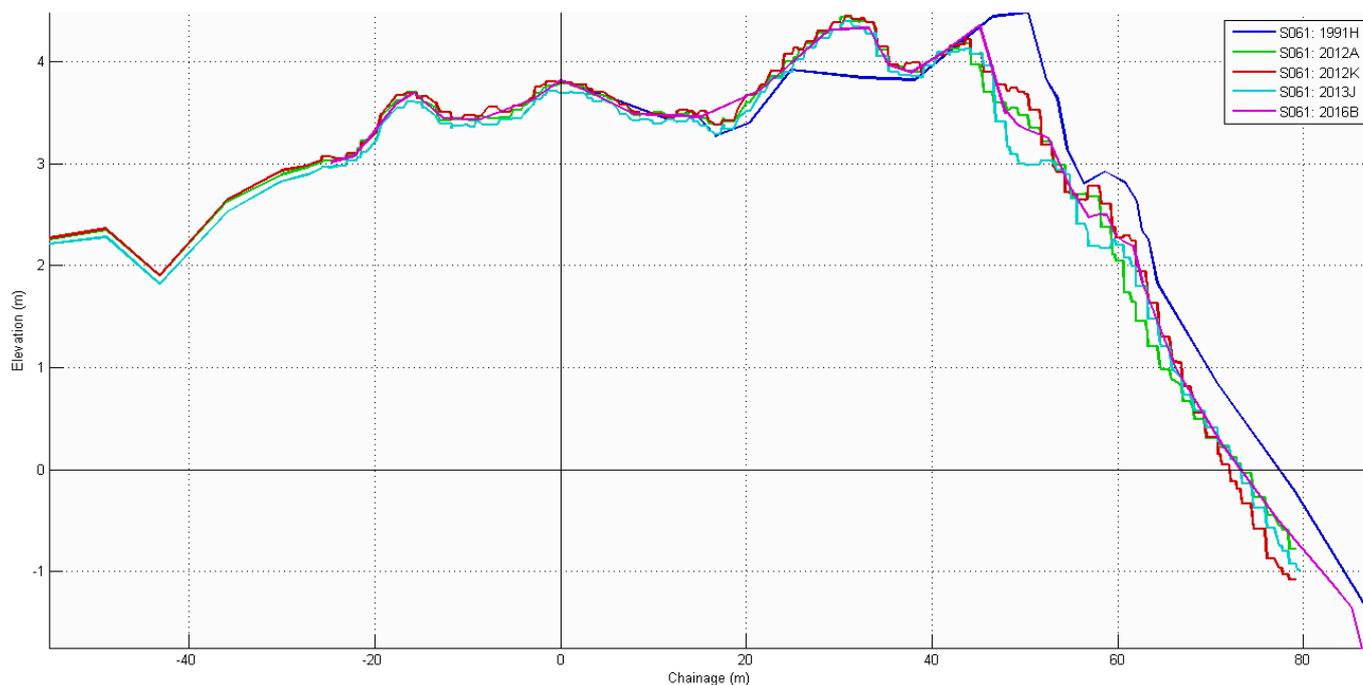
Figure 11: Beach profiles extracted from the three LiDAR surveys with August 1991 (blue) and February 2016 (pink) walked topographic surveys along transect S061.
