# BEACH MANAGEMENT PLAN REPORT

Document Title: **Beach Management Plan Site Report 2005**

Project Name: **Strategic Regional Coastal Monitoring**

**Beach Management Plan Site Report 2005**  
**Unit 9A: DEAL**  
*(Sandown Castle – Oldstairs Bay)*

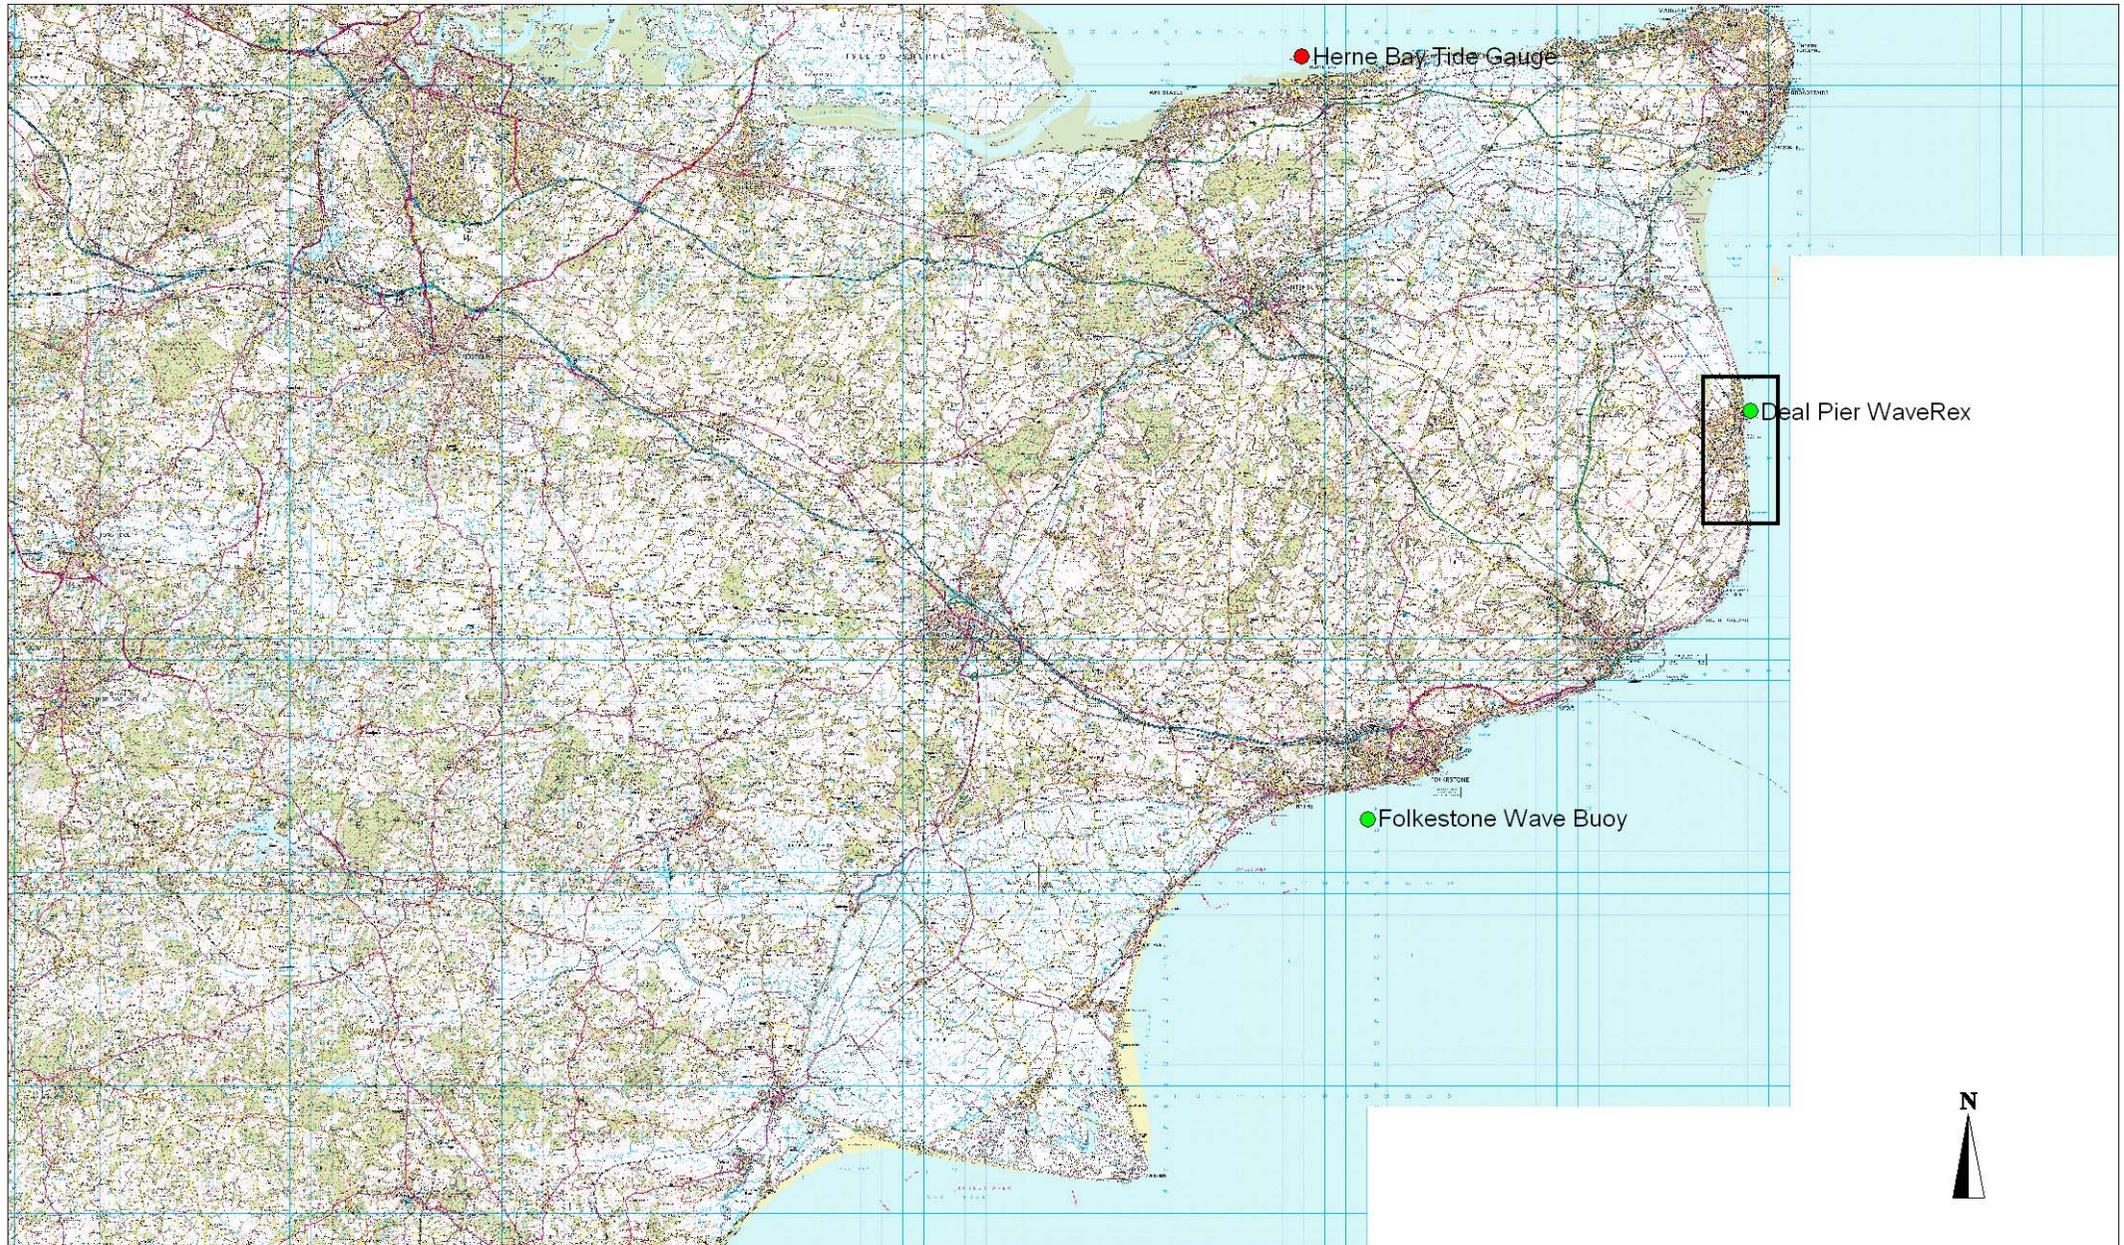
The location of the frontage is shown on Figure 1.1, which includes the location of the nearest wave buoy and tide gauge.

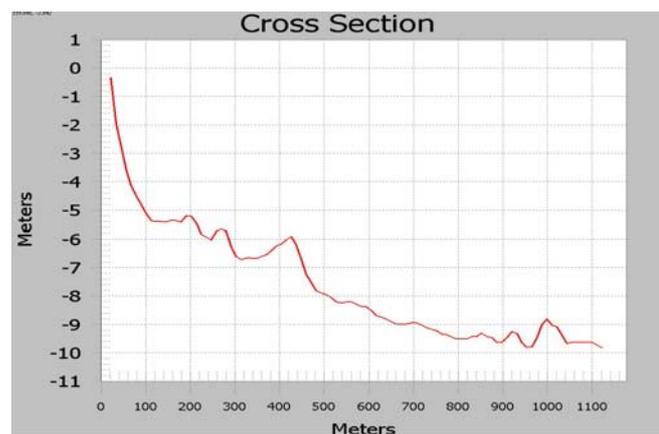
Figure 0.2-1: Example of Bathymetric data

In general this units exhibit a steep gradient at the nearshore end followed by a steady gradient down to depths in the region of -10m ODN at a kilometre offshore (Figure 3.2-1).

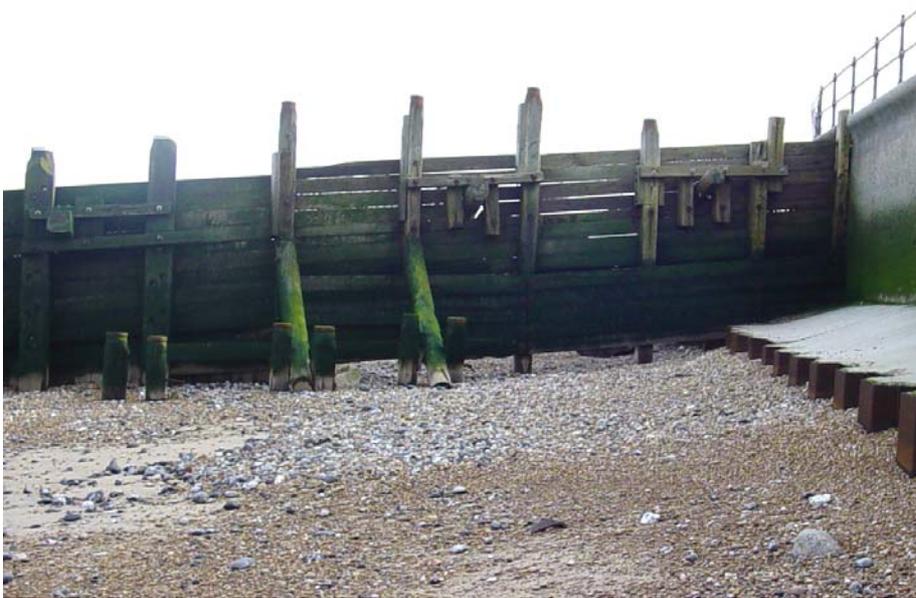
The figures are also somewhat skewed by the significant losses that have taken place in the southern most bays (in front of the Zetland Arms), which has been as a result of material leaking out of the bays due to lowering beach levels to the south. The mechanism for the loss of material from these groyne bays was triggered when beach levels on the updrift side of the groynes (southern side) fell dramatically in 2004/05. This uncovered the base of the groynes and gaps in the planking, which can be seen in Figure 4.1, thus allowing material to move out of the bays.

*Plate 4.1 – Groyne at southern most end of Kingsdown beach*

This realignment is expected to reverse during the autumn and winter south and south-westerly storms and when this occurs the base of the groynes at the southern end of the Kingsdown seawall will again be covered in shingle. This will prevent further washout of material and should make beach renourishment in this area effective.

The second area of beach where a 'warning' threshold has been triggered is at the southern end of the Kingsdown seawall (profile 4b00520). Here the groyne bay is almost empty and this rapid loss of material has been initiated by the realignment of the beach to the south. This has caused beach levels to fall below the base of the timber groyne, therefore allowing shingle to move freely out of the groyne bay.

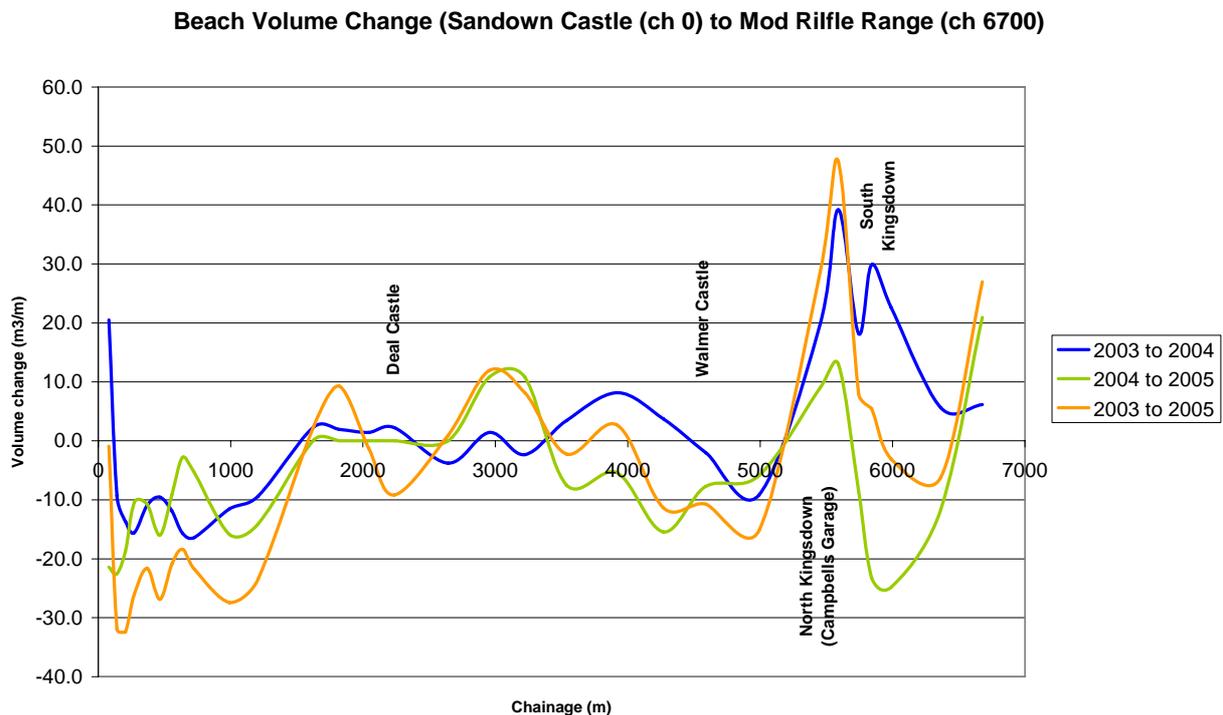
Plate 4.2 – Graph showing beach volume change per linear metre

The graph shown below in Plate 4.2 shows the volumetric change per linear metre of the frontage. From inspection of this plot it is possible to draw some rudimentary conclusions as to how the frontage is behaving as a single unit.

- Firstly, the northern end of the frontage, between Sandown Castle and North Street has been eroding at a relatively constant rate and it is likely that this material has been permanently lost to the beaches north of Deal.

- In the central section, between Deal Pier and Walmer, the frontage is relatively stable, with material moving freely along it.
- In front of Walmer Castle and the beach recycling borrow area to the south, the frontage has suffered some erosion.

- Between the beach recycling borrow area and the north of Kingsdown there has been significant accretion.
- Along the Kingsdown frontage the capital beach renourishment works have increased the beach volumes considerable, however, the majority of the capital recharge has now moved to adjacent beach sections. The exposure of the base of the southernmost groyne has resulted in significant losses from these groyne bays.

- The beach between Kingsdown and the MoD Rifle Range has accreted by about 6,000m<sup>3</sup> during the 2003/05 period, although the realignment of this frontage has resulted in erosion in the northern half.

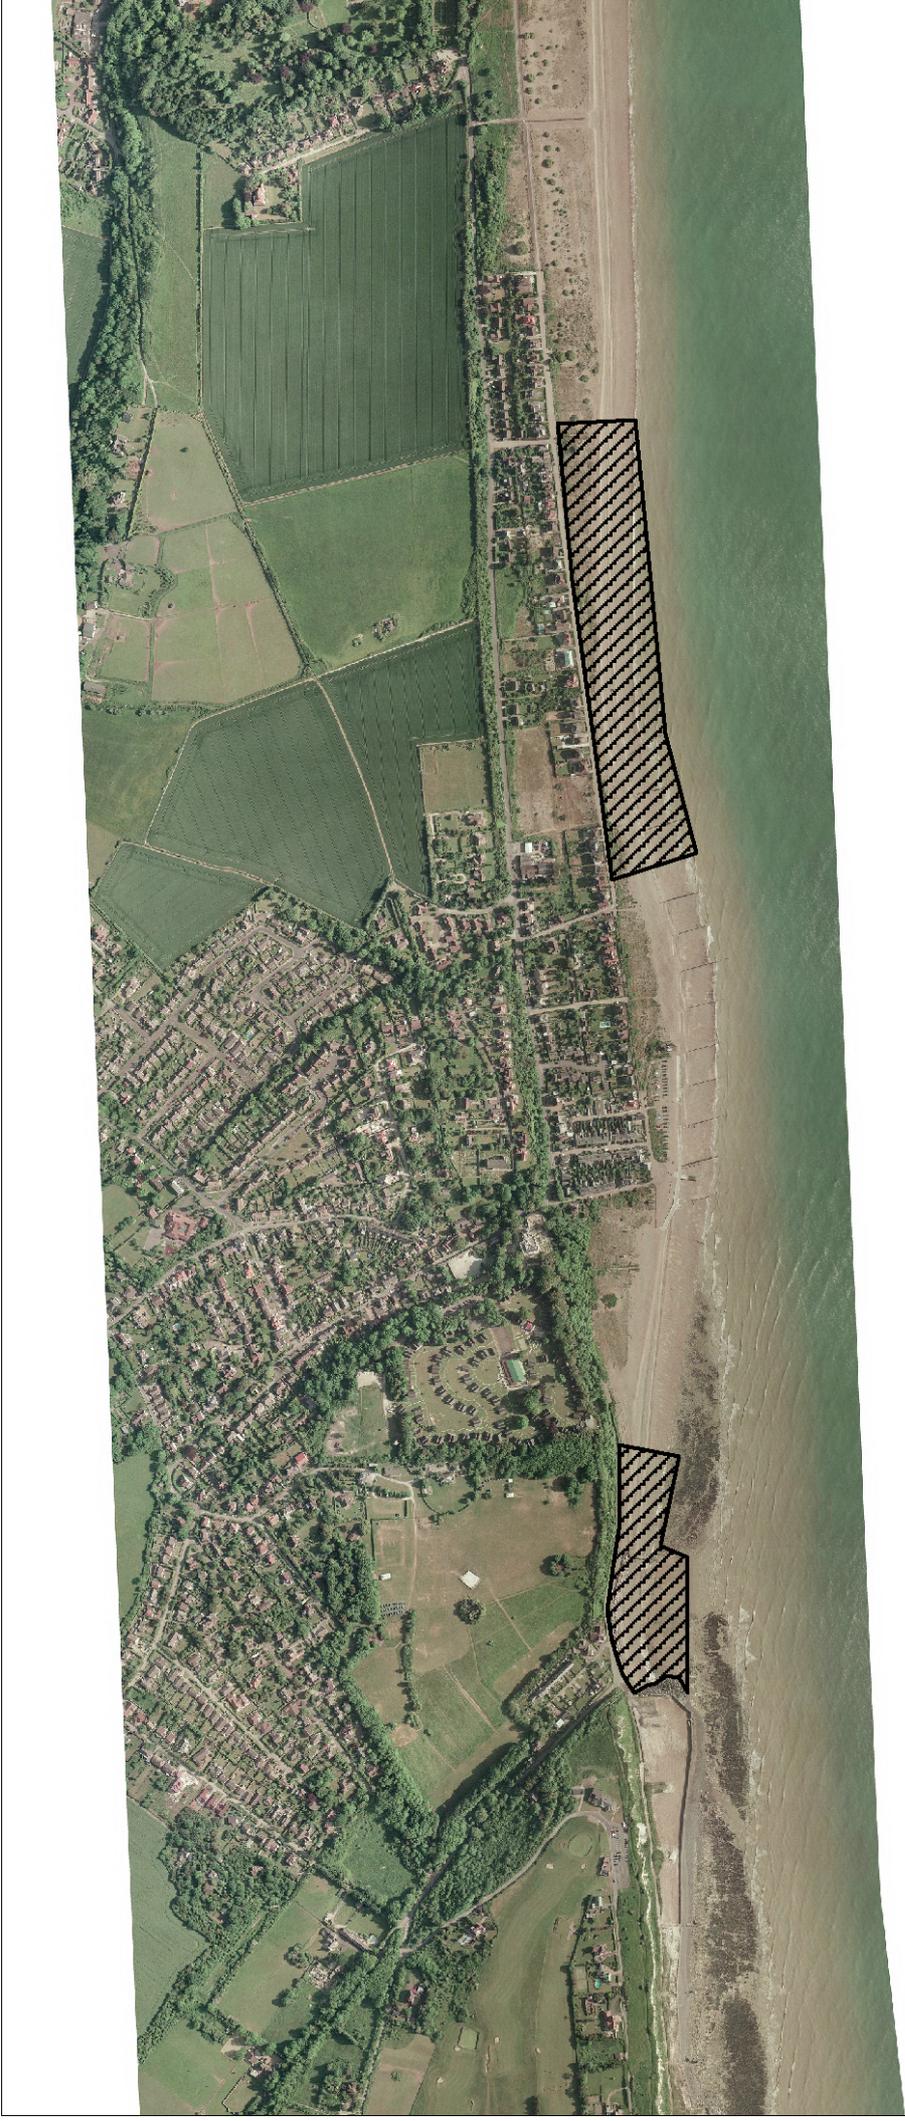
Potential recycling sites are identified on Figure 10.1

There are two areas of significant accretion that could be used as borrow locations for any beach recycling works in this coming year. The first is at Oldstairs Bay which has gained approximately 8,400m<sup>3</sup> during the 2003/05 period. However, the material that has accreted here is as a result of a slight realignment of the beach crest between Kingsdown and Oldstairs Bay and the excess material at the southern end of this frontage is likely to move north again this coming year, therefore providing benefit to the Kingsdown frontage. Removal of material from this frontage is therefore likely to have a detrimental effect in the short to medium term.

The second area that has accreted significantly is section between Kingsdown and Cecil Road where close to 20,000m<sup>3</sup> of shingle has accumulated since 2003. However, given that some of this material is accreting in an area where the beach crest is relatively narrow, it would be prudent to take material only from the wider parts of the beach.

Alternatively, material could be extracted from the established beach recycling borrow area, which is only 400m to the north. This could be done in the knowledge that the material that has accreted to the south will, through natural processes, move northwards and replenish the material extracted from the borrow area.
