# BEACH MANAGEMENT PLAN REPORT

## Hythe Ranges

**BMP 57**

Project Name: **Strategic Regional Coastal Monitoring**

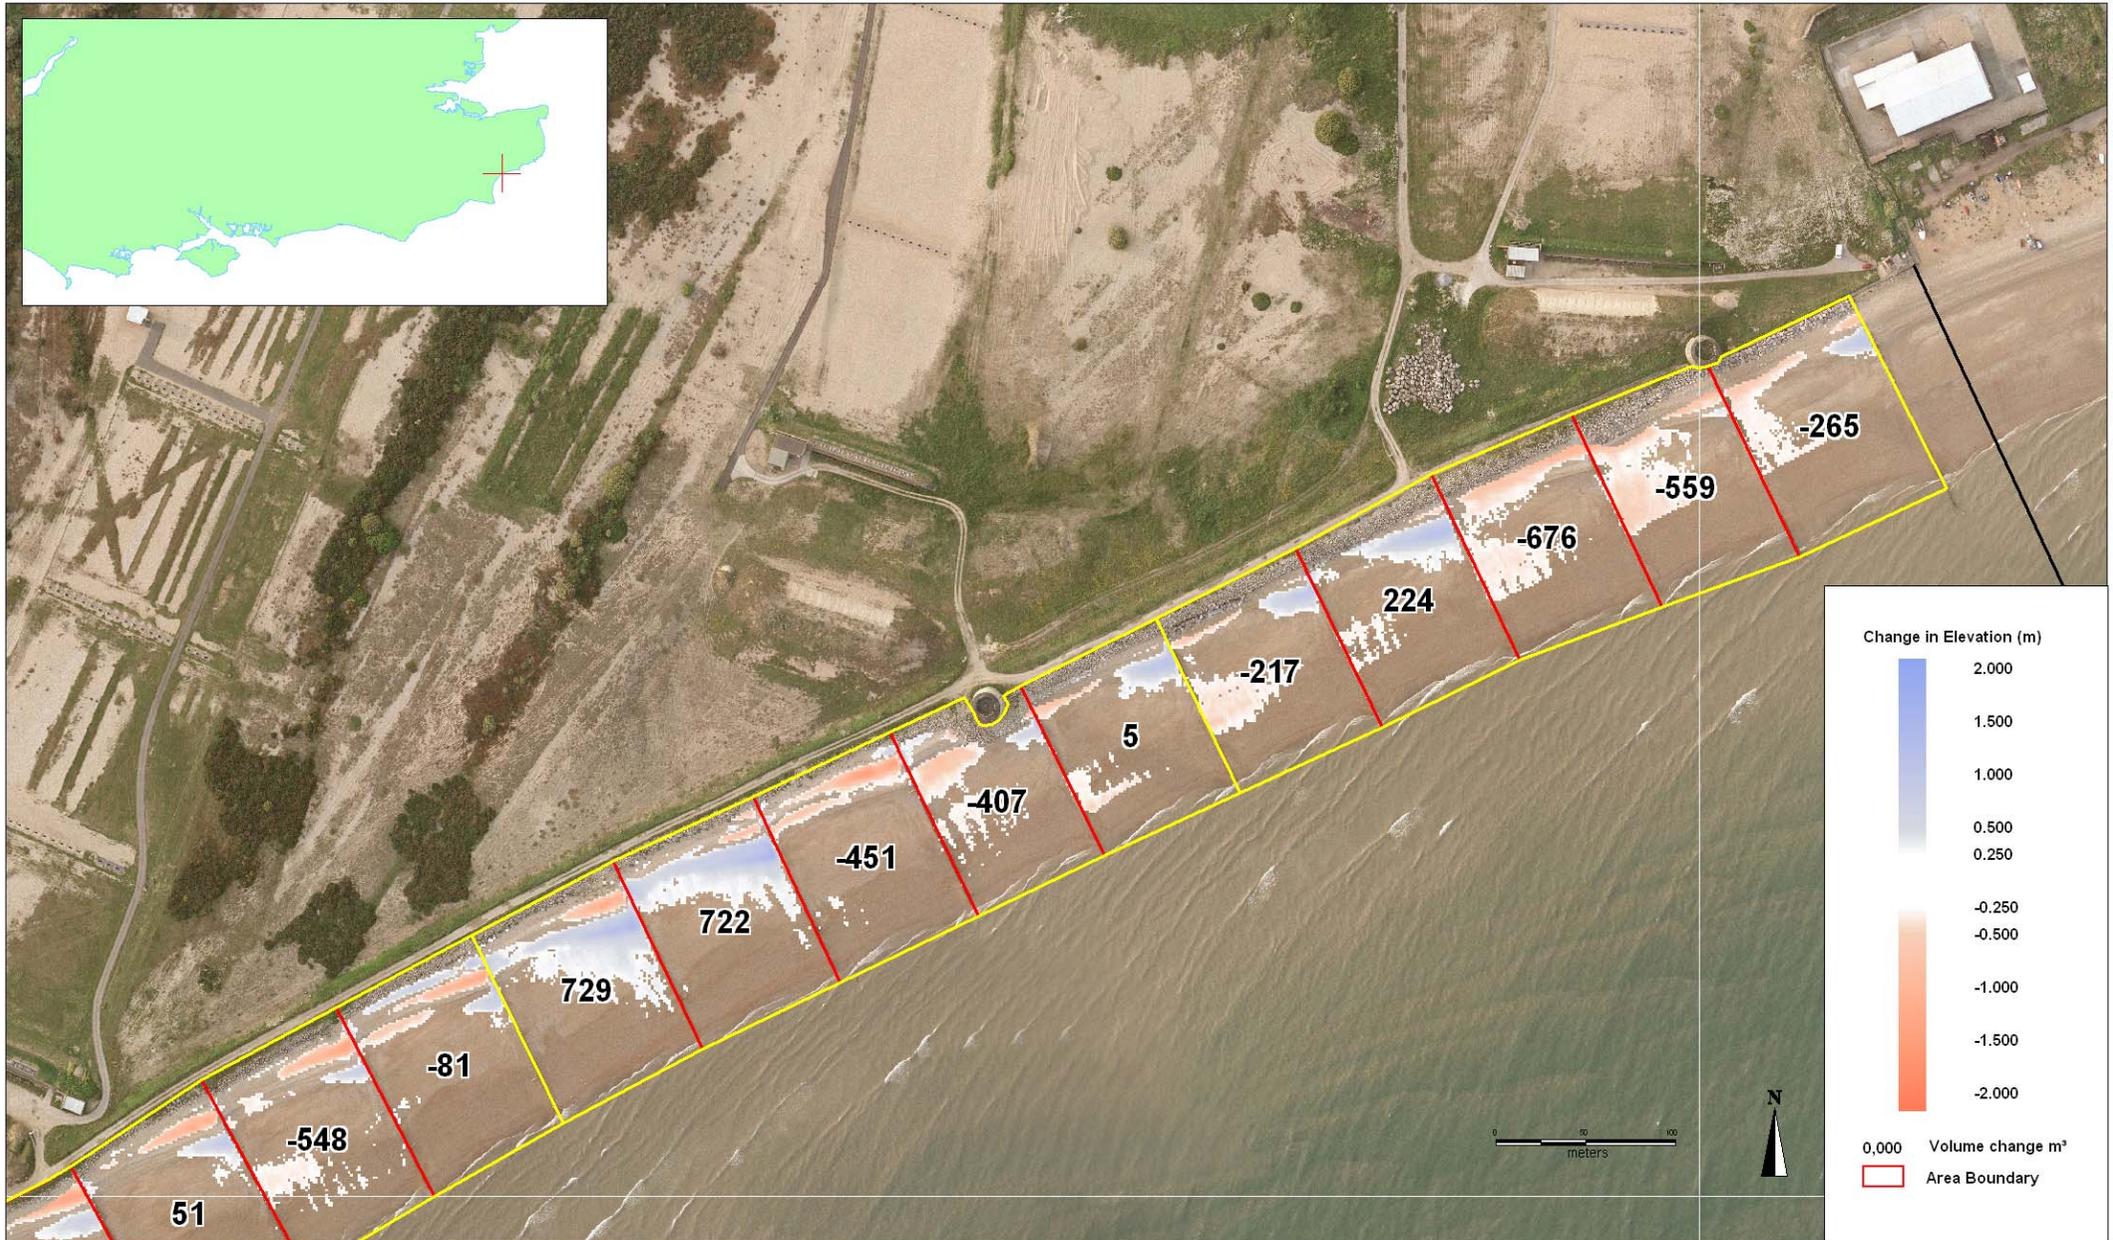
Figure 4.1 (1–4) are the difference models generated from the summer 2007 survey minus the 2006 survey, with negative values representing erosion that has occurred during that past period and positive values accretion. Whilst these figures show an overall change in beach volume within each discrete ‘area change boundary’ it should be recognised that the data is based on the beach management survey, which is undertaken once each year. It is therefore only a snapshot in time and the particular dynamics of each frontage need to be considered. This will ensure that the information shown in the difference models represents the net change rather than capturing a particular extreme variation caused by a large event.
