Figure 1: Management Unit 6A (Minnis Bay)

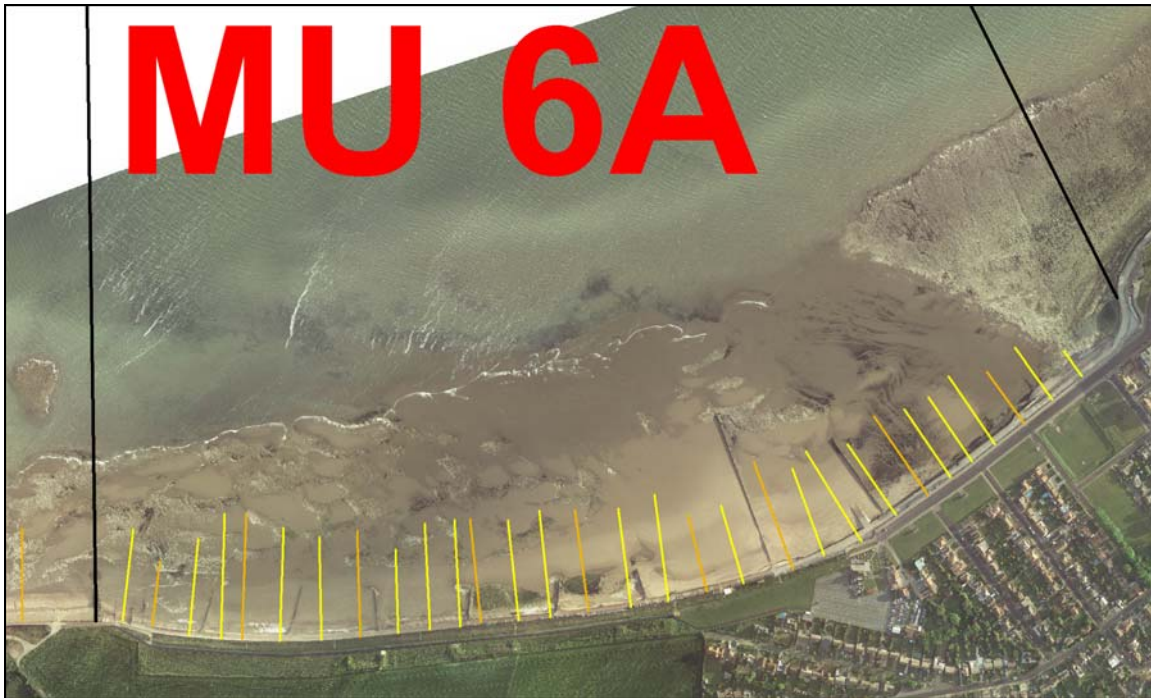
*Blue: Recycling Extraction Point*
Red: Recycling Deposition Area

The beach at Minnis Bay is a 1.3km stretch comprising of sand interspersed with shingle and rocks. The coastal defence along this stretch of coasts consists of a combination of timber and concrete groynes. A rock groyne divides Minnis Bay and its neighbouring area at the western end of this unit, primarily used to trap sediment travelling alongshore.

Due to fairly minimal sediment activity this section has not undergone any recycling works, although it has been subject to profile re-grading through the use of large machinery in attempt to reshape the beach face to increase protection.
