**ALLONBY BAY (MARYPORT TO DUBMILL POINT)****Baseline Information**

**Allonby Bay (Maryport to Dubmill Point)**  
Geomorphological Change in 2013

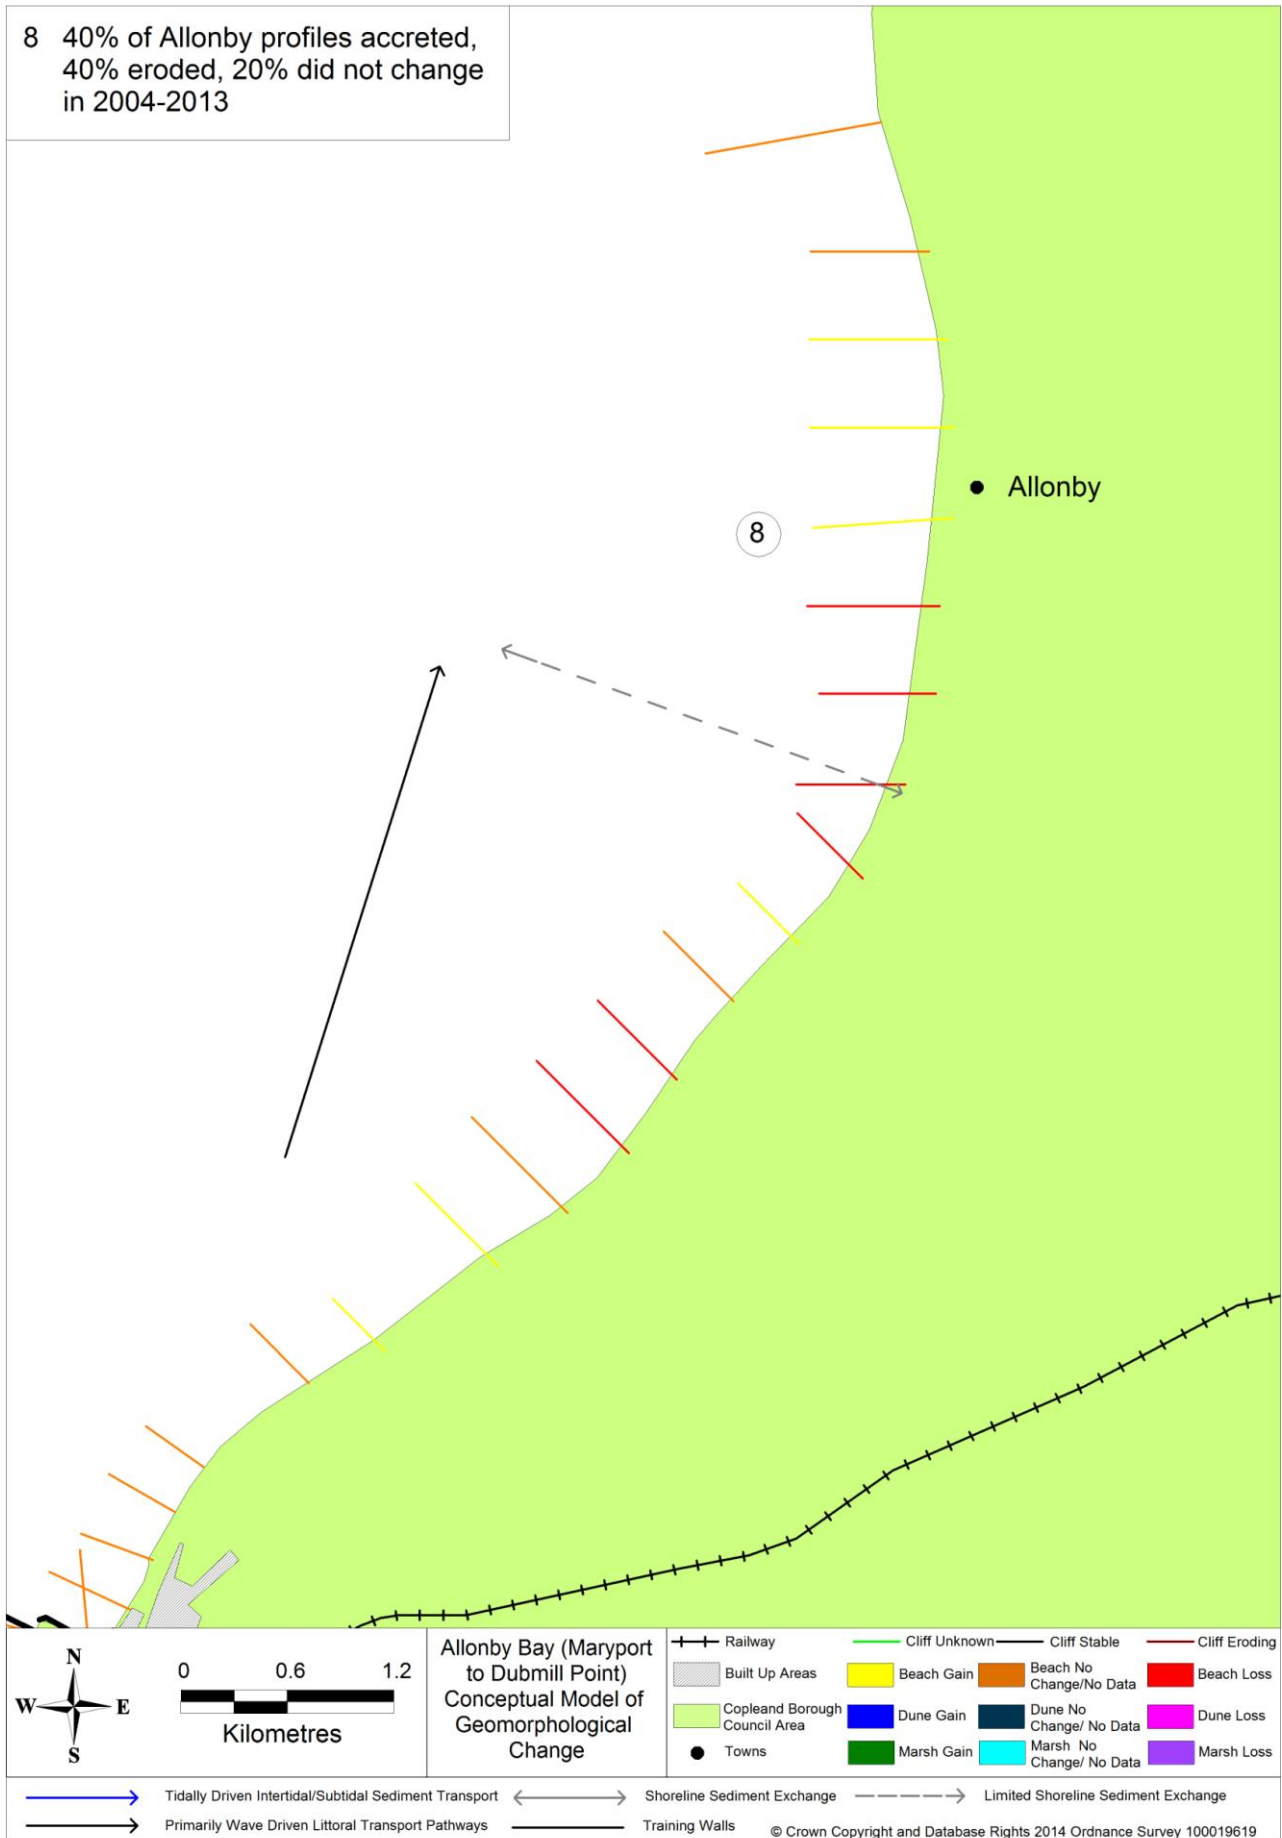
This behaviour is illustrated graphically on the plan overleaf.

Note: Where profile change is shown for individual profiles on the pictorial summaries, beach gain or loss is identified, where the magnitude of change in cross sectional area is greater than 2%. Where the magnitude of change is less than or equal to 2% this is denoted as no change.
