THE GRUNE

Baseline Information

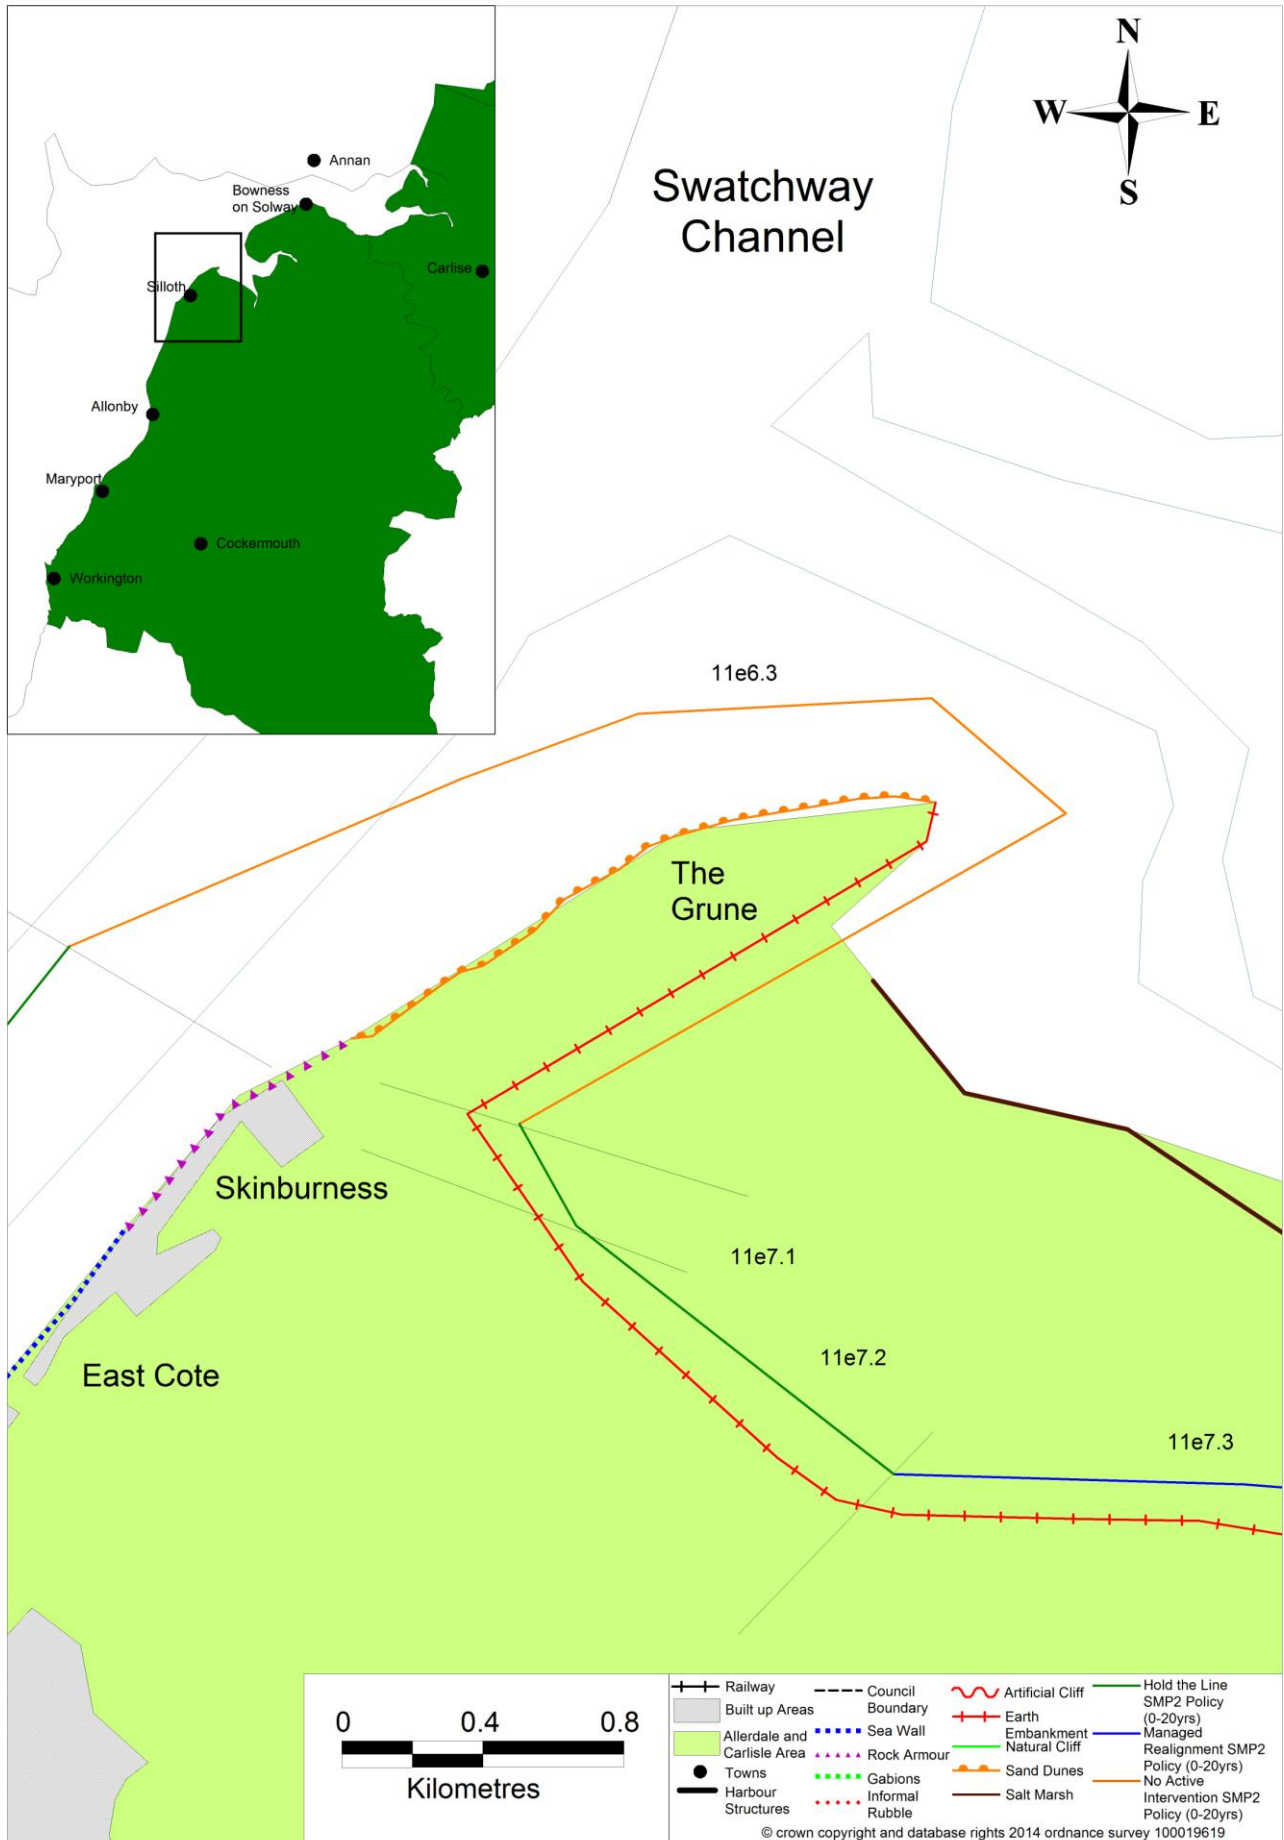
This section consists of a 2km long shingle spit and dune system formed by the northerly drift of sediment into the Solway Firth.

Historically, the spit was located seaward of its current position, so that it merged with the nearshore sand banks, but following a shift landward of the "Swatchway" Channel over the past century, the spit has narrowed and shortened, and detached from the intertidal sand and mud flats that it once joined. Erosion is thought to be connected with the movement of the zone of erosion following harbour construction at Silloth Bay in the 1850s (Halcrow, 2002).

Currently, the Swatchway moves away from the shoreline in this section, increasing the width of the inter-tidal zone. The upper foreshore consists of a steep, sand and shingle bank, with the lower foreshore consisting of sand and mud.

Localised rock armour defences were constructed around the slipway access to Grune House in 2008.

- **The Grune:** No Active Intervention in the short term (0-20yrs), medium term (20-50yrs) and long term (50-100yrs).

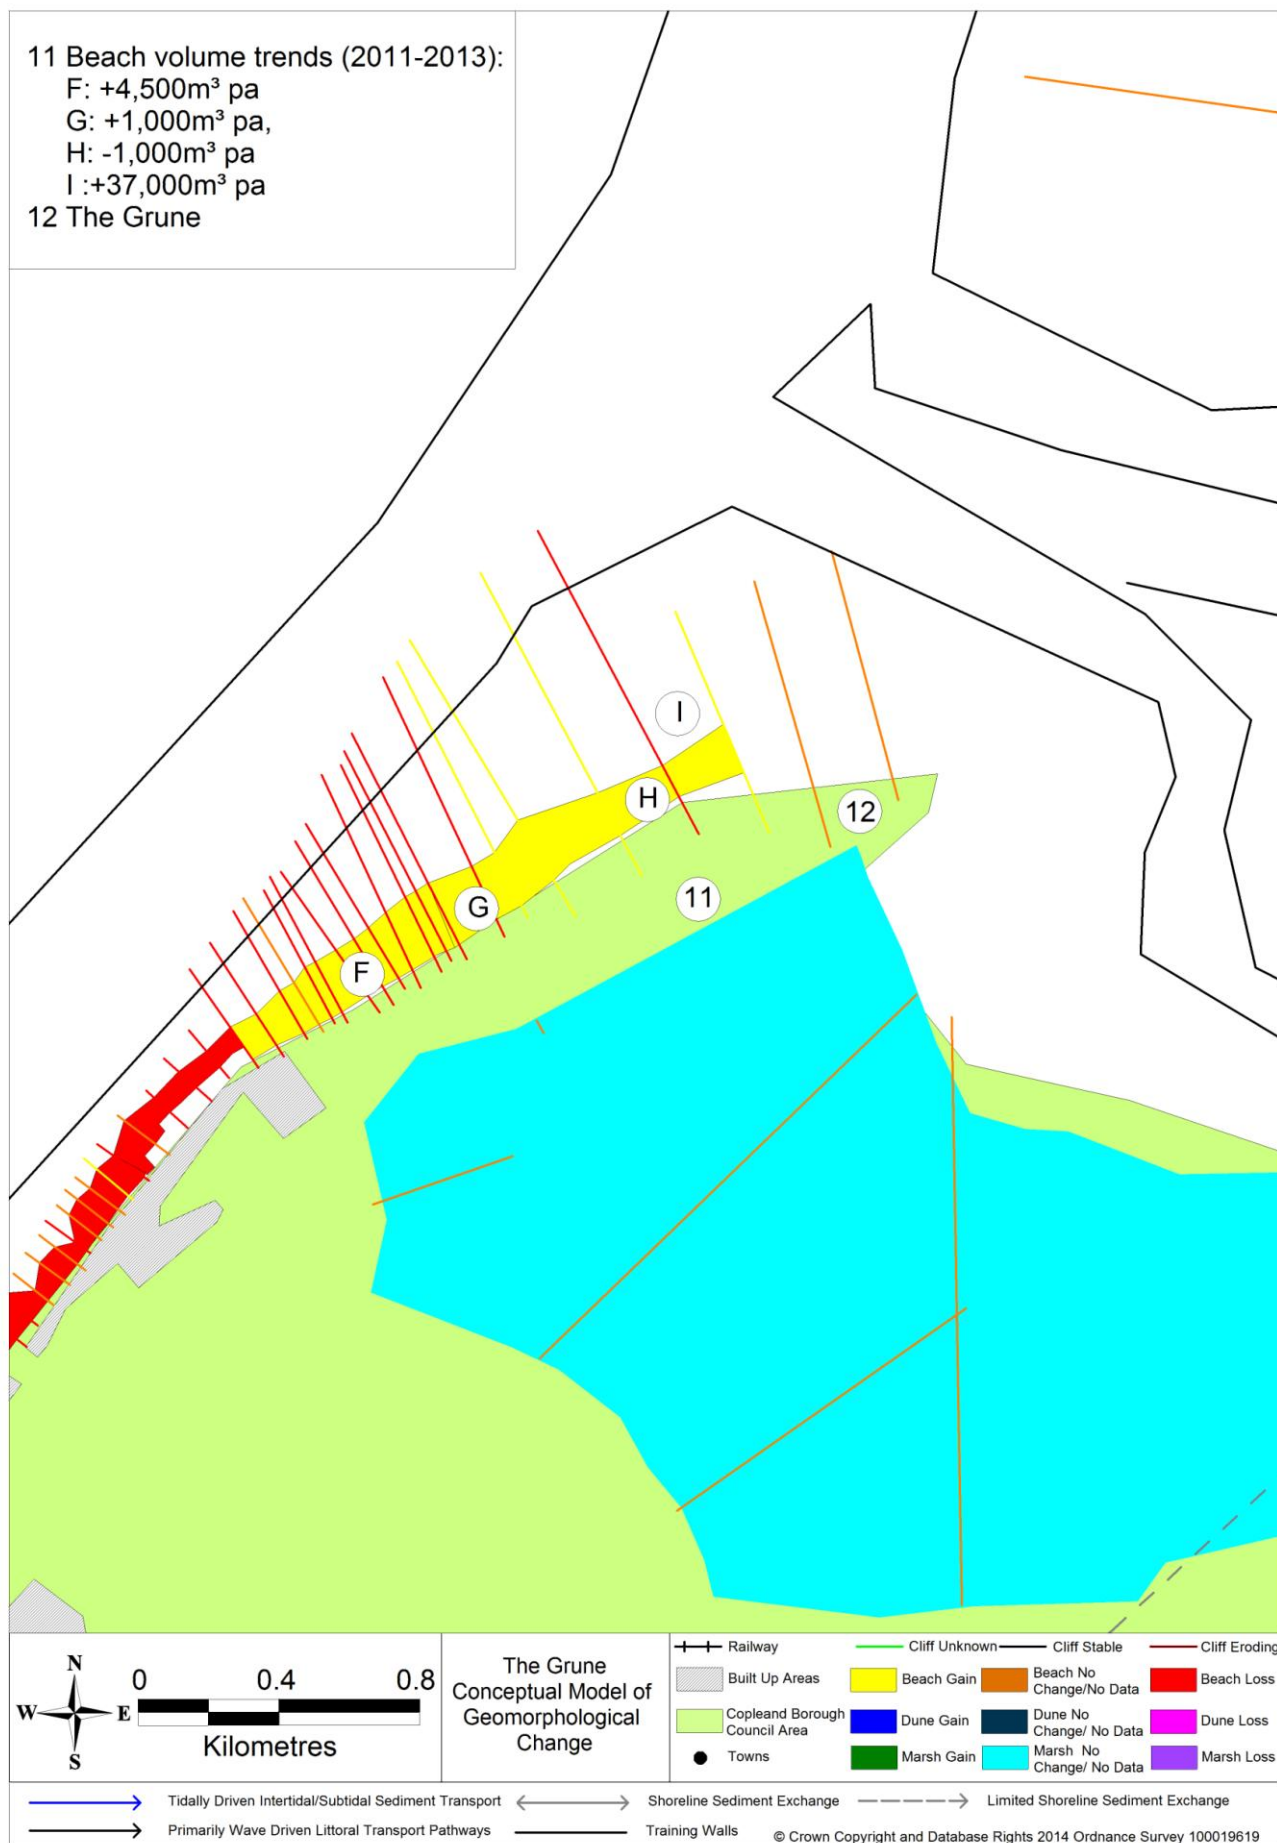
- Erosion of backshore and upper beach at western end but stability/accretion at northern end;
- Overall upper parts of beach accreting;
- Average volume increase in area F of 4,500m³ per year, based on 2011-2013 data;
- Average volume increase in area G of 1,000m³ per year, based on 2011-2013 data;
- Average volume decrease in area H of 1,000m³ per year, based on 2011-2013 data;
- Average volume increase in area I of 37,000m³ per year, based on 2011-2013 data; and
- Overall out of a total of 13 cross shore profiles recorded since 2004/05, 31% –accretion, 69% – erosion, and 0% – no change.

This behaviour is illustrated graphically on the plan overleaf.

Note: Where profile change is shown for individual profiles on the pictorial summaries, beach gain or loss is identified, where the magnitude of change in cross sectional area is greater than 2%. Where the magnitude of change is less than or equal to 2% this is denoted as no change.

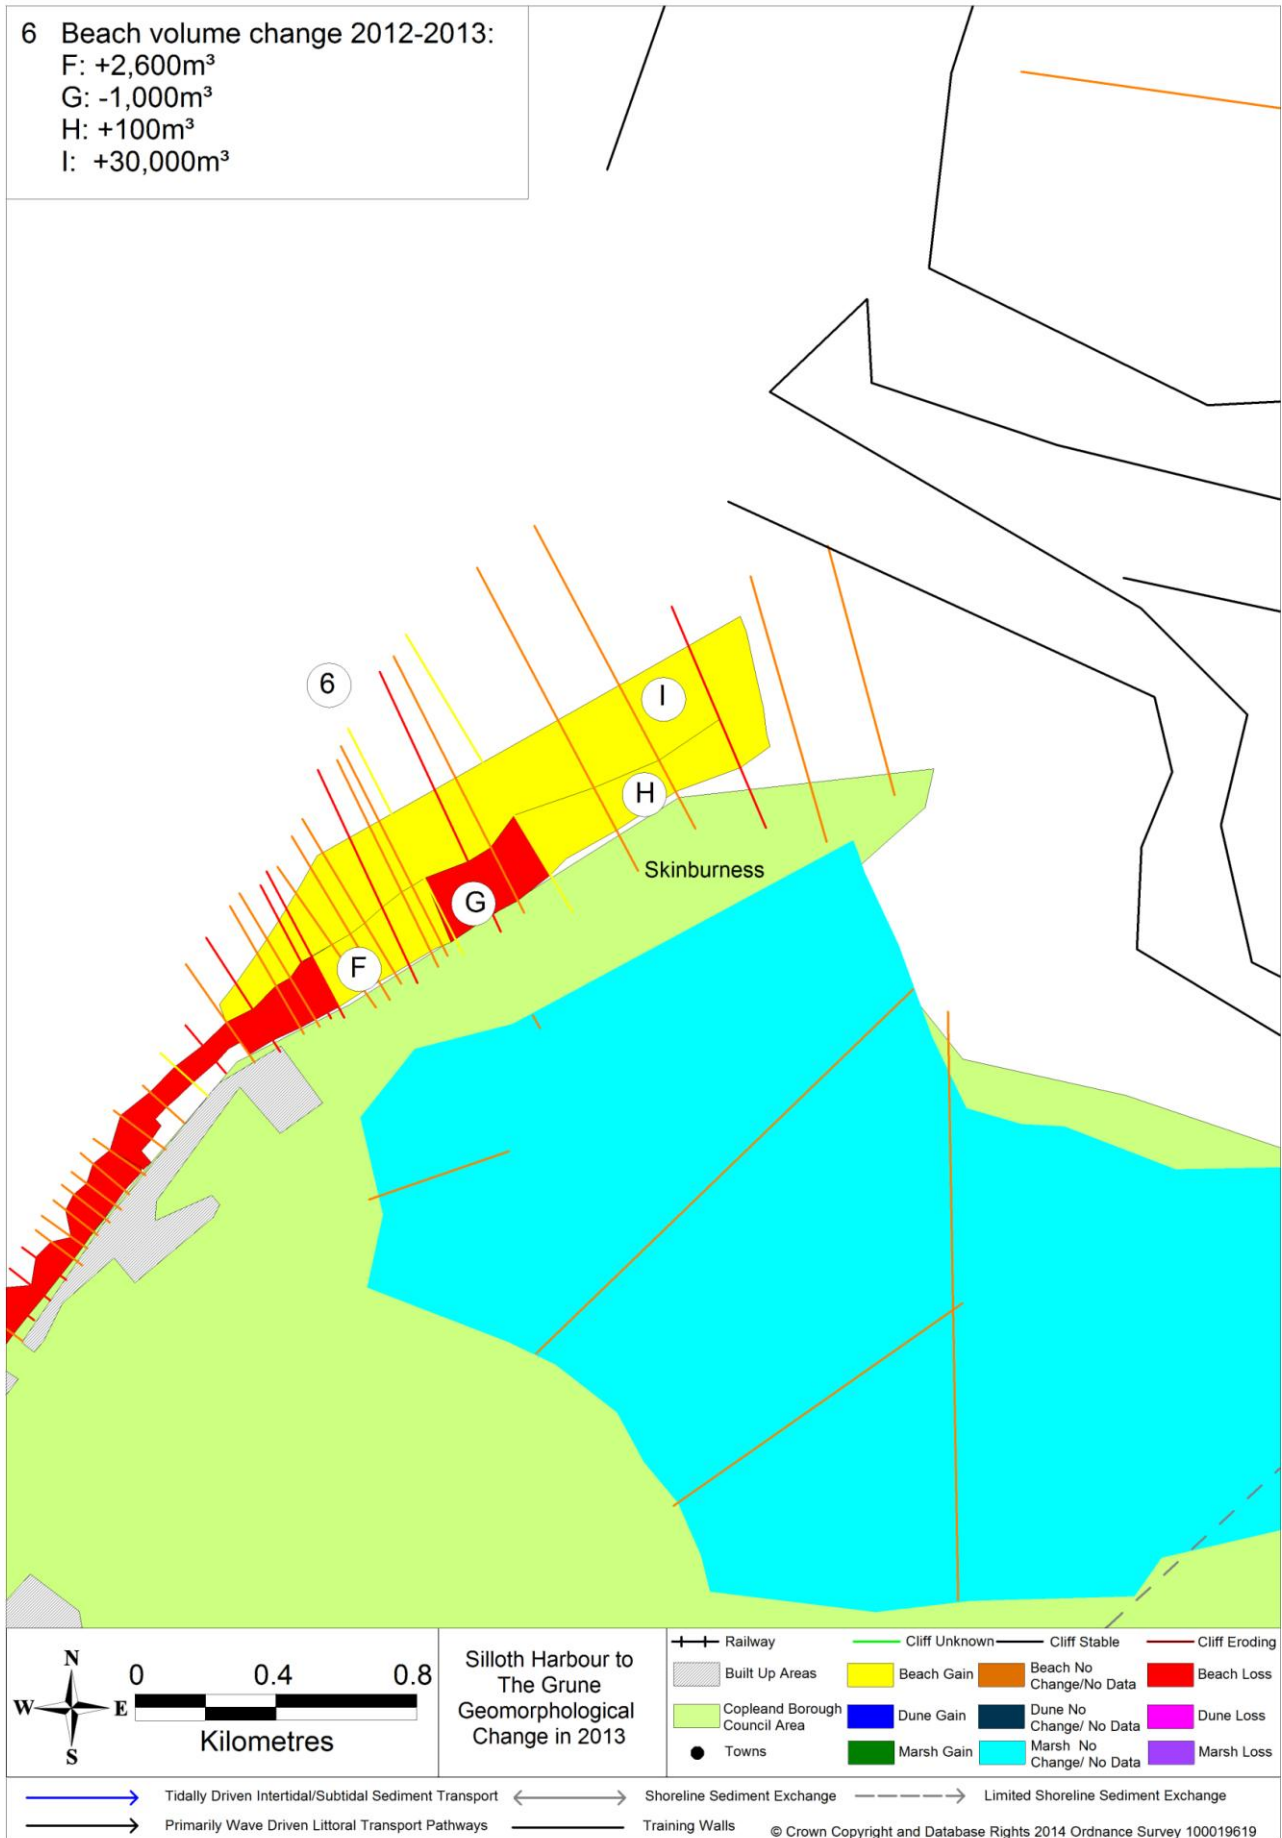
- Overall accretion of wider beach area (I) but variable behaviour on higher sections of foreshore;
- Beach volumes increased in area F by 2,600m³;
- Beach volumes decreased in area G by 1,000m³;
- Beach volumes increased in area H by 100m³;
- Beach volumes increased in area I by 30,000m³; and
- Overall out of a total of 13 cross shore profiles recorded, 15% –accretion, 23% – erosion, and 62% – no change.

Note: Where profile change is shown for individual profiles on the pictorial summaries, beach gain or loss is identified, where the magnitude of change in cross sectional area is greater than 2%. Where the magnitude of change is less than or equal to 2% this is denoted as no change.

The plot overleaf summarises the results from the monitoring data analysis for this section in 2013.

The following monitoring and management actions are recommended:

- Continue current monitoring regime;
- Improve additional remote sensing e.g. LiDAR;
- On-going monitoring of condition of artificial defence structures; and
- Carry out remedial works to maintain integrity of defences, as required.
