**Figure 1: Management Unit 09 (Sandgate)**

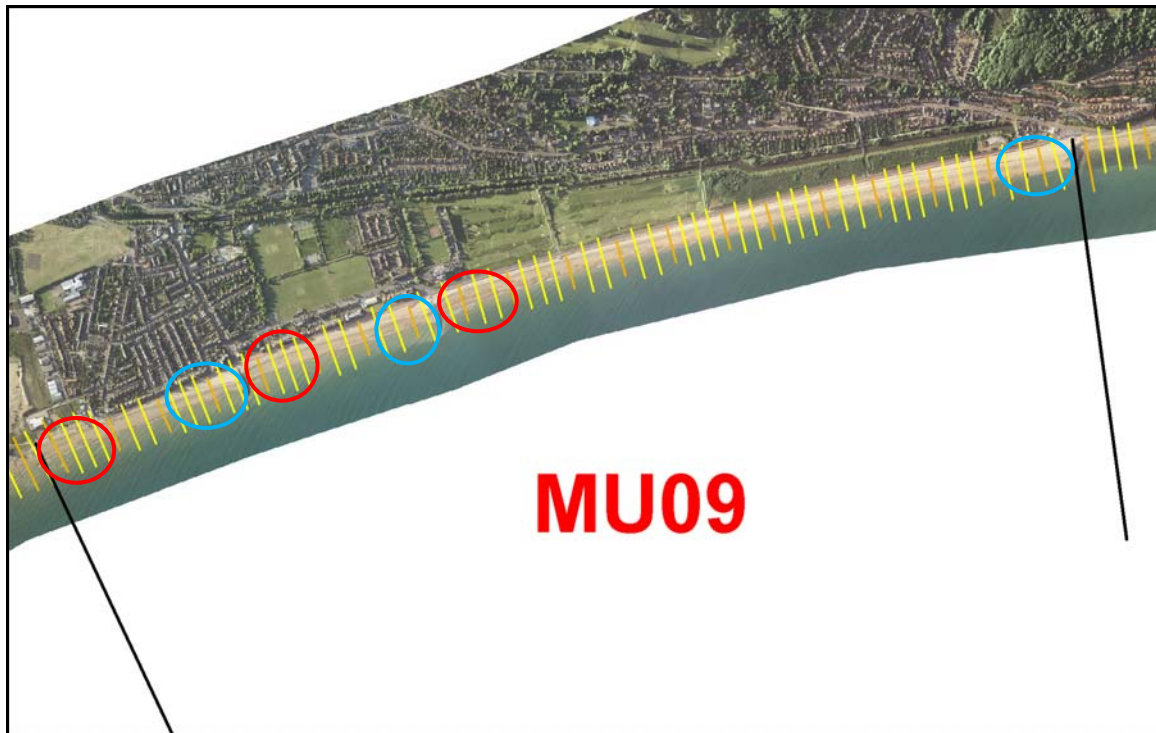
*Blue: Recycling Extraction Point*

*Red: Recycling Deposition Area*

This area is primarily low lying including amenity spaces Royal Military Canal and Hythe developments. The frontage is primarily shingle and backed by a seawall and promenade.
